## Northparkes Mines

# Annual Environmental Management Report

January 2014 – December 2014

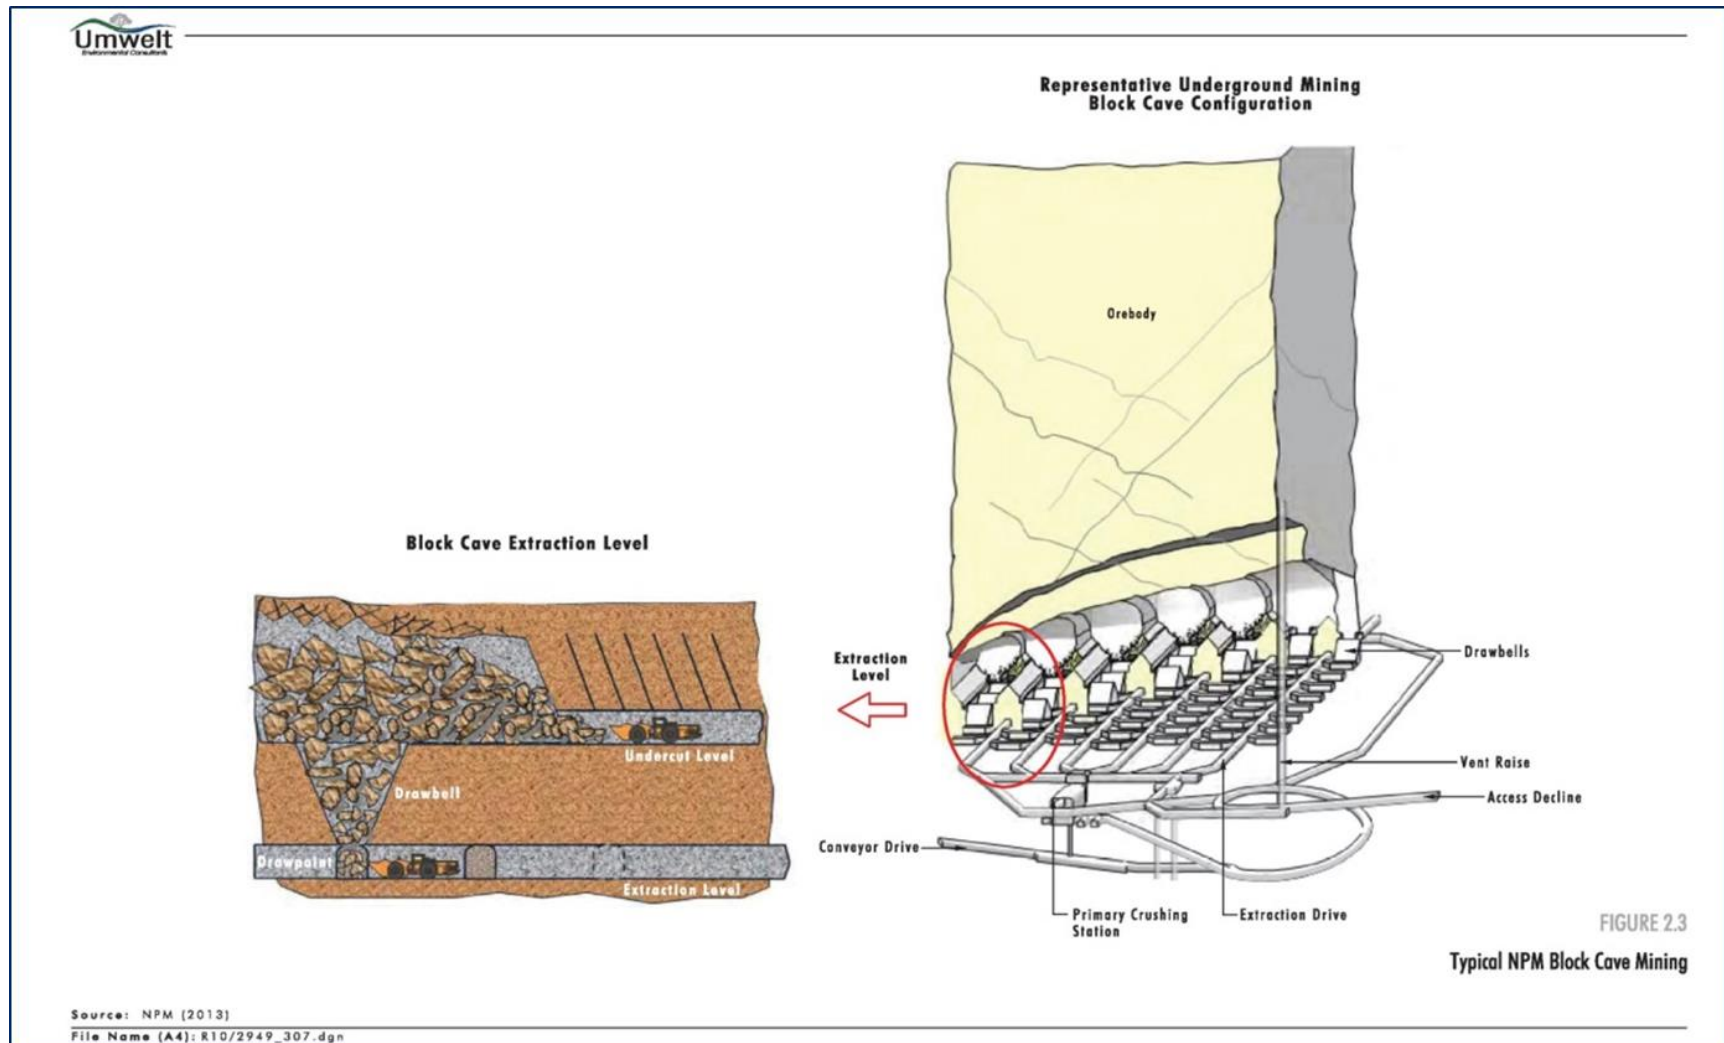
Figure 5 Block Cave Mining Method

In our Underground mine, automation of our loaders remained a crucial element to the success of Northparkes. In a world first, our E48 block cave reached 100% automation, making it our primary method of extracting ore from underground. This makes the E48 production level the most automated mining environment in the world.

The Underground team also added three new extraction drives to the E48 block cave. These drives expand the existing production level by 30%, broadening resources within the cave and extending the cave's life of the mine by a further two years and 12.6Mt.

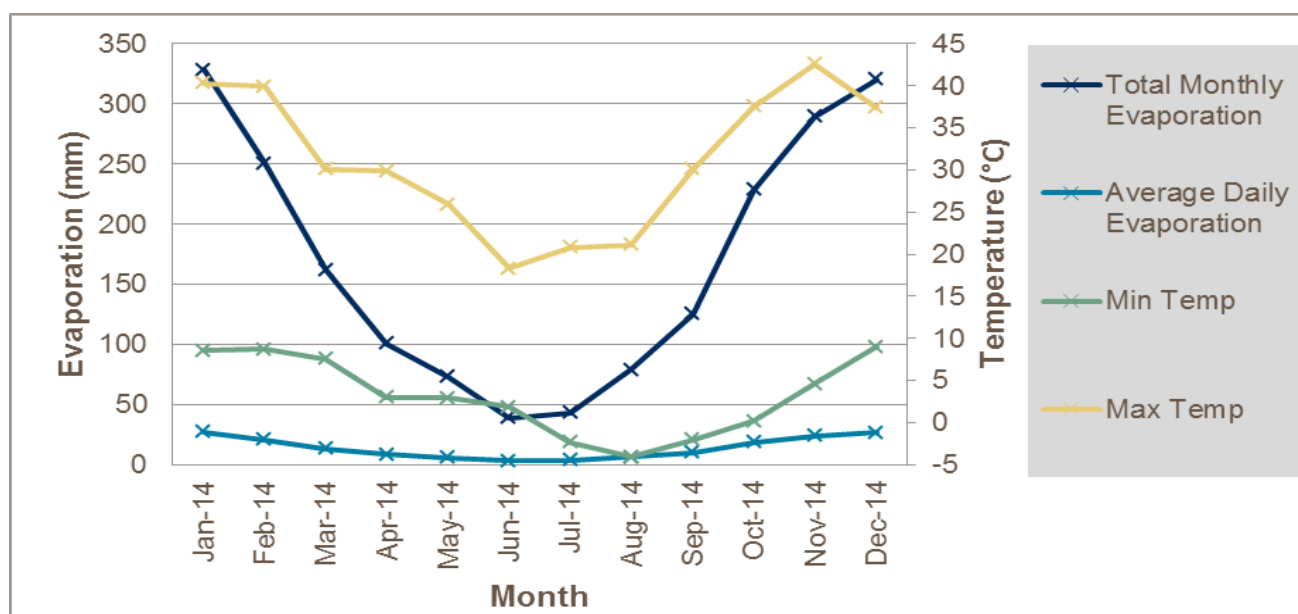
**Figure 8 Temperature and Evaporation Summary for 2014**

Temperature and evaporation for the reporting period are shown in Table 4. Daily temperature, wind and rainfall data is provided in Appendix 3 for the reporting period. Evaporation followed expected seasonal trends observed in previous climatic conditions for the region. The monthly maximum temperatures were significantly warmer, recorded at a mean of +1.26°C above the average. These figures are consistent with the national average which experienced the third warmest year on record.

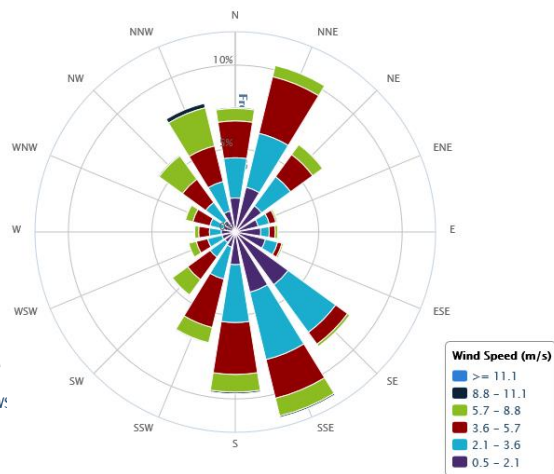
Summary Windrose – NPAWS001  
1/1/2014 – 31/12/2014

**North-east and south-east winds were the dominant winds throughout the reporting period. This is similar to previous reporting periods and is consistent with long term trends. Annual and quarterly wind roses have been produced to identify the predominant wind directions observed throughout the reporting period.**

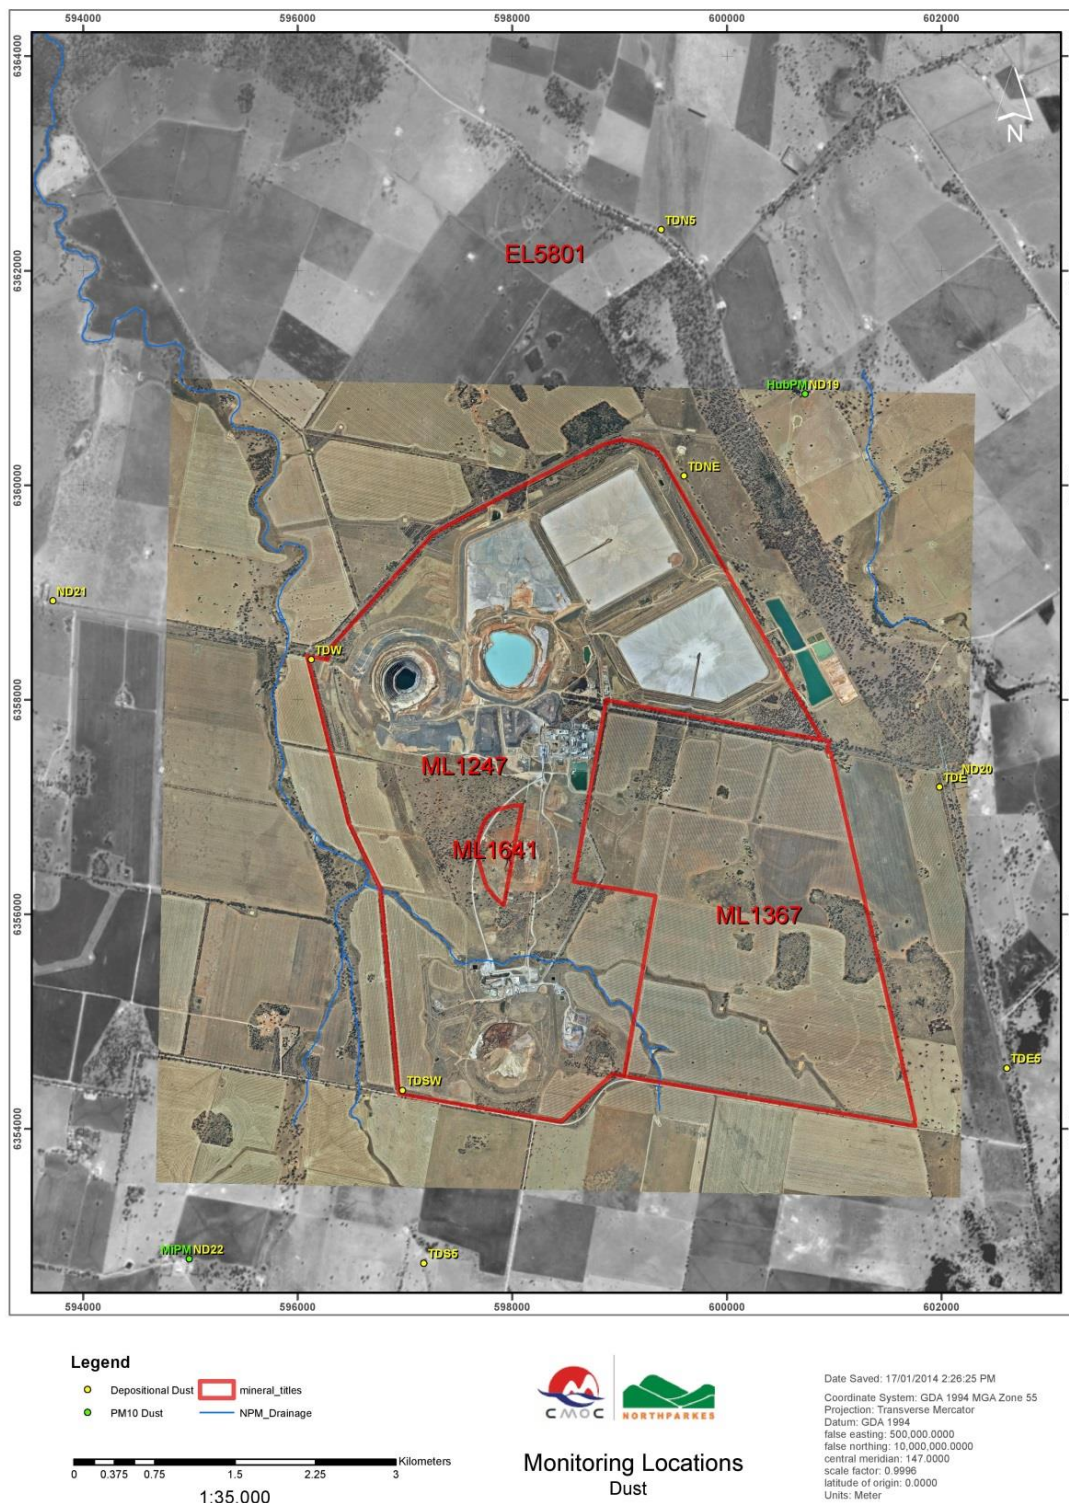
**Figure 10 NPM Air Quality Monitoring Locations**

Depositional dust gauges record the total of deposited dust for a month long period. Depositional dust gauges are a useful measure of broad scale changes to the local air quality but may be influenced by a number of sources including mining, agriculture, ambient dust, fires and vehicle emissions. Sample collection may also be affected by non-mining organic contamination (e.g. bird droppings, sticks and insects). For this reason depositional dust gauges are a less accurate sampling method from a particular activity.

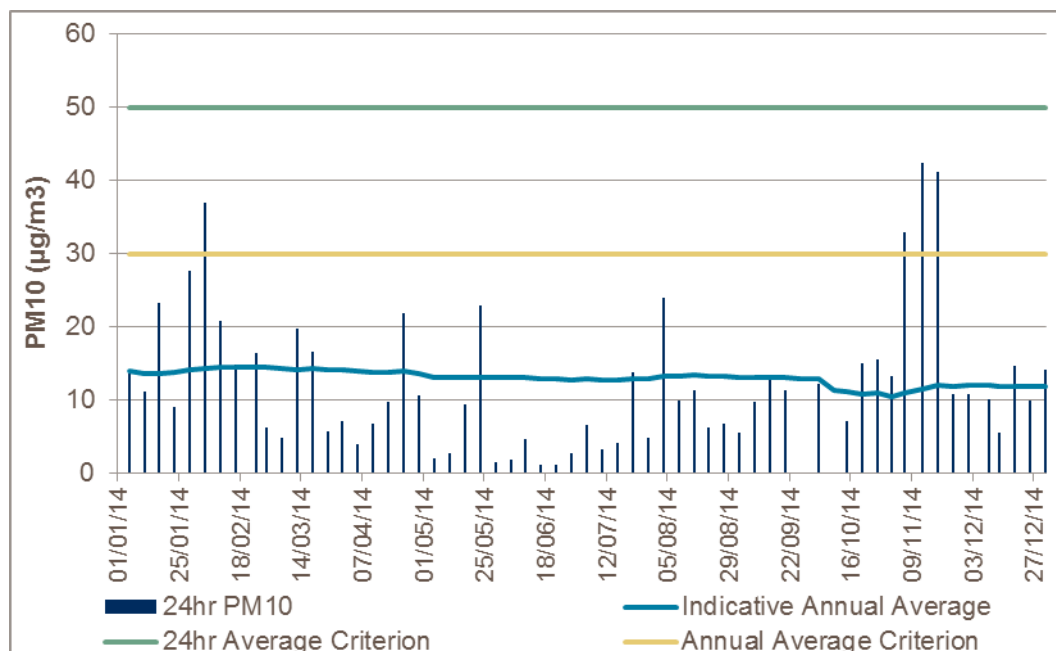
Figure 11 PM<sub>10</sub> Results for 'Hubberstone'

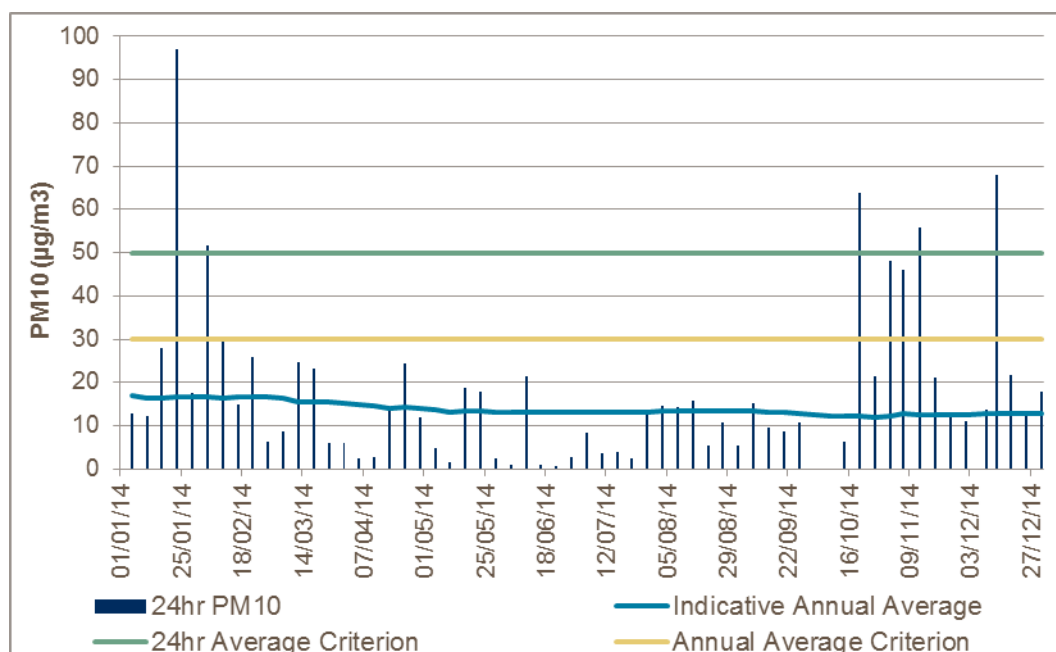
Figure 12 PM<sub>10</sub> Results for 'Milpose'

NA	23 January 2014	<p>PM<sub>10</sub> 24 hour average result (98.1 ug/m<sup>3</sup>) for "Milpose" monitoring location exceeded the 24 hour performance criteria (50 ug/m<sup>3</sup>) set out in Development Consent 06-0026. The result did not cause an exceedence of the annual average limit. An investigation was undertaken immediately to determine the likely cause of the exceedence.</p> <p>The investigation concluded that the prevailing wind direction was primary from the North East. Field notes indicate the presence of sheep activity in the nearby paddock. The monitoring cycle occurred on the 12<sup>th</sup> day without rain; rainfall occurred subsequent to this monitoring result, and under similar field observations (sheep in nearby paddock) PM<sub>10</sub> concentrations were considerably lower</p>
NA	4 February 2014	<p>PM<sub>10</sub> 24 hour average result (51.7 ug/m<sup>3</sup>) for "Milpose" monitoring location exceeded the 24 hour performance criteria (50 ug/m<sup>3</sup>) set out in Development Consent 06-0026. The result did not cause an exceedence of the annual average limit. An investigation was undertaken immediately to determine the likely cause of the exceedence.</p> <p>The investigation concluded that the prevailing wind direction was from North East. Field notes indicate dry conditions with sheep movement in the yard. A review of the monitoring data indicates that the elevated results were localised to the Milpose location.</p>

NA	20 October 2014	<p>PM<sub>10</sub> 24 hour average result (63.8 ug/m<sup>3</sup>) for "Milpose" monitoring location exceeded the 24 hour performance criteria (50 ug/m<sup>3</sup>) set out in Development Consent 06-0026 and Project Approval (11_0600). The result did not cause an exceedence of the annual average limit. An investigation was undertaken immediately to determine the likely cause of the exceedence.</p> <p>The investigation concluded that the prevailing wind direction was from South, towards the Mine Lease from the monitor location. A review of the monitoring data indicates that the elevated result was localised to the Milpose farm. Other PM<sub>10</sub> monitoring events in the month of May had a lower recorded value and Depositional Dust results recorded lower values toward the Mine Lease boundary whilst high results were localised to the Milpose location.</p>
NA	13 November 2014	<p>PM<sub>10</sub> 24 hour average result (55.8 ug/m<sup>3</sup>) for "Milpose" monitoring location exceeded the 24 hour performance criteria (50 ug/m<sup>3</sup>) set out in Development Consent 06-0026 and Project Approval (11_0600). The result did not cause an exceedence of the annual average limit. An investigation was undertaken immediately to determine the likely cause of the exceedence.</p> <p>The investigation concluded that the prevailing wind direction was primarily from the South, towards the Mine Lease from the monitor location. A review of the monitoring data indicates that the elevated result was localised conditions in the vicinity of the sampler.</p>

NA	13 December 2014	<p>PM<sub>10</sub> 24 hour average result (68.1 ug/m<sup>3</sup>) for "Milpose" monitoring location exceeded the 24 hour performance criteria (50 ug/m<sup>3</sup>) set out in Development Consent 06-0026 and Project Approval (11_0600). The result did not cause an exceedence of the annual average limit. An investigation was undertaken immediately to determine the likely cause of the exceedence.</p> <p>The investigation concluded that the prevailing wind direction was primarily from the North West, towards the Mine Lease away from the monitor location. A review of the monitoring data indicates that the elevated result was localised sheep shearing activities in the vicinity of the sampler.</p>
74003816	02 October 2014	<p>NPM reported a tailings spill incident to EPA on 02 October 2014 thorough EPA Pollution Hotline. The tailings line on the western line at concentrate truck access gate spilt which resulted in 5m<sup>3</sup> of tailings spill, causing the spillage pond to overflow into access road drain. The flange section of the pipe gave away which resulted in the tailings spilt.</p>

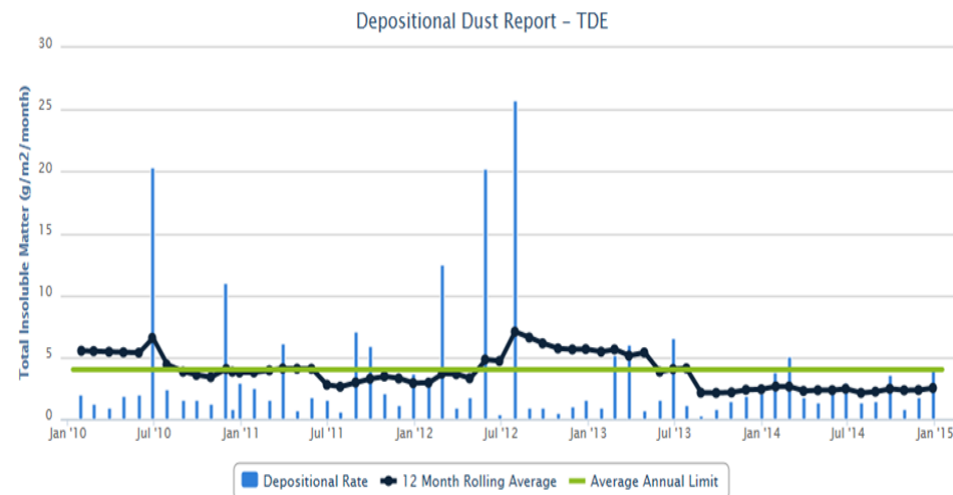
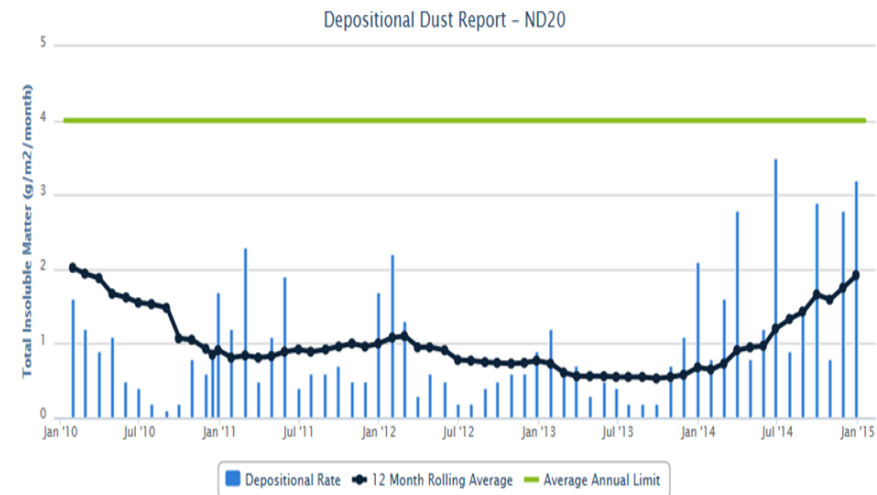
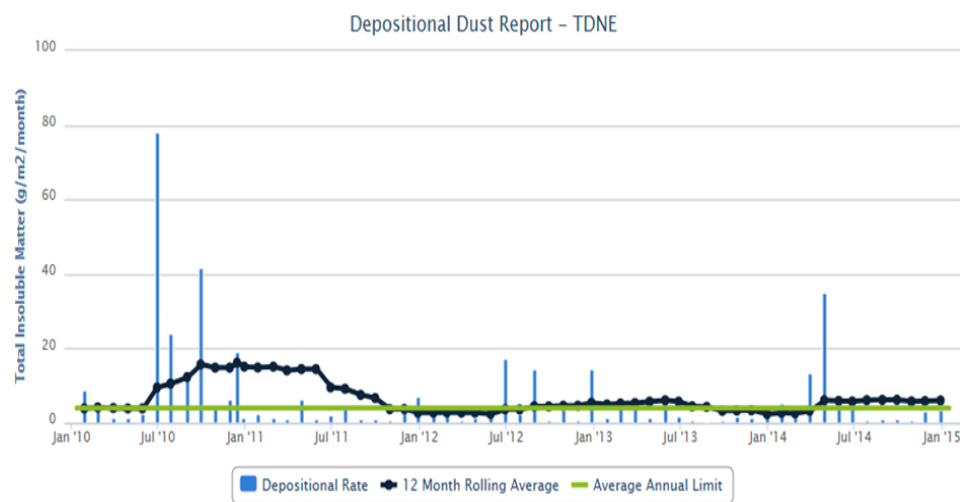
Figure 13 Depositional dust annual averages

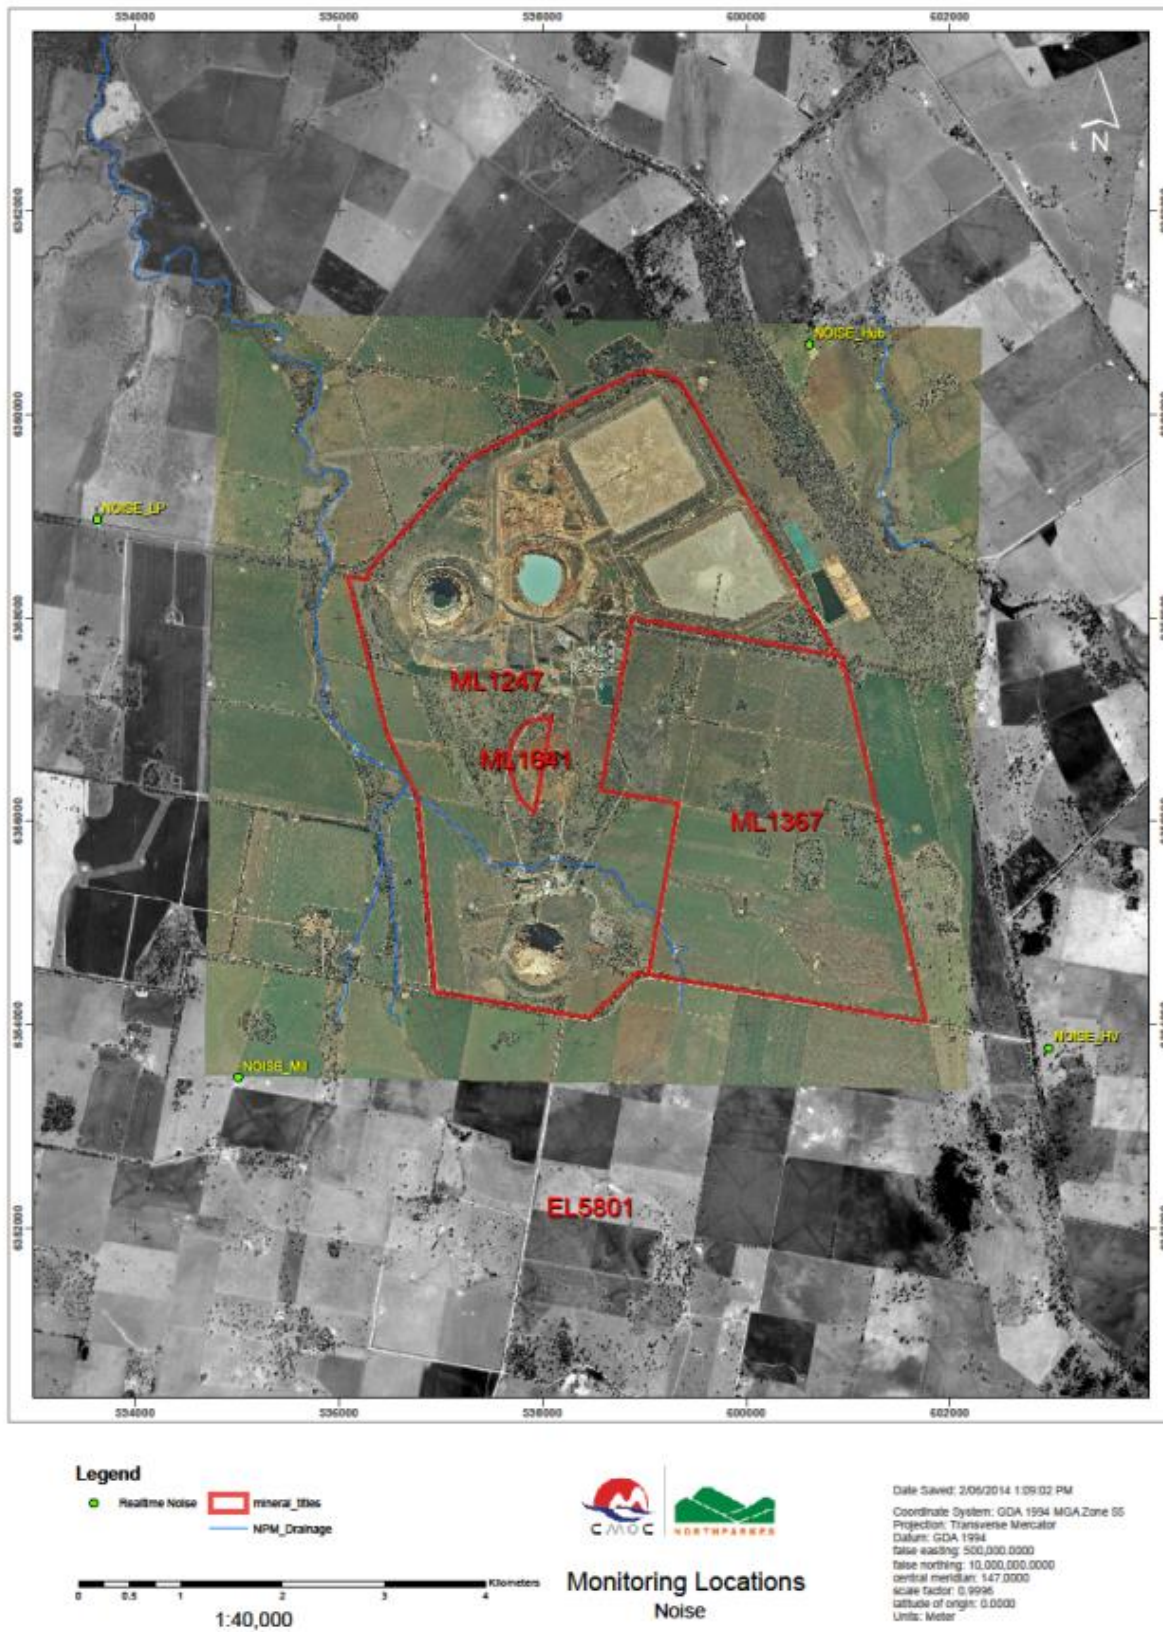
Figure 14 NPM Noise monitoring locations

In addition to the operator-attended monitoring, unattended continuous noise logging is undertaken at the three monitoring locations to determine the overall ambient noise amenity levels of background noise, and any noise generated by mine activity. This is undertaken over a seven day period at which point the loggers are retrieved and the information is assessed. It should be noted that the ambient noise levels obtained from the loggers are not necessarily the contributed noise emissions arising from NPM operations alone. The ambient noise level data quantifies the overall noise level at a given location independent of its source or character. The noise logger calculates the statistical noise indices and does not 'record' the actual noise.

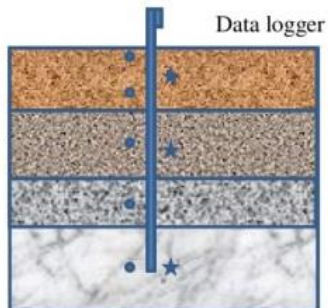
Plot 3 Shallow cover with capillary break

Top soil (2 suction, 1 moisture)

Waste rock (1 suction, 1 moisture)

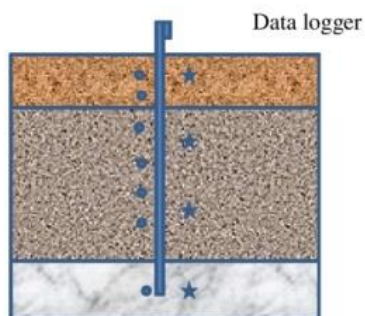
Plot 4 Standard cover

Top soil (2 suction, 1 moisture)

Waste rock (4 suction, 2 moisture)
