Northparkes Mines

Environmental Monitoring Results Summary

01 January to 31 March, Quarter 1, 2015

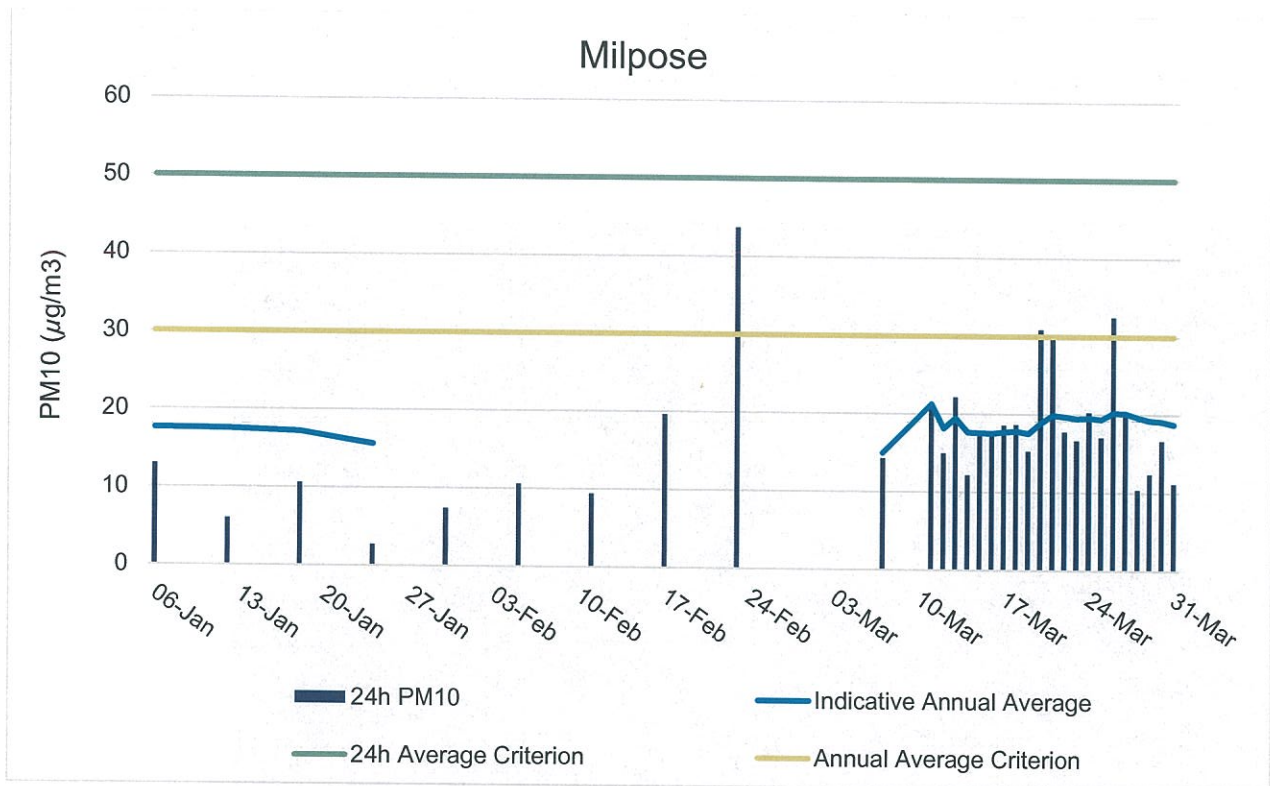
Figure 5 PM₁₀ results for 'Milpose' residence in the reporting period

All PM10 results were below both the 24 hour criterion for the quarter. No exceedences were recorded at any of the locations. One monitoring cycle on the 1st of March was missed at both Hubberstone and Milpose, this was in the early stages of the transition from Hi-Volume air samplers to real-time beta-attenuation monitoring.

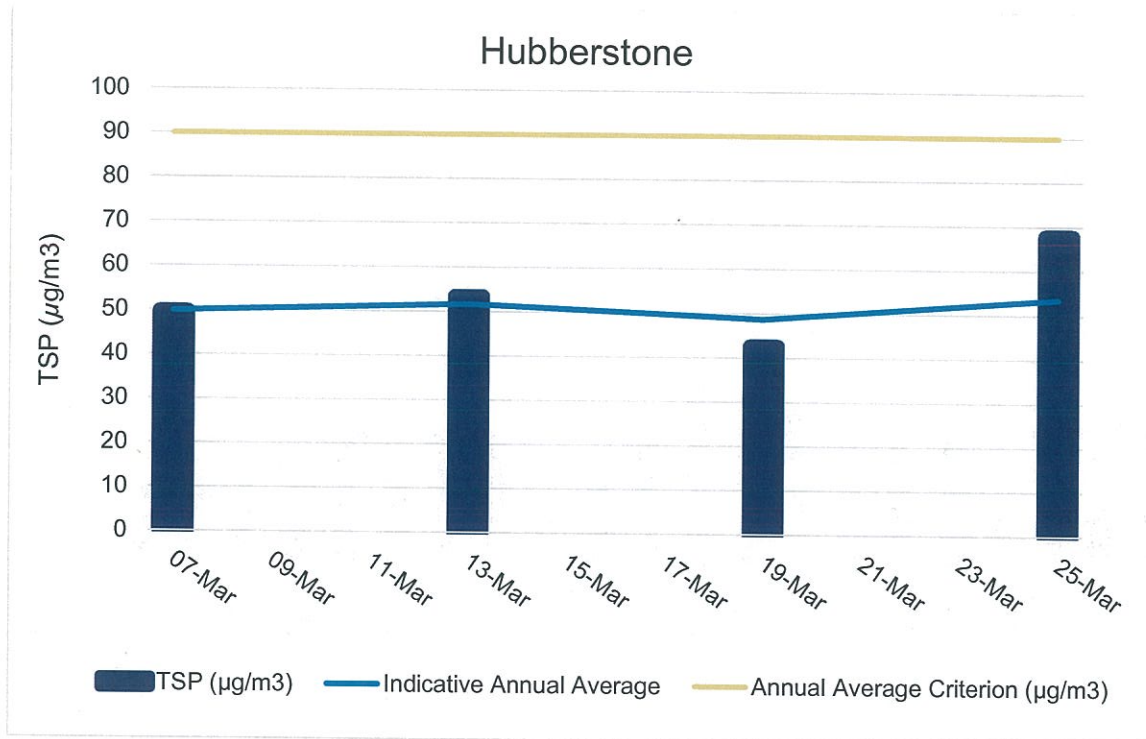
Figure 8 TSP results for 'Hubberstone' residence in the reporting period

TSP monitoring is reported from the 7th March, to align with the commencement of the Rosedale tailings Project. Early TSP data shows that levels are well below the annual average criterion across all locations.

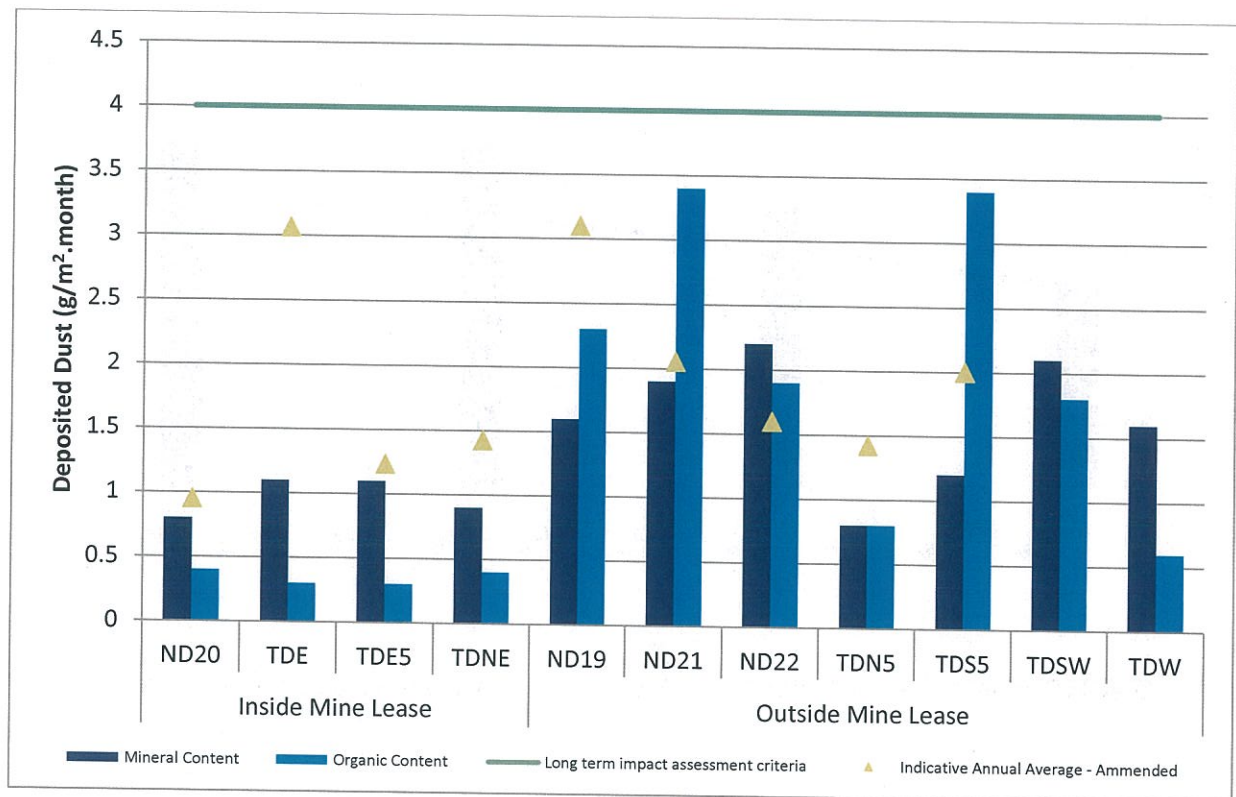
Figure 11 Depositional dust monitoring results for January 2015

There were four depositional monitoring results that exceeded the trigger levels and resulted in investigations. Three of the exceedances were reported in January at ND21, ND22 and TDS5 (Figure 11) and one in February (Figure 12) at TDE, all exceedances were identified and investigated.

All depositional investigations concluded that exceedances were the result of localised farming activities and traffic on nearby dirt roads. No exceedances were attributed to NPM Mining operations for the period.

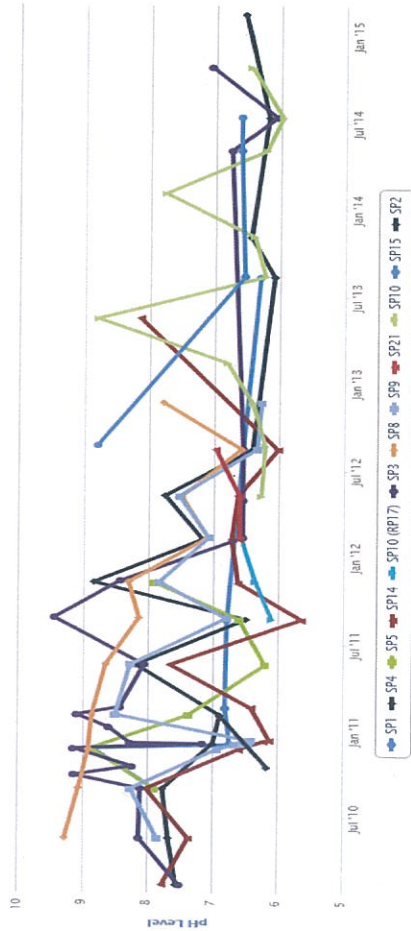
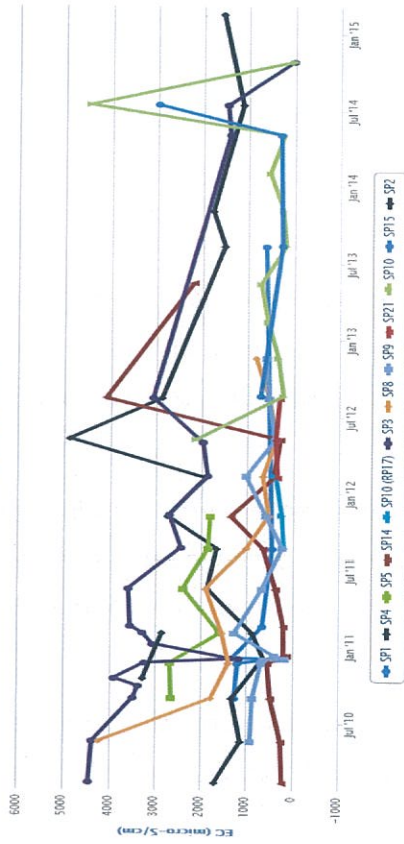
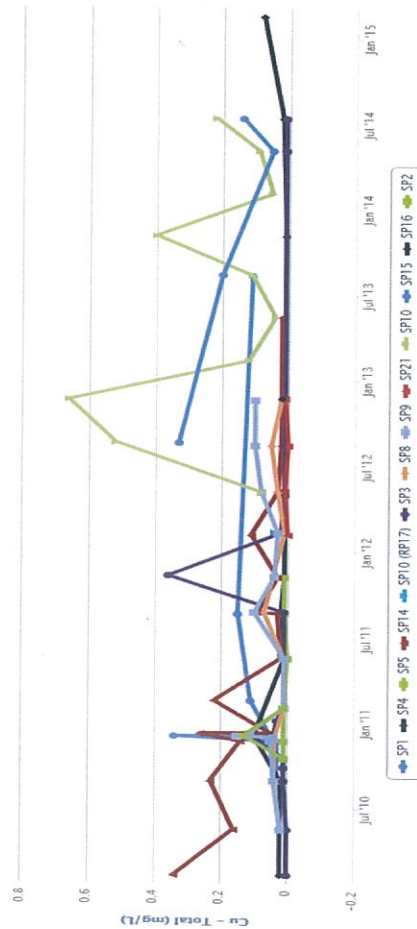
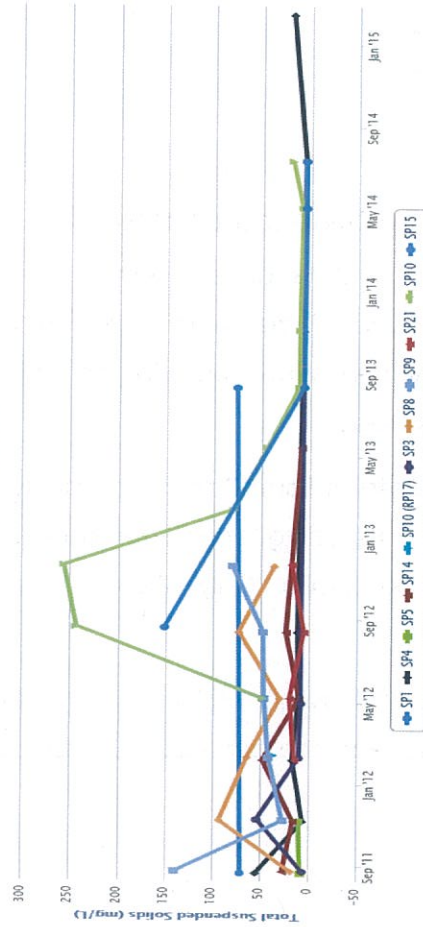
Figure 16 Surface water quality results - Sediment ponds

Water quality of onsite sediment ponds are presented in Figure 16. Dry conditions during the reporting period meant the majority of the sediment ponds were dry or at levels below 10%, resultantly only SP04 was monitored for the period. All results for SP04 were generally within range of the long term average.

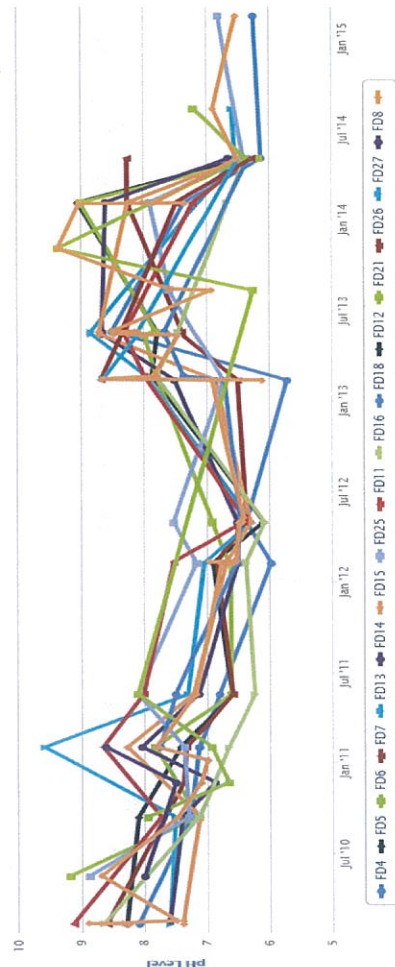
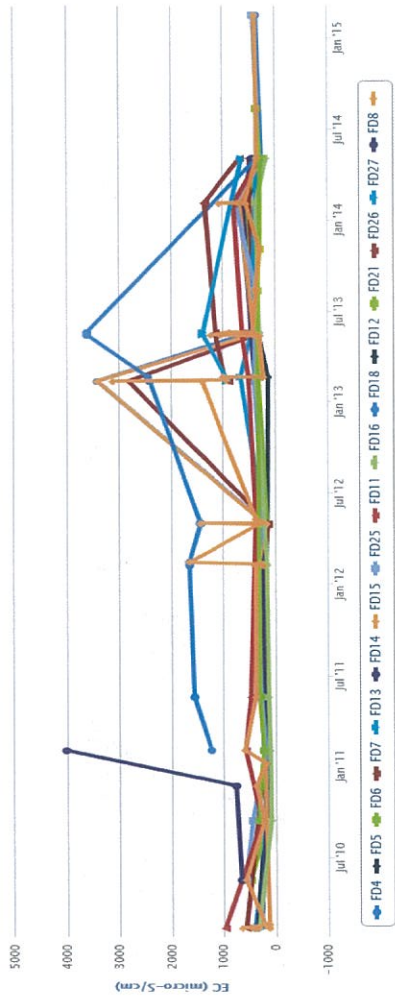
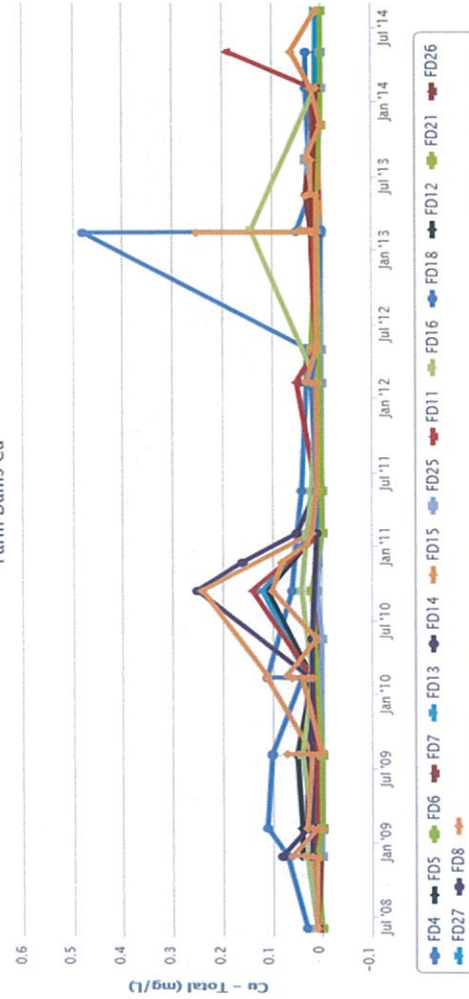
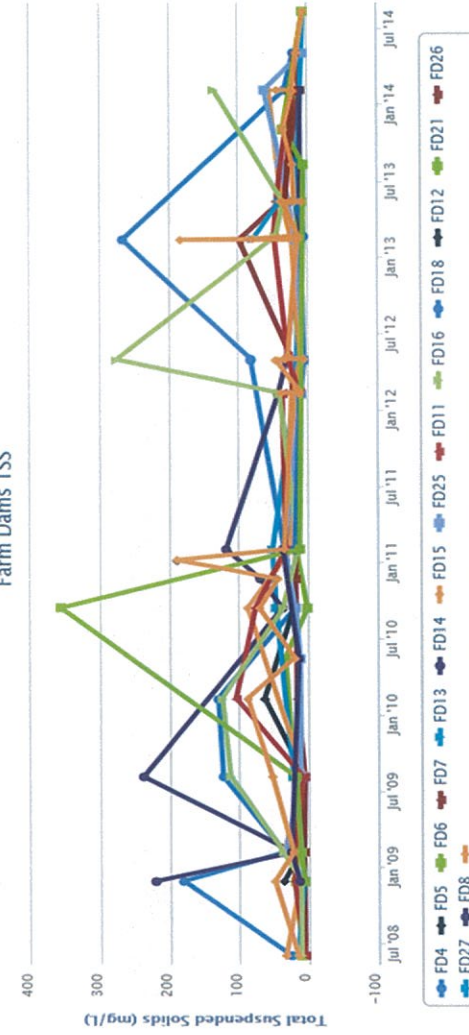
Figure 17 Surface water quality results - Farm dams

Historical trend data of Farm Dams in proximity to the mine lease is recorded in Figure 17. Results from the current reporting period for both pH and conductivity continue to follow historical background water quality. Only FD4 and FD25 had volumes that were above 10% full for the period.

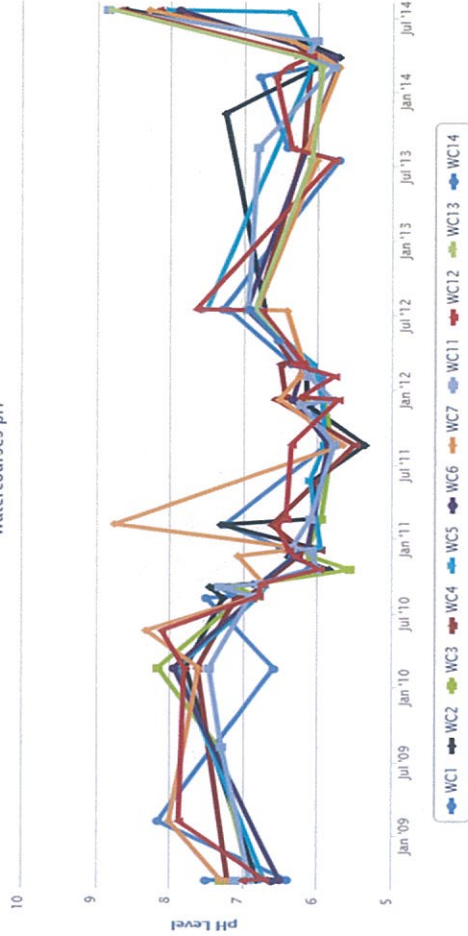
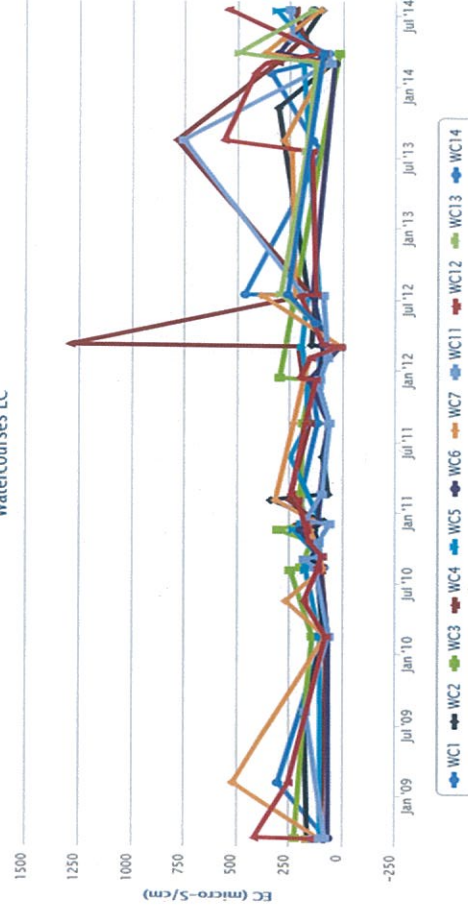
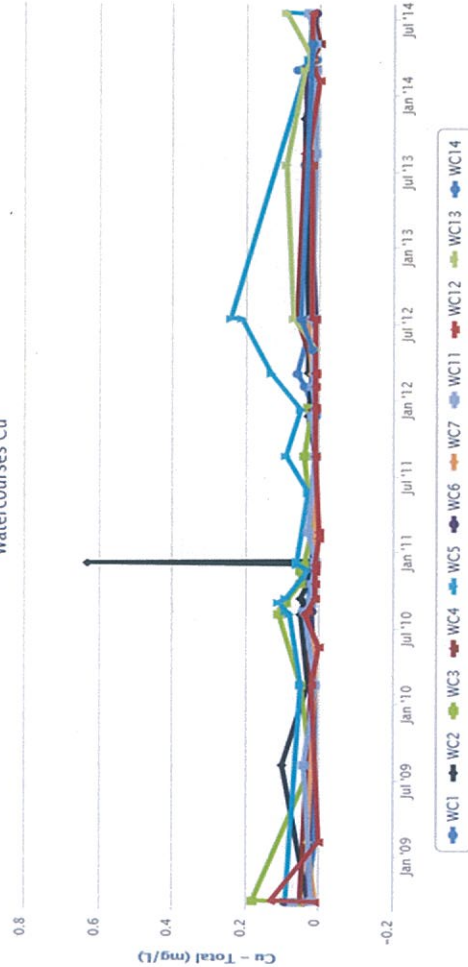
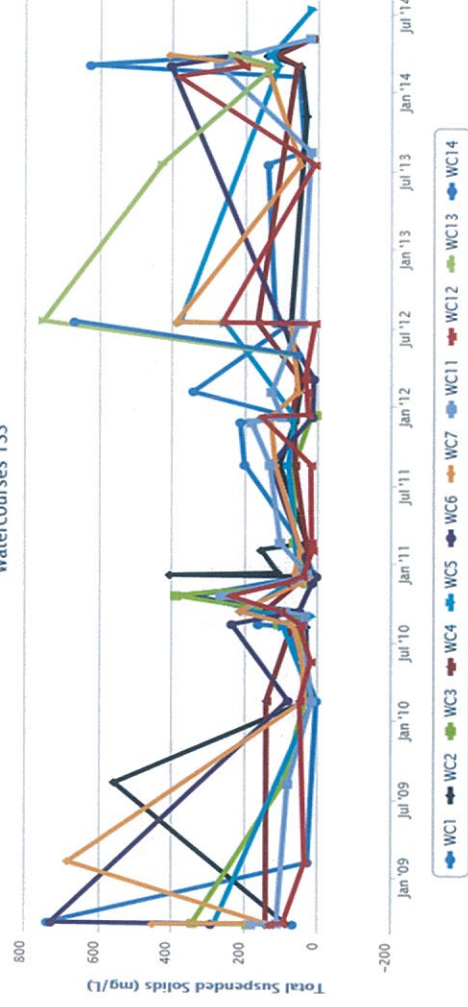
Figure 18 Surface water quality results – Water Courses

There was no rainfall event resulting in flow during the reporting period. No watercourses were monitored for the reporting period. Results remain unchanged from Quarter 4, 2014, shown in Figure 18.

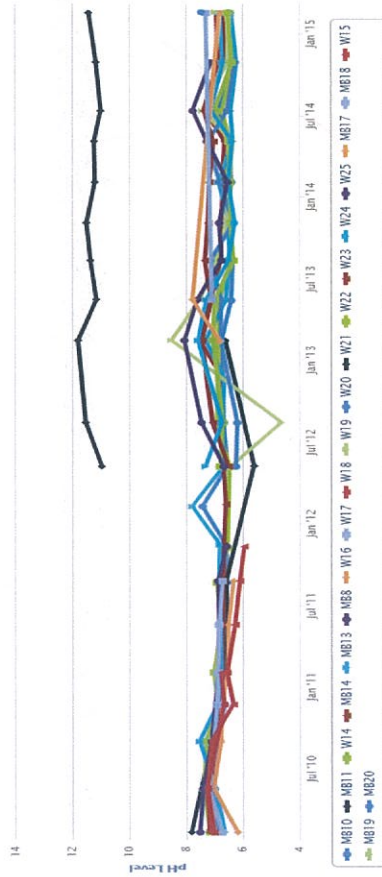
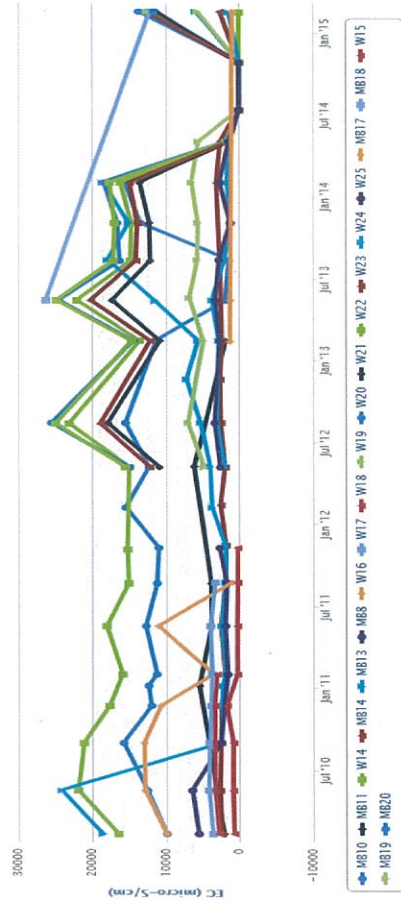
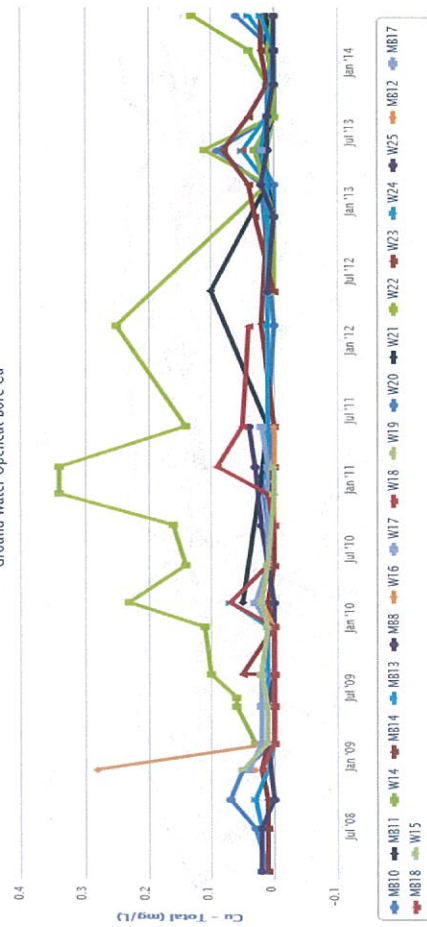
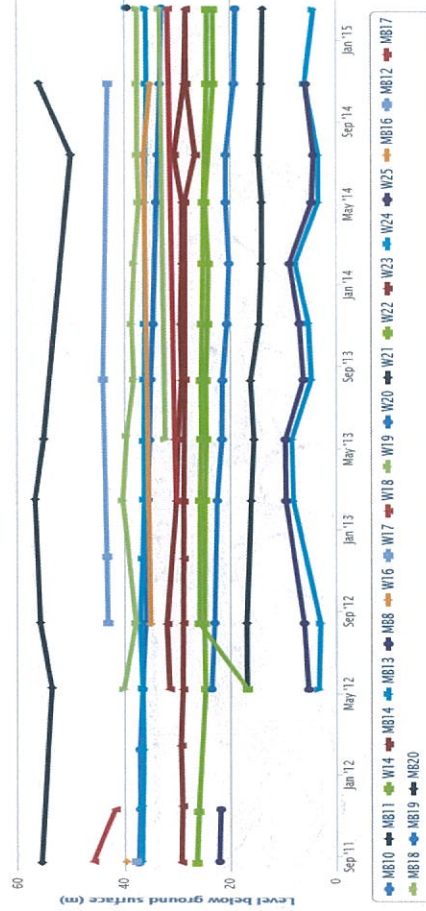
The pH and copper concentrations from Opencut groundwater bores are in line with historical trends (refer to Figure 20). EC AND Cu concentrations have been readily fluctuating and are exhibiting an upward trend this quarter. The results however remain in line with the historical water quality and will be closely monitored.

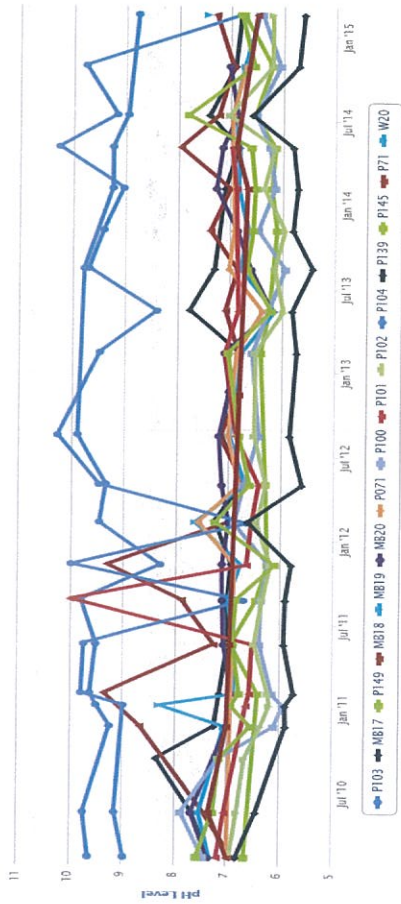
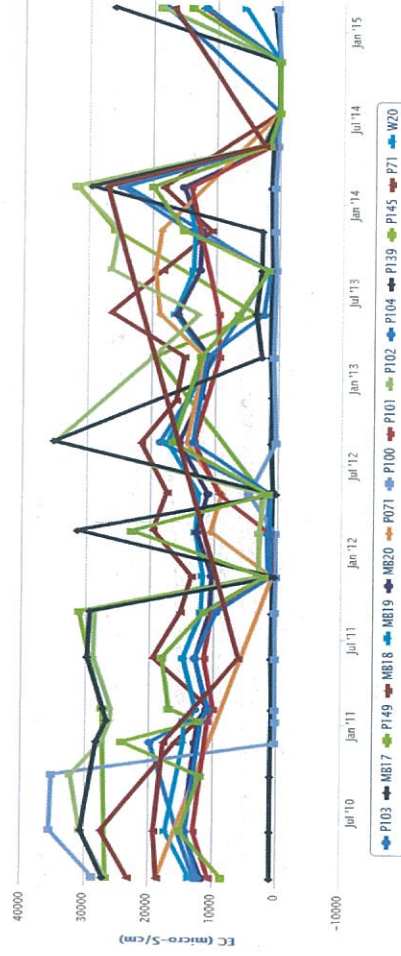
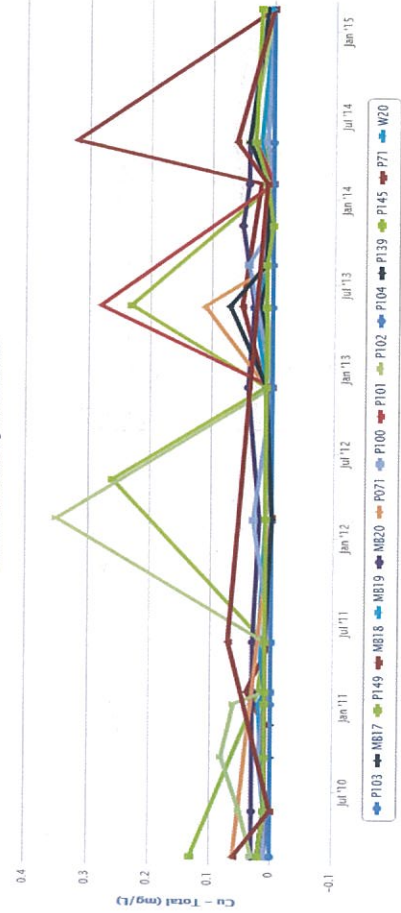
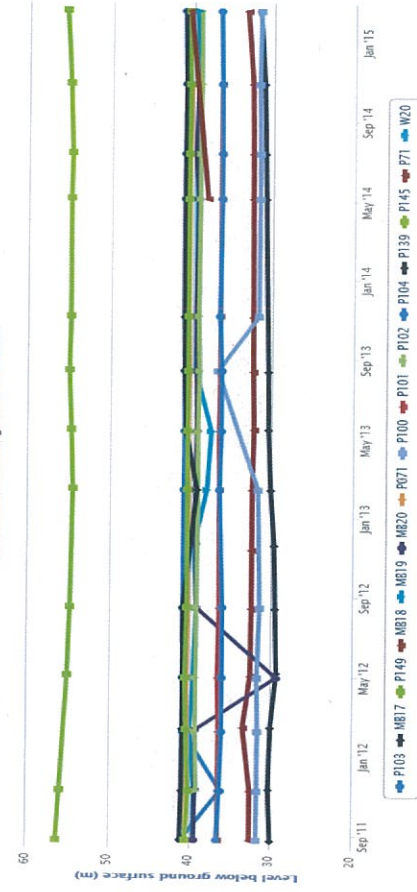
Figure 21 Groundwater quality and water levels – Underground

Groundwater quality results from the underground area (Figure 21) indicate that the water levels have remained constant. Electrical conductivity (EC) results have increased from the previous monitoring period but are in line with the historical water quality average. The copper concentrations on average have decreased.

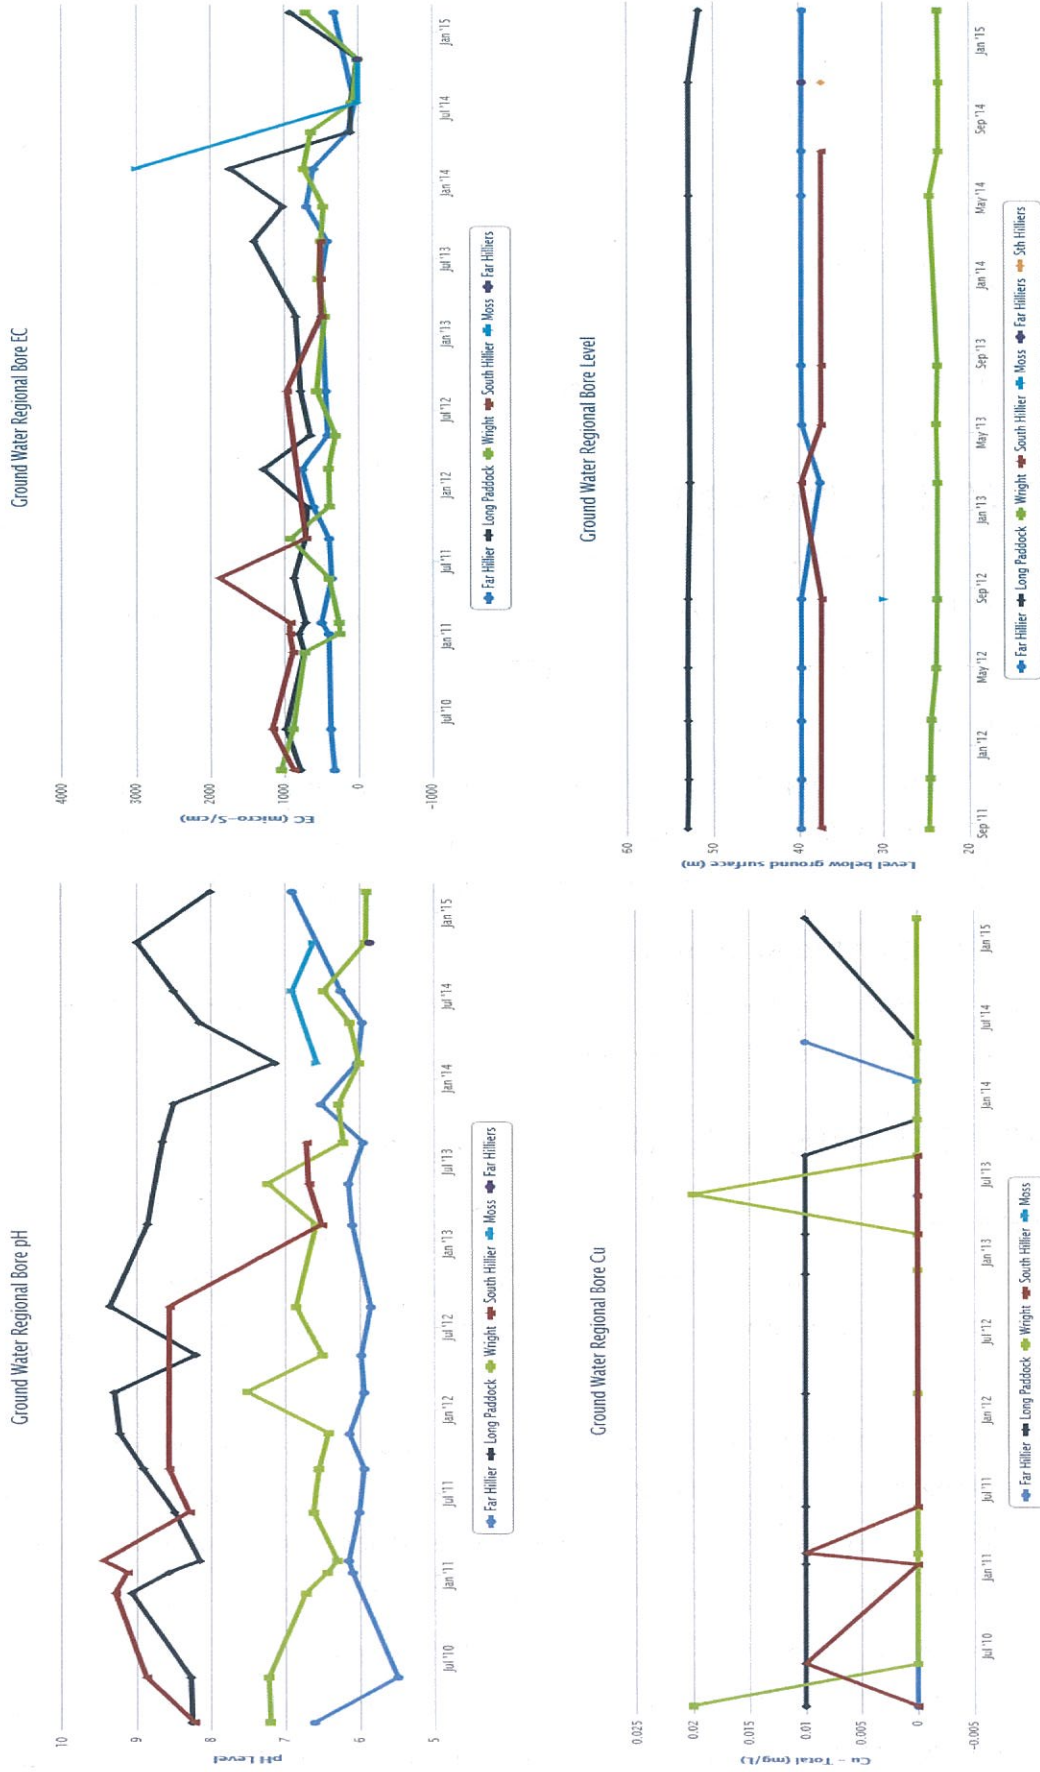
Figure 22 Groundwater quality and water levels – Regional bores

Regional groundwater pH is variable between the bores (Figure 22) with quality being a variable of bore depth and underlying geology. EC, copper concentrations and standing water level results for the monitoring period remain in line with historical trend. There was an increase in EC in all regional bores compared to the last reporting period.
