Northparkes Mines Annual Environmental Management Report

2016

January 2016 – December 2016

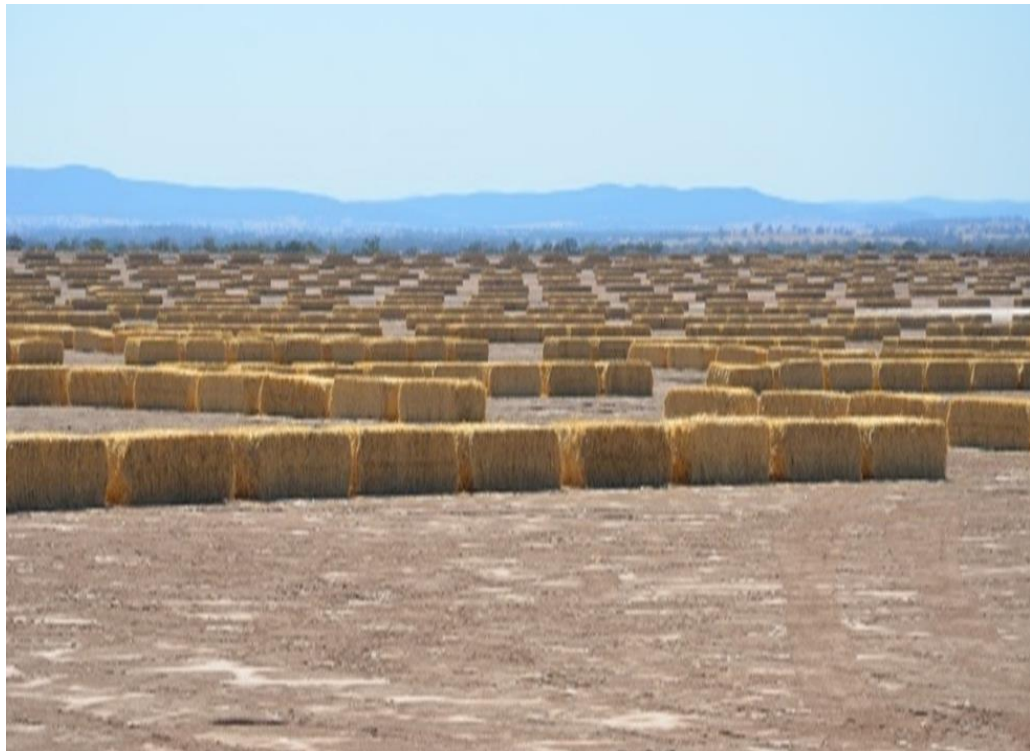
- All required monitoring was completed during the reporting period.
- Straw bales on the surface of TSF1 continued to operate as an effective breakdown of wind activity and reduce dust exceedances / complaints.

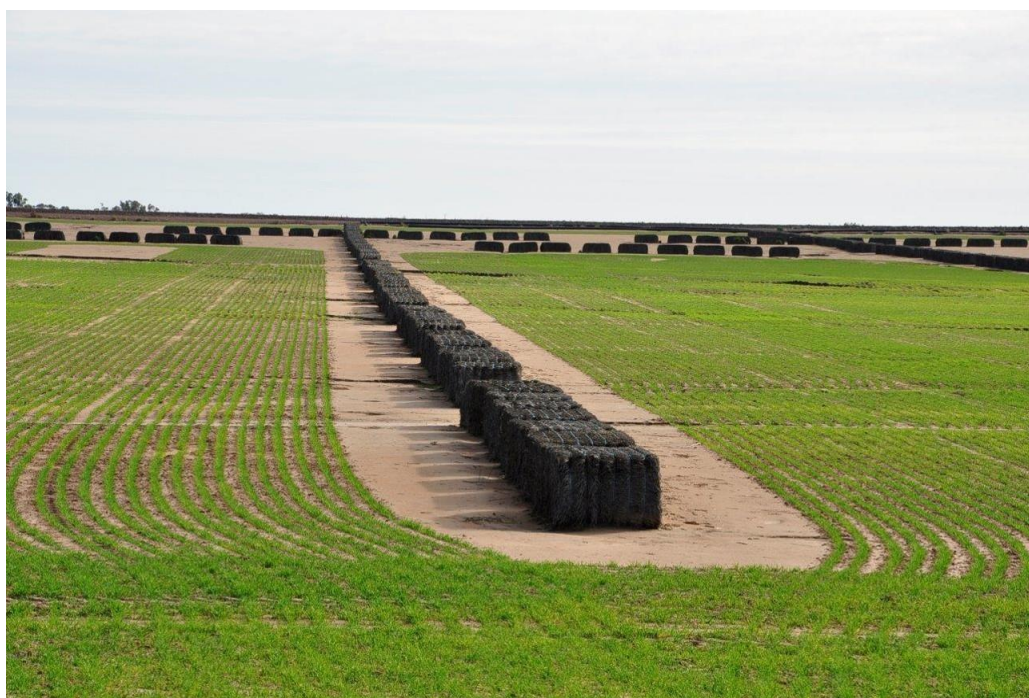
- Barley planting on TSF 1.

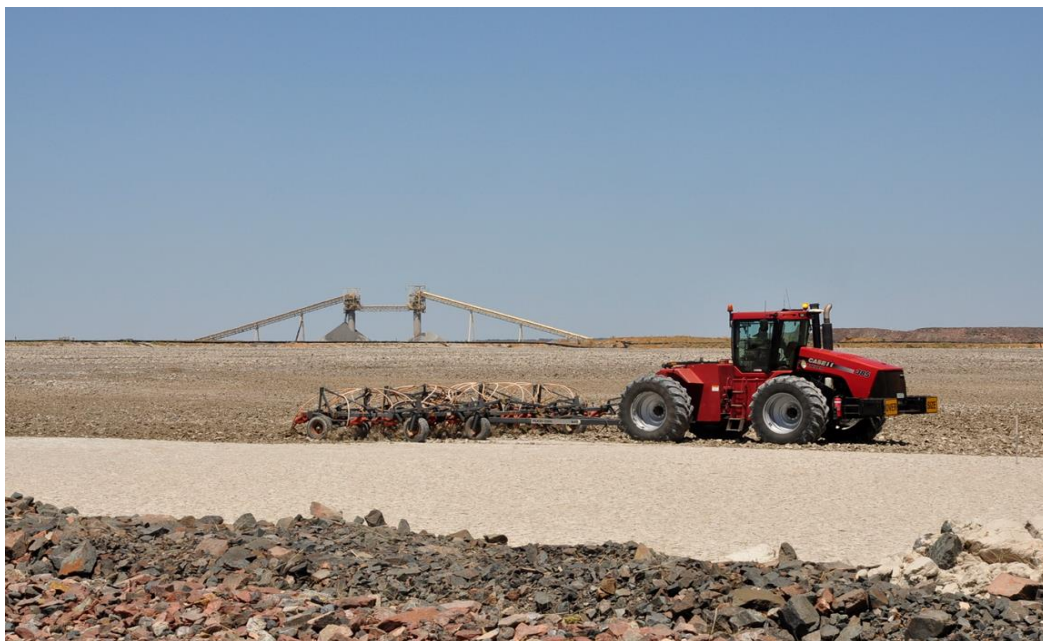
48 hectares of TSF1 and 75 ha of TSF2 were ripped in preparation for sowing barley in April 2016. A small trial area on the north eastern end of TSF2 was sown with Barley in 2015. The barley growth was deemed to be successful and as such additional sowing was completed in 2016 along with various trials of nitro humus.

Chisel ploughing on TSF surface

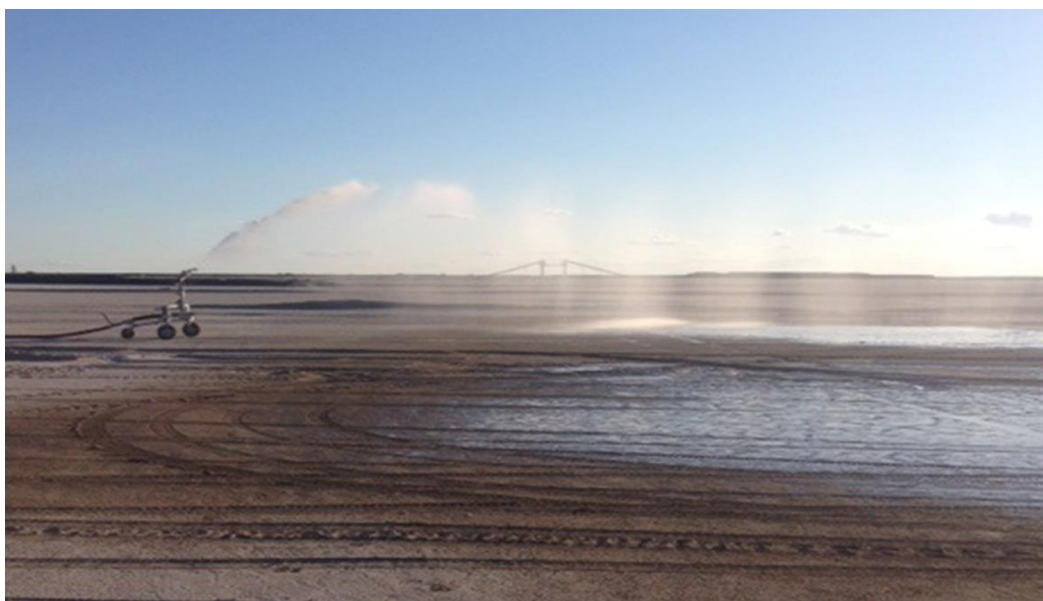
Irrigator on TSF

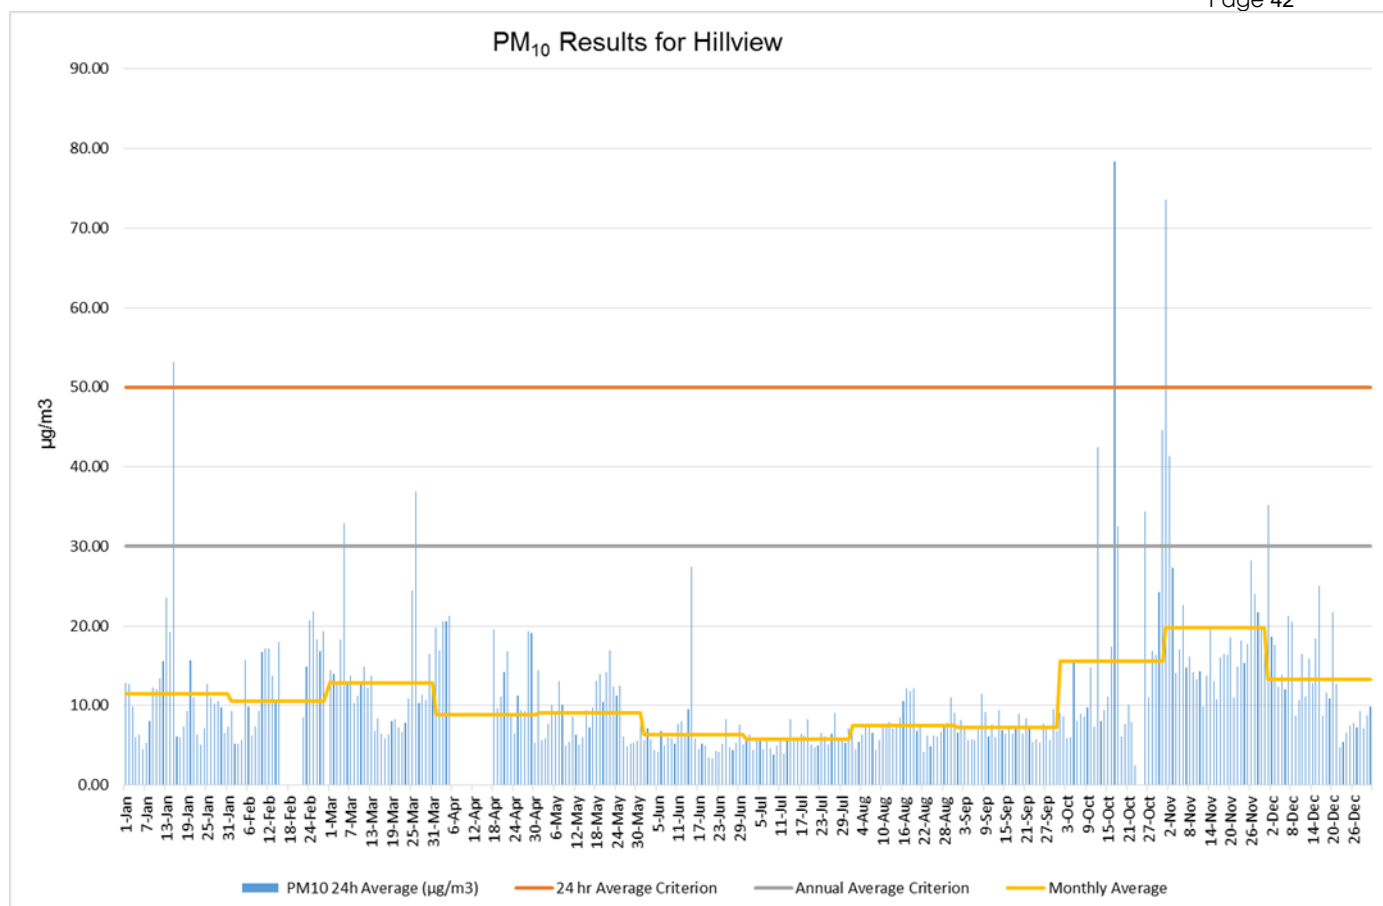
Figure 16 PM10 monitoring results – Hillview

Similarly, monitoring results for the 'Hillview' location shows three exceedance for the reporting period. The PM10 monitor at 'Hillview' did not operate between 6 February to 21 February, 6 April to 17 April and 24 to 25 October due to equipment error due to electrical fault in the equipment.

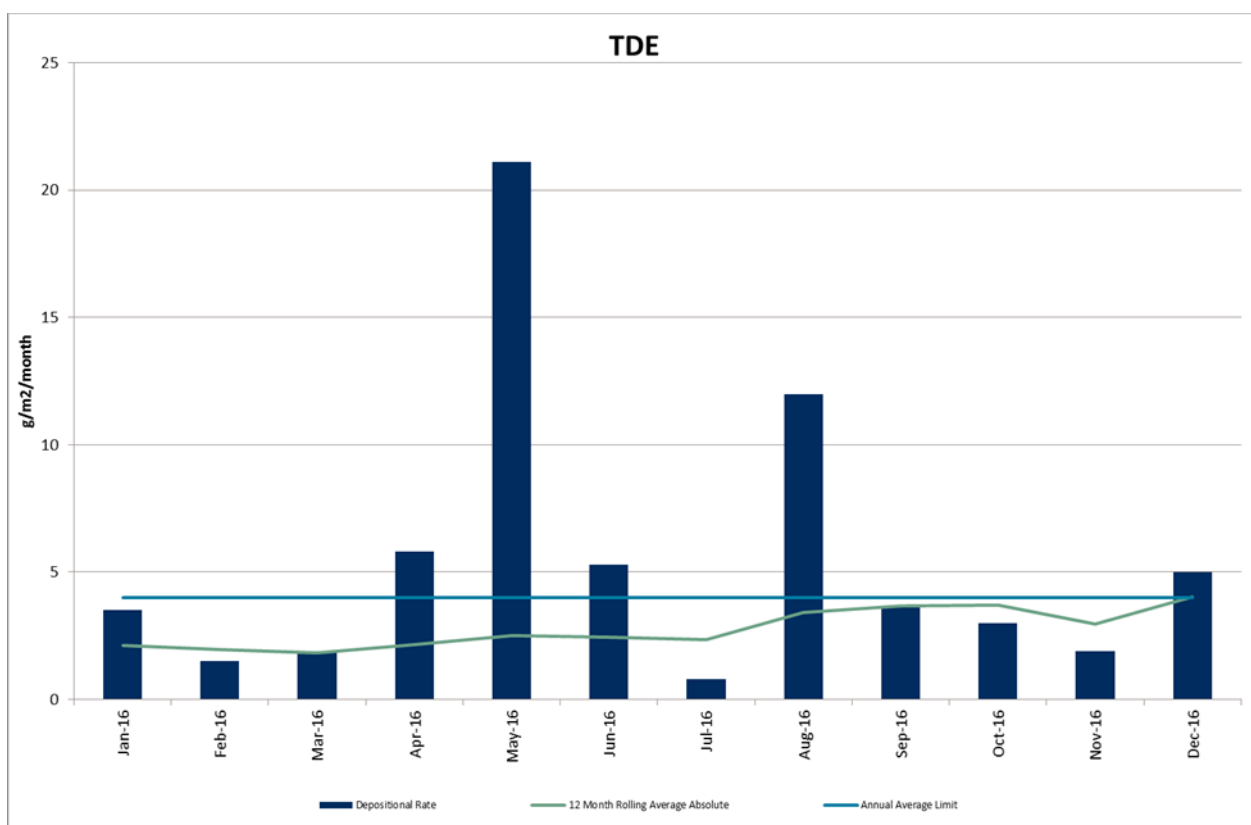
Figure 20 Depositional Dust Annual Averages

Note: All depositional dust exceedances have been investigated and reported to the relevant regulatory agency. Further details can be found in Table 6.

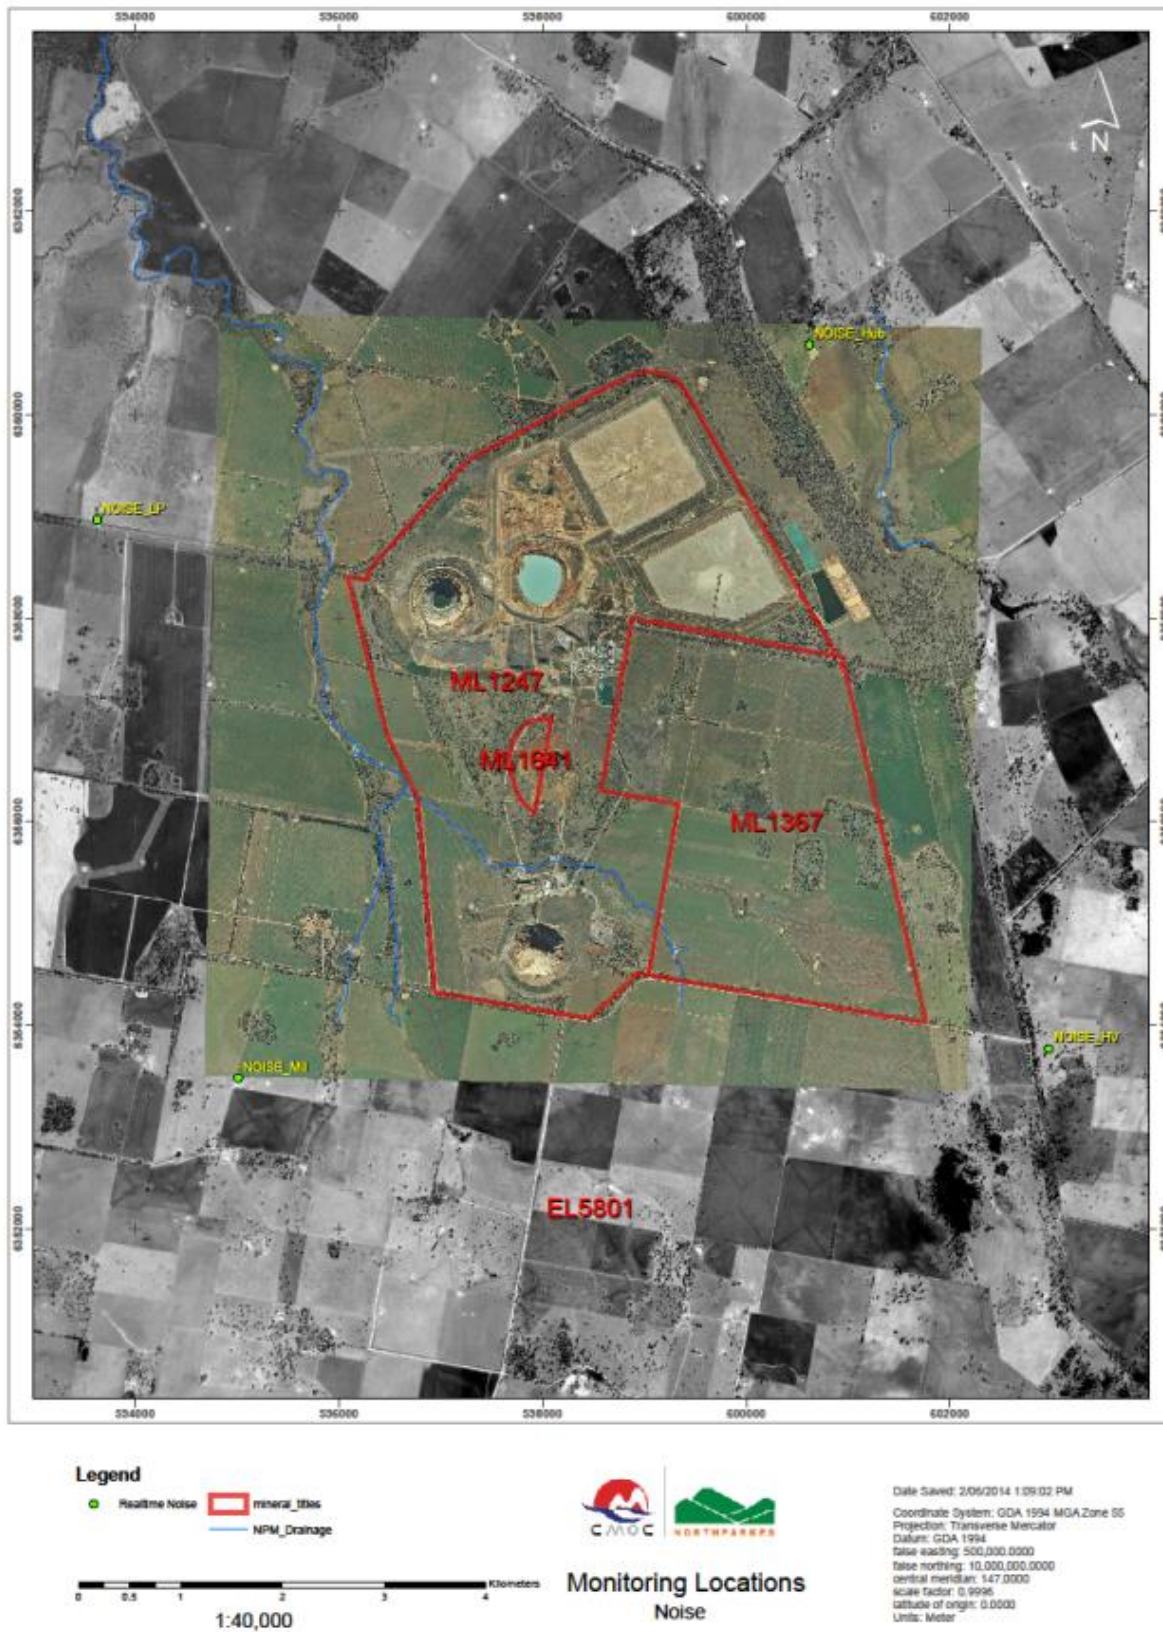
Figure 21 Northparkes Noise monitoring locations

In addition to the operator-attended monitoring, unattended continuous noise logging is undertaken at the four monitoring locations. This allows Northparkes to determine the overall ambient noise amenity levels of background noise, and any noise generated by mine activity. This is undertaken continuously over the year and the information is assessed. The ambient noise levels obtained from the loggers are not necessarily the contributed noise emissions arising from Northparkes operations alone. The ambient noise level data quantifies the overall noise level at a given location independent of its source or character. The noise logger calculates the statistical noise indices and does not 'record' the actual noise.
