Northparkes Mines

Annual Environmental Management Report

January 2013 – December 2013

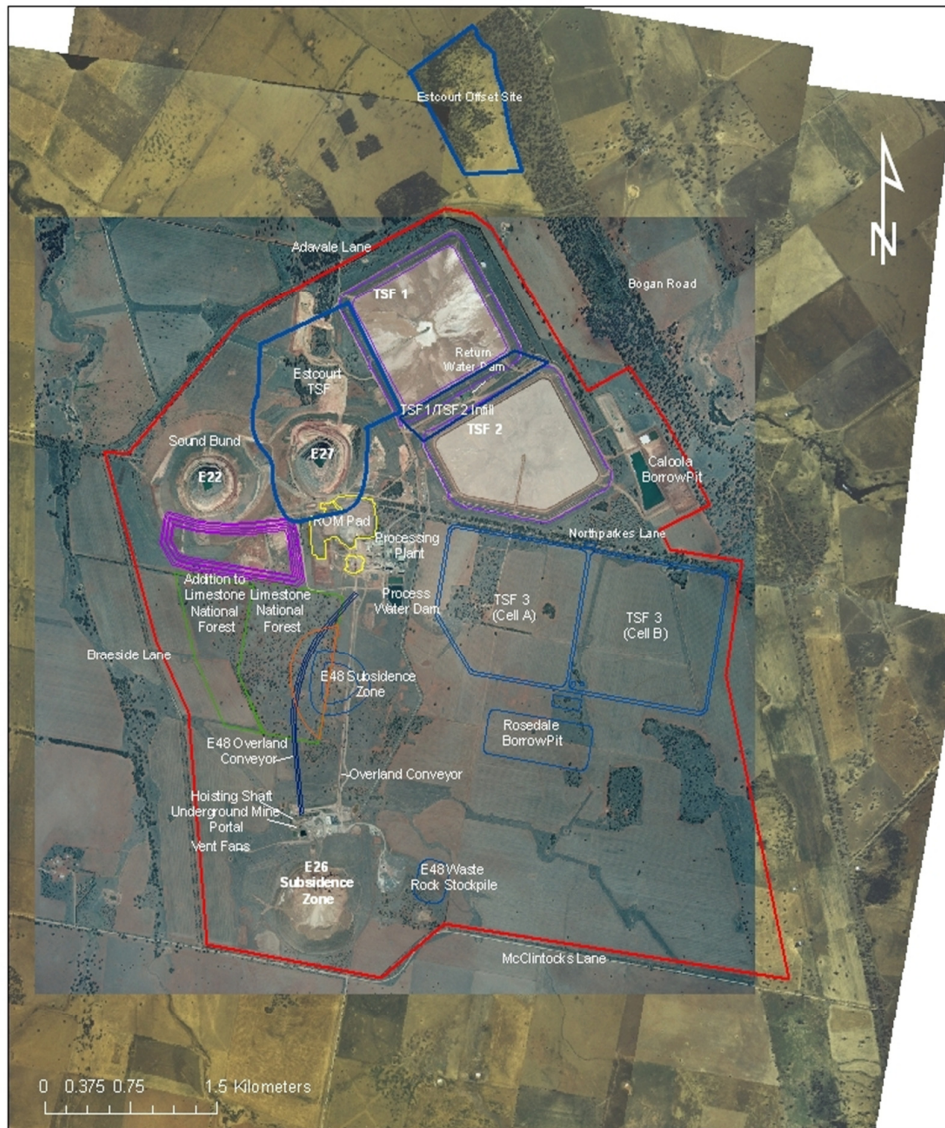
Figure 2: Operational Layout

Surface infrastructure and operation layout is shown in Figure 2. Onsite infrastructure includes:

- Two former open cut pits E22 and E27, surrounded by ore stockpiles, waste rock dumps and a sound bund.
- Tailings Storage Facilities (TSFs): TSF1, TSF2 and Estcourt.

- The E26 and E48 underground block cave mine and resultant surface subsidence zone.
- Underground mining fixed plant infrastructure including two crushers, maintenance workshops and materials handling conveyor system.

- Surface mining related infrastructure such as the portal, hoisting shaft, ventilation fans, transfer and overland conveyor, mining offices and contractor laydown areas.

- Marginal ore stockpiles, waste rock dumps and stockpiles of clay and oxide material are located around the surface subsidence zone outside the predicted subsidence limits.

- The processing plant, including surface crusher, crushed ore stockpiles, active grinding mills, froth flotation area, concentrate filtration and storage bays and tailings storage facilities.

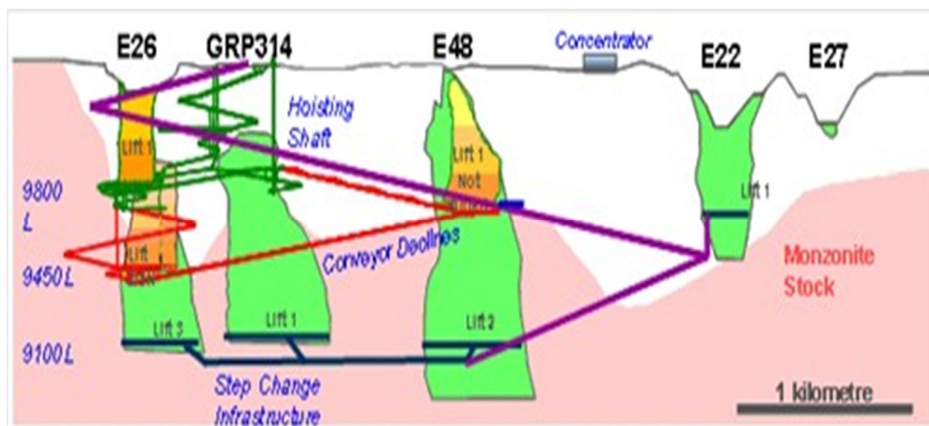
Figure 3: Cross-section showing the zones of mineralisation in relation to existing and proposed mine infrastructure

Exploration and evaluation programs continued in the current reporting period, on both the mining and exploration leases. Mining lease evaluation under the pre-feasibility mine expansion study termed “Step Change Project” (SCP) was completed during the reporting period. The SCP Pre-Feasibility Study evaluated the potential for further underground mining and processing operations based on a series of large tonnage, low-grade areas of mineralisation within the existing mine leases. The ore bodies are identified in Figure 3.

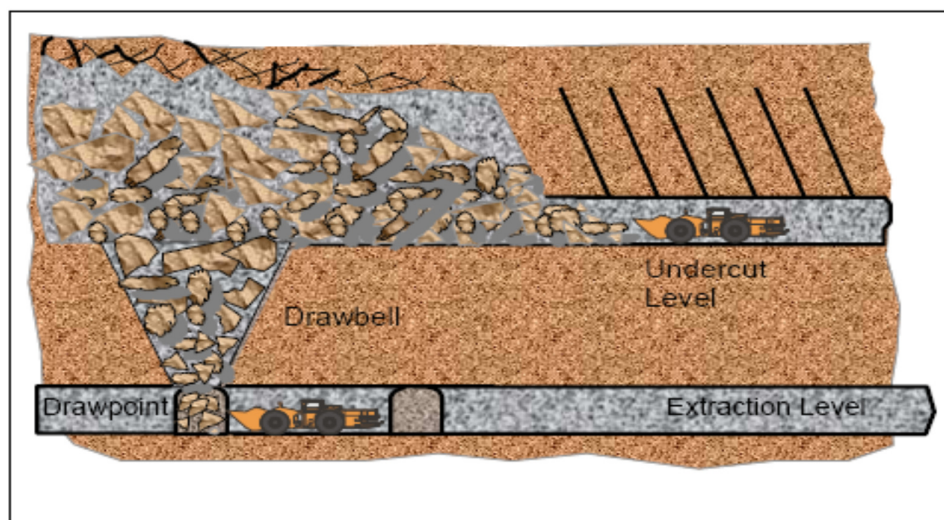
Figure 4: Block Cave Mining Method (schematic)

Underground mining activities are currently undertaken in ore body E48 using block caving methods. A schematic of the underground mining section is seen in Figure 4. During the previous reporting periods, the E48 mine experienced higher than expected convergence rates which resulted in a destabilisation of underground mine infrastructure. A rehabilitation project commenced to reduce convergence, improve cave integrity and enable continued production from these drives. During the current reporting period, convergence was stabilised and redevelopment took place with notable success. From December 2013 all previously destabilised drives were re-opened. Currently four drawpoints are up and operational, with six more drawpoints to be reopened.

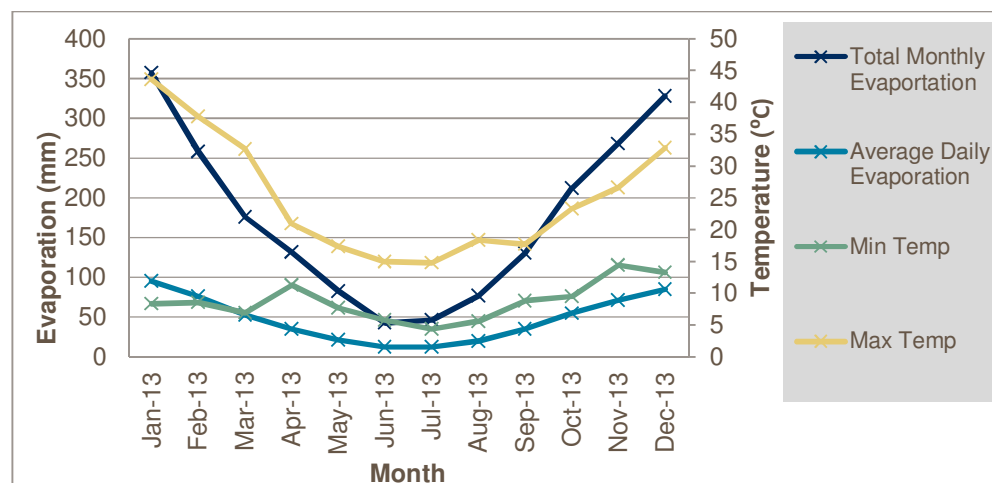
Figure 6: Temperature and Evaporation Summary

period. Temperatures and evaporation followed expected seasonal trends observed in previous climatic conditions for the region.

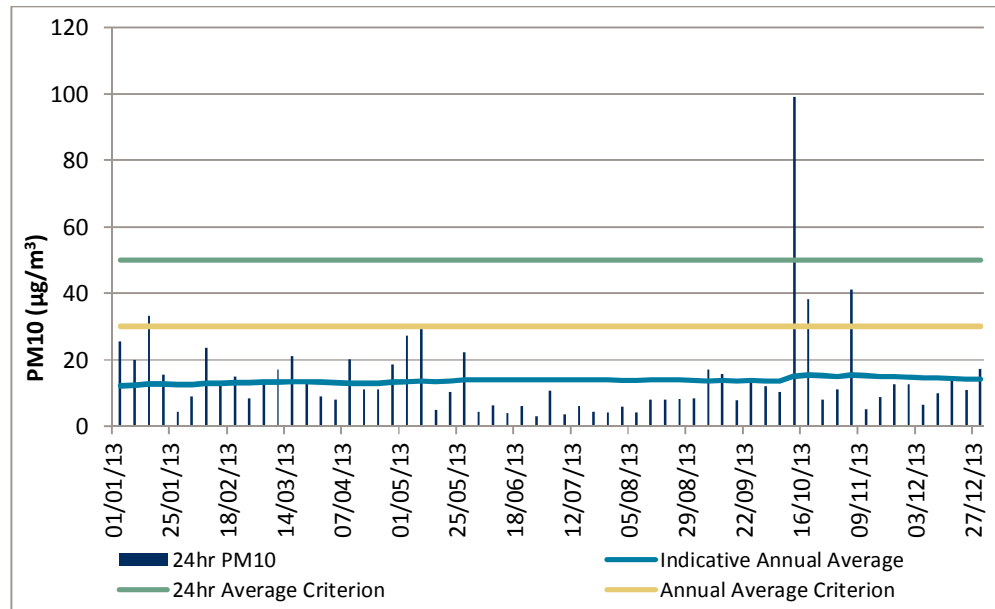
Figure 9: PM_{10} Results for 'Hubberstone'

1000252307	13 October 2013	<p>PM₁₀ 24 hour average result (99.2 ug/m³) for "Hubberstone" monitoring location exceeded the 24 hour performance criteria (50 ug/m³) set out in Development Consent 06-0026. The result did not cause an exceedence of the annual average limit. An investigation was undertaken immediately to determine the likely cause of the exceedence.</p> <p>The investigation concluded that the wind monitoring data from the 13th October 2013 indicated that the prevalent winds were from the South West (29%) and North West (29%). Secondary winds were experienced from the West (13%) and South (11%). The average wind speed for the 24h time period was 5.33 m/s. Calm winds were present 3.13% of the time.</p> <p>Field notes indicate the sample contained a moderate to heavy loading of grey coloured dust and the colouration of the dust in association with the strong south westerly winds, some exceeding 11.1 m/s, are indicative of contribution from Northparkes operations</p>

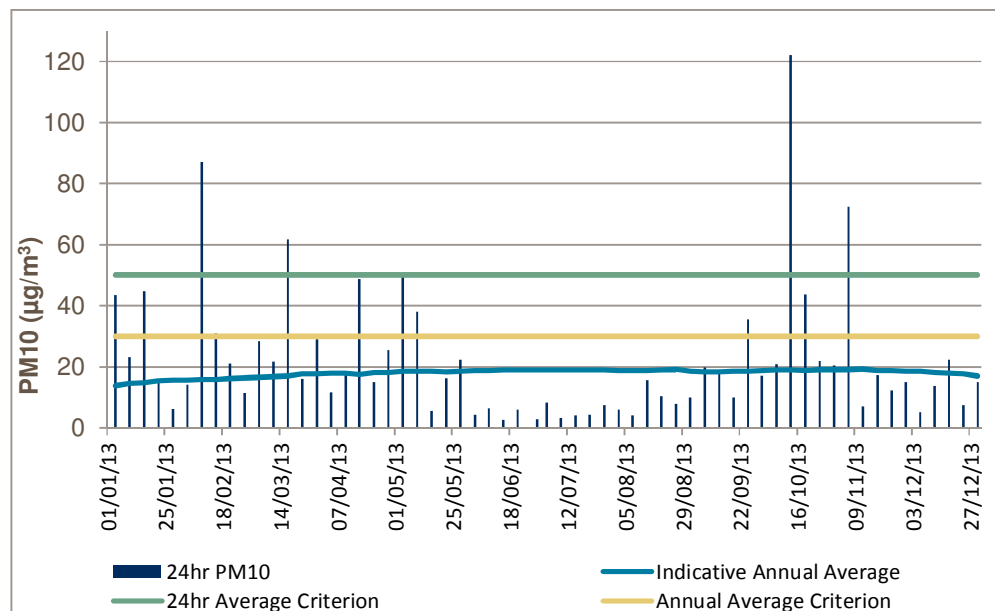
Figure 10: PM_{10} Results for 'Milpose'

Incident No.	Date	Details
1000200825	09 February 2013	<p>PM₁₀ 24 hour average result (87.3 ug/m³) for "Milpose" monitoring location exceeded the 24 hour performance criteria (50 ug/m³) set out in Development Consent 06-0026. The result did not cause an exceedance of the annual average limit. An investigation was undertaken immediately to determine the likely cause of the exceedance.</p> <p>The investigation concluded that the prevailing wind direction was primary from the North West, the direction from the shearing shed toward the PM₁₀ dust monitor location and away from Northparkes mines. Field notes indicate the presence of sheep activity in the nearby paddock. The monitoring cycle occurred on the 11th day without rain; rainfall occurred subsequent to this monitoring result, and under similar field observations (sheep in nearby paddock) PM₁₀ concentrations were considerably lower</p>
1000203946	17 th March	<p>The PM₁₀ High Volume Air Sampler result for the month of March was received on the 10th April 2013. Upon review of results, it was identified that the recorded PM₁₀ value for the 24-hour monitoring cycle on the 17th March 2013 for Milpose was 61.7 ug/m³. This exceeded the 24hr performance criteria (50 ug/m³) set out in Development Consent 06-0026. An investigation was undertaken immediately to determine the likely cause of the exceedance.</p> <p>The investigation concluded that the prevailing wind direction was towards the Mine Lease from the monitor location. Field notes indicate dry conditions with sheep movement in the yard. A review of the monitoring data indicates that the elevated results were localised to the Milpose location.</p>

1000225341	04 May 2013	<p>PM₁₀ 24 hour average result (50.1 ug/m³) for "Milpose" monitoring location exceeded the 24 hour performance criteria (50 ug/m³) set out in Development Consent 06-0026. The result did not cause an exceedance of the annual average limit. An investigation was undertaken immediately to determine the likely cause of the exceedance.</p> <p>The investigation concluded that the prevailing wind direction was towards the Mine Lease from the monitor location. A review of the monitoring data indicates that the elevated result was localised to the Milpose farm. Other PM₁₀ monitoring events in the month of May had a lower recorded value and Depositional Dust results recorded lower values toward the Mine Lease boundary whilst high results were localised to the Milpose location.</p>

Incident No.	Date	Details
	06 November 2013	<p>PM₁₀ 24h average result (72.4 µg/m³) for Milpose monitoring location exceeded the 24 hour performance criteria (50 µg/m³) set in the Development Consent 06-0026. The result did not cause an exceedance of the annual average limit. An investigation was undertaken to determine the likely cause of the exceedance.</p> <p>An investigation was undertaken into the cause of the recorded PM₁₀ exceedance at Milpose. The investigation involved the review of meteorological data, comparison with other monitoring results, field notes, local activities, operational activities and regional PM₁₀ results.</p> <p>It was considered from the investigation that this exceedance is not a result of NPM activities. Winds tended to be North Easterly in nature, strongest winds were experienced from the North West. Both ND22 and TDS5 are the neighbouring depositional sites which also lie South West of the mining lease, neither of these experienced any exceedance for the month of November. November is typically a time for harvesting, notes show that harvesting was undertaken at Milpose during the month, with lead-up work likely to have influenced the current results.</p>

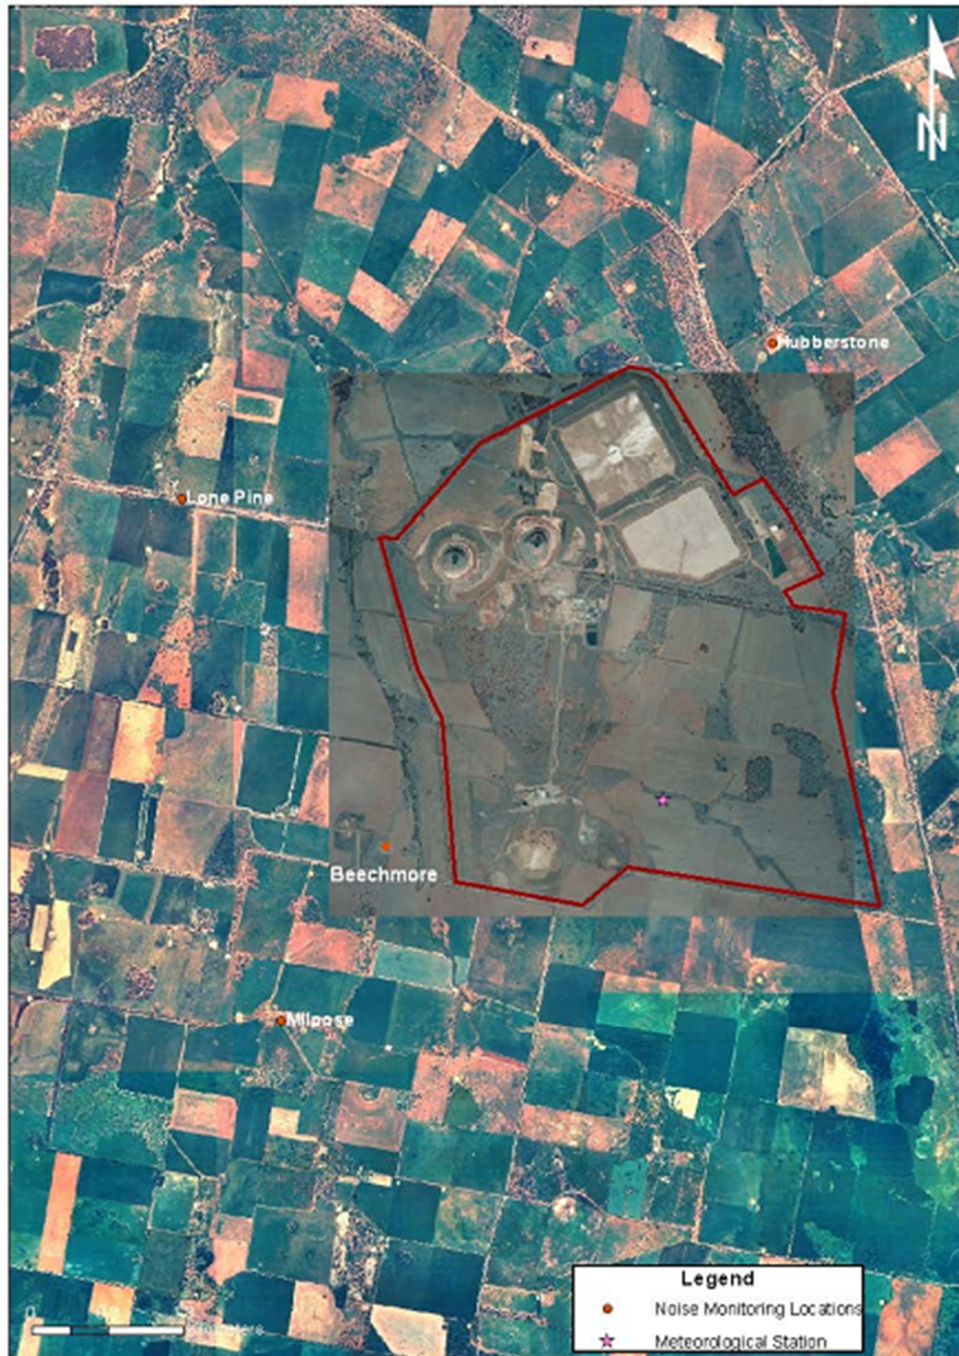
Figure 12: Noise monitoring locations

Received levels from various noise sources are noted during operator-attended monitoring and particular attention is paid to the extent of the NPM contribution, if any, to measured noise levels. In addition, the operator quantifies and characterises the overall levels of ambient noise. Noise occurring during the surveys is recorded by the operator with an indication of the noise source, noise type, and the time of occurrence. Effect on the mine noise propagation is established by assessing prevailing weather conditions recorded at the NPM weather station, and at the time of the monitoring by the operator. A summary of the weather data is available in Appendix 3.

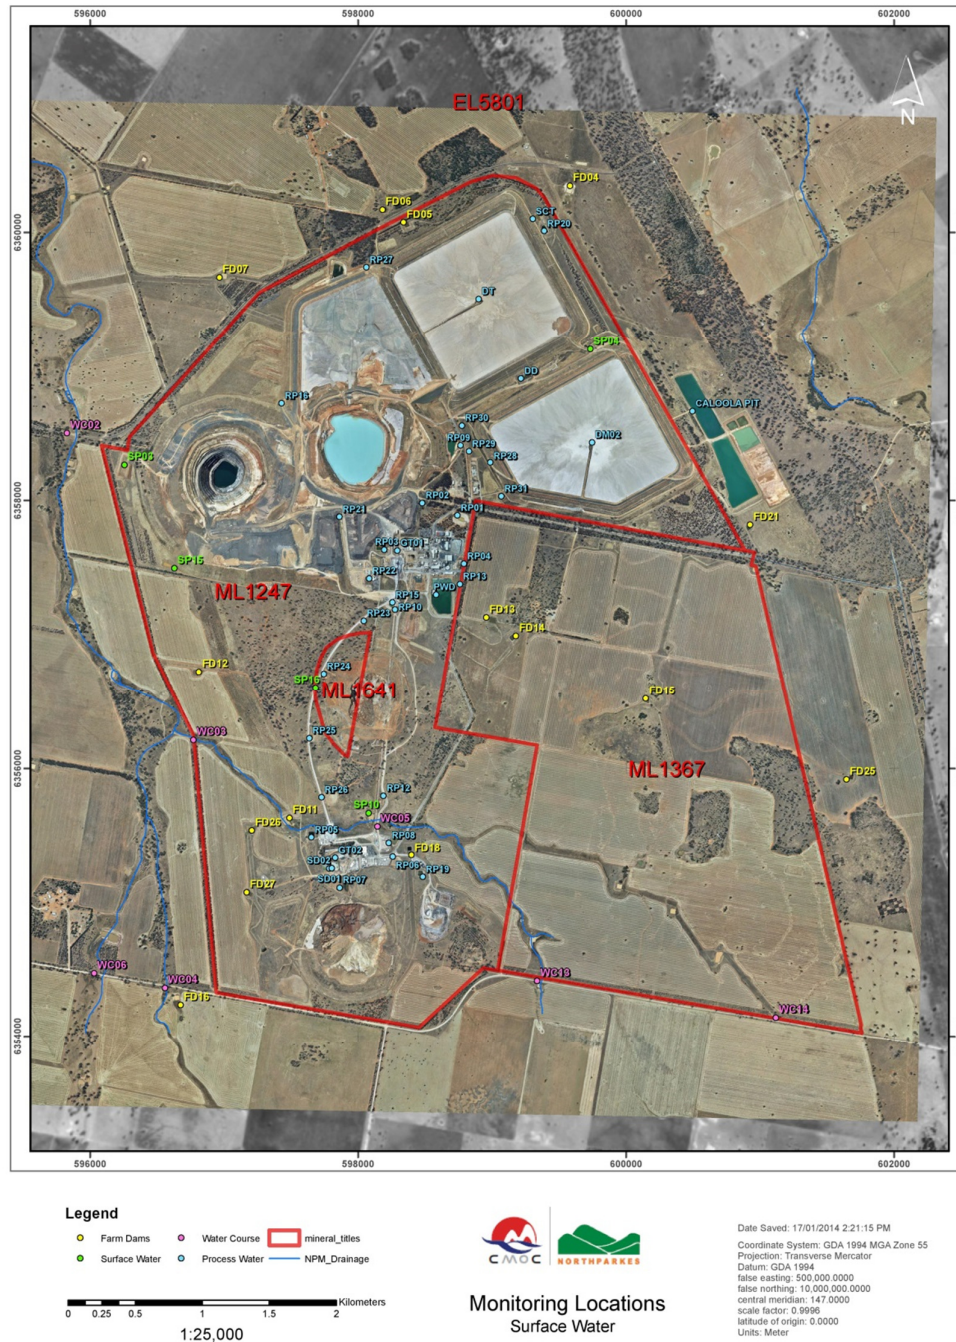
Figure 13: Surface water Monitoring Locations

Ground and surface water impact assessment criteria is not established under NPM EPL 4784, based upon the fact that Northparkes is a zero discharge site. NPM assesses water quality sample results against background water quality and communicate results on quarterly basis via the NPM website.
