CMOC-Northparkes Mines 2017 Annual Review

January 2017 – December 2017

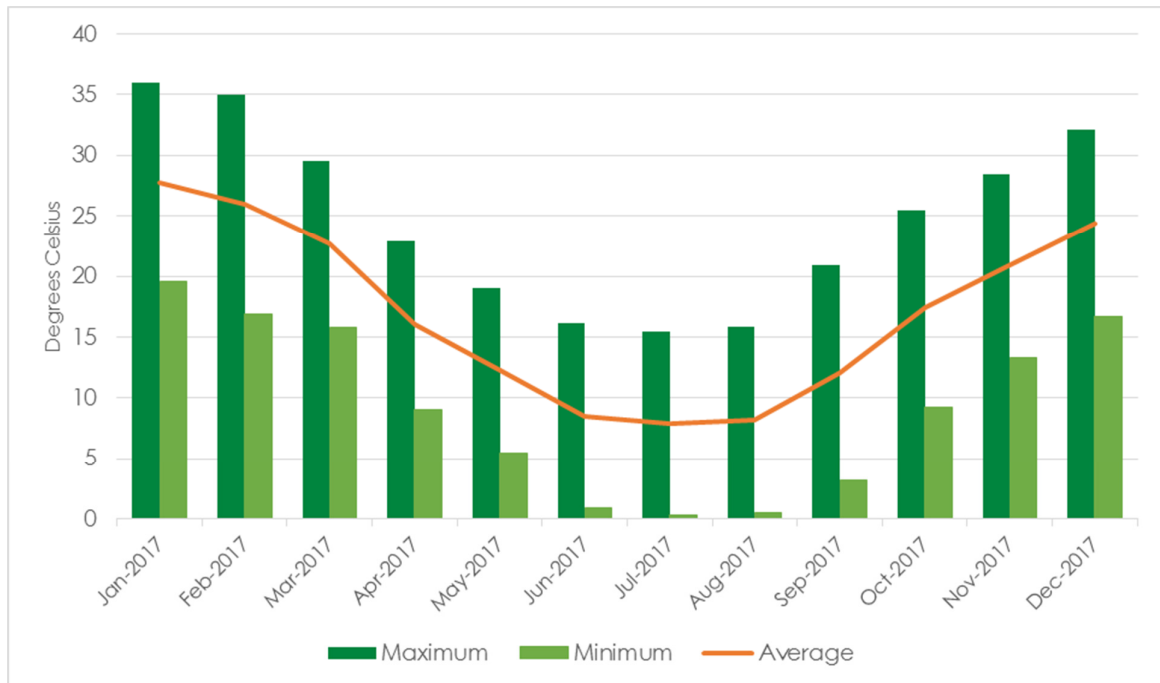
Figure 7 Monthly temperature records

Maximum, minimum and average temperatures are calculated daily from the 15 min recordings. Figure 7 shows average monthly temperature records for the reporting period (10m MET recordings). Compared to the previous reporting period, the average minimum temperatures are notably lower in winter and lower in spring, while maximums remain consistent with the previous reporting period.

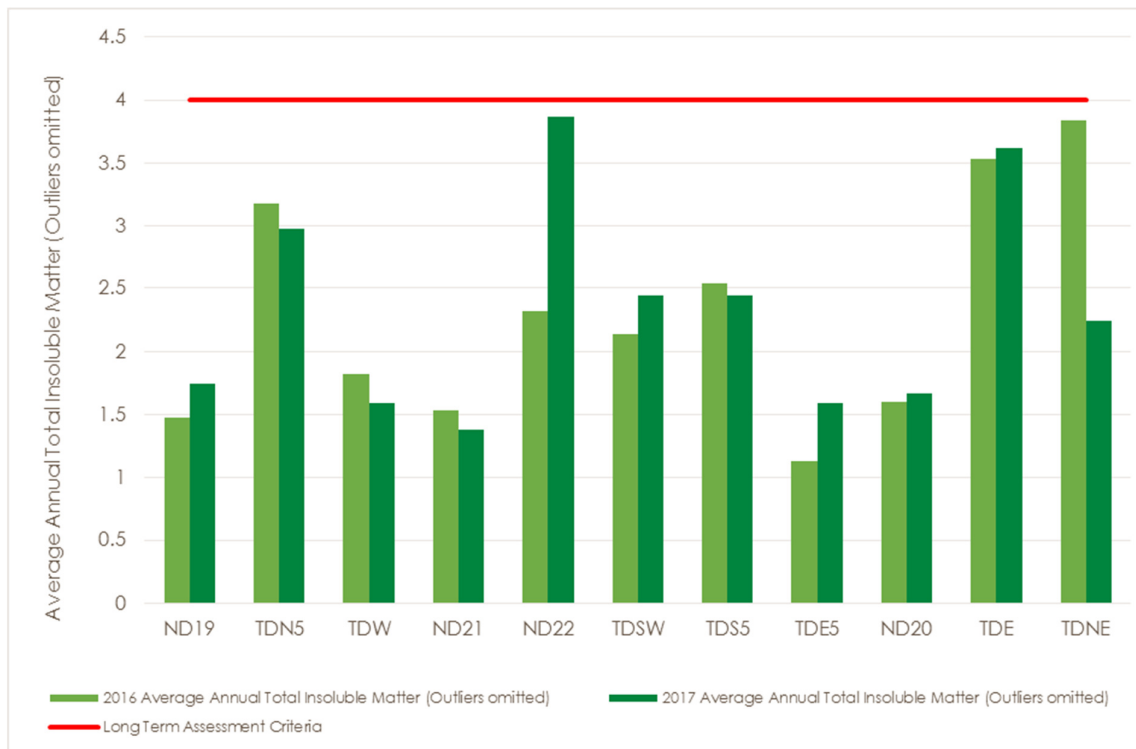
Figure 16 Depositional Dust Annual Averages

Depositional dust samples were subject to visual analysis by a NATA accredited laboratory to determine sample contamination by naturally occurring impurities. Figure 16 presents the corrected annual average (CAA) results following visual analysis of the eleven dust monitors.

The results indicate that all depositional dust gauges remained below the criterion for the annual average during 2017.

Depositional dust systems are often subject to contamination by naturally occurring impurities such as bird droppings, insects and vegetation or regularly impacted by local extraneous sources (such as farming activities or local dirt roads). On thirteen occasions over the reporting period, samples were deemed contaminated, reordered as an outlier and excluded from the CAA calculation. This included samples from January (ND22), February (ND22 and TDN5), April (TDNE and ND22), May (TDE, TDNE, ND22 and TDN5), June (TDN5), July (TDNE and TDN5) and October (TDE).

The annual average depositional dust levels recorded at all depositional dust monitoring locations, with the exception of ND22 were below the predicted levels within the EA (2.9g/m²/month). CMOC's investigations have found that the monitoring locations TDE and ND22 are consistently impacted by extraneous sources and recommend they be removed from the regional air quality monitoring network.

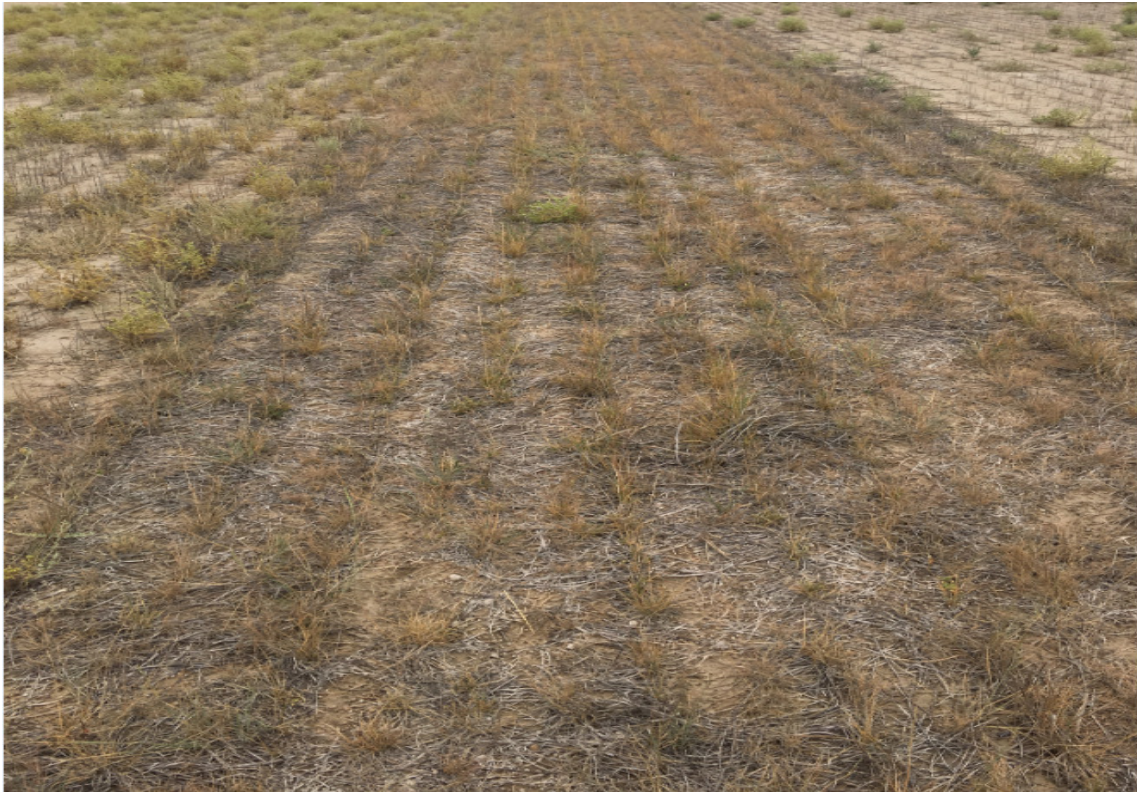
- Regeneration of cover crop on TSF2 which provided vegetation cover and crust stability, reducing dust lift off, which still remains (Figure 24). This resulted in zero dust related complaints for the three years since commencement of the project; and
- The following vegetation species (annual and perennial) were the most appropriate species for future TSF surface sowing: Tall Wheat Grass, Medic Scimitar, Medic Cavalier, Clover Hykon Rose and Clover Balansa.

Figure 24 The effectiveness of seed trials conducted in April 2015 still provides effective ground cover

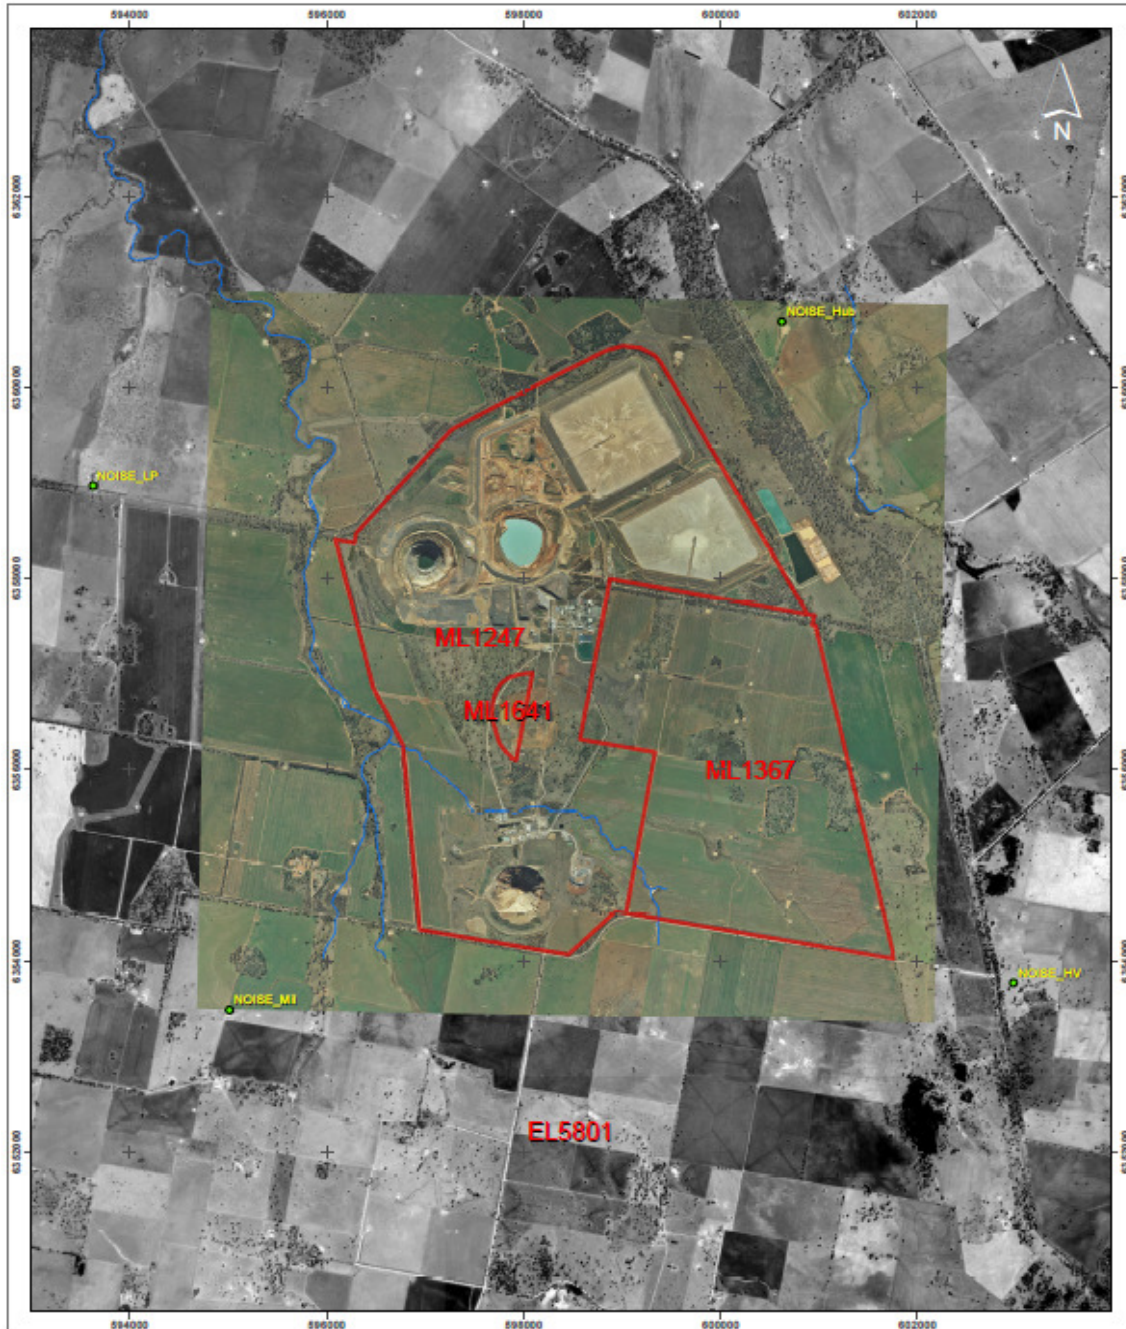
Noise monitoring Locations

- Realtime Noise
- mineral_sites
- NPM_Drainage
