Appendix B - 2018 Kokoda Biodiversity Offset Ecological Monitoring Report

The Northparkes Mine Step Change Project (the Project) was approved with conditions under section 130 (1) and 133 of the Environment Protection and Biodiversity Conservation Act 1999 (EPBC Act 1999) on 13<sup>th</sup> February 2014 (EPBC 2013/6788). Key elements of the Project included:

This report has been produced to address compliance with Condition 12, EPBC 2013/6788 stating that:

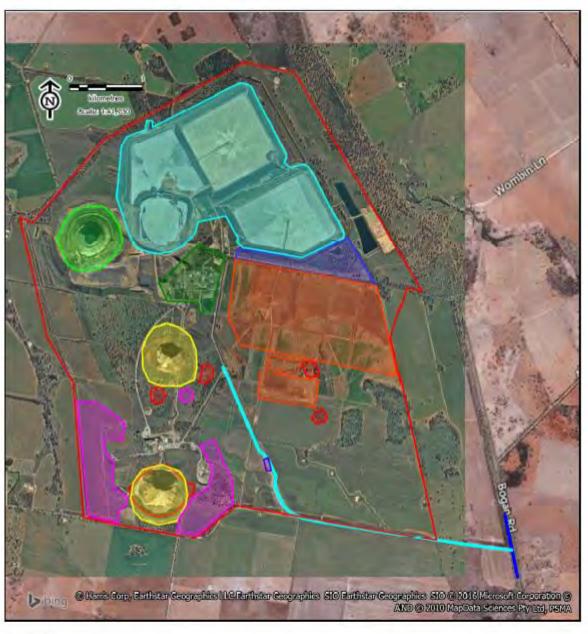
Figure 1 Indicative Location of Northparkes Mines Step Change Project Features

- continued underground block cave mining in two existing ore bodies;
- the development of an additional underground block cave mine, under one of the existing open cut pits;
- additional campaign open cut mining in existing mine leases;
- augmenting approved Tailings Storage facilities (TSFs);
- moving the existing access road;
- construction of the new TFS (Rosedale) in Figure 1; and
- extending the life of the mine by seven years to 2032.

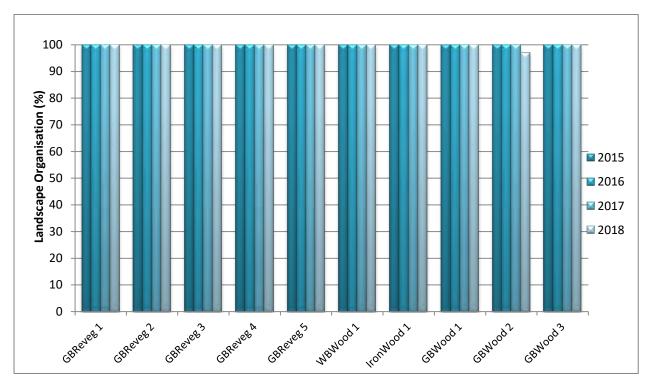
The White Box and Ironbark woodland sites were also characterised with having a mature tree canopy and a well developed leaf litter layer. In the White Box woodland, native grass and forb cover was low, while in the Ironbark woodland there continued to be scattered low shrubs and both sites also continued to have high functional patch areas and LO's of 100%.

Figure 8-1. Landscape Organisation Indices recorded in the Grey Box woodland monitoring sites.

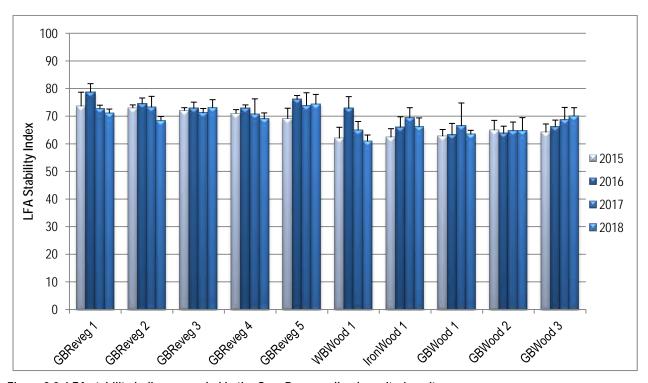
In the Grey Box revegetation sites the stability continued to decline in three sites including GBReveg1, GBReveg2 and GBReveg4 but they continued to more stable than the Grey Box reference sites. While there was a reduction in live ground cover and loss of integrity of the litter and cryptogam layers in some sites, there was limited erosion or deposition occurring in the sites. There was a marginal increase in stability in GBReveg3 and GBReveg5 and with indices of 73.1 and 74.4 respectively, continued to be more ecological stable than the reference sites.

Figure 8-2. LFA stability indices recorded in the Grey Box woodland monitoring sites.

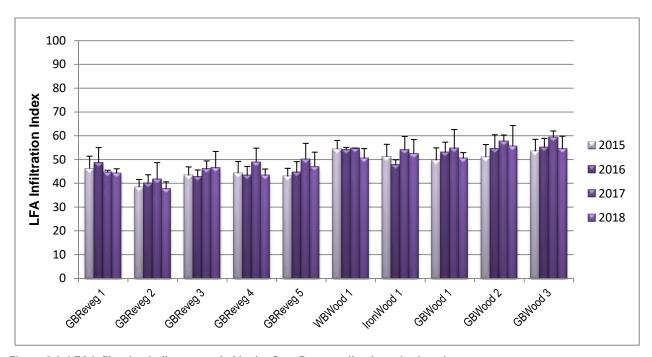
In comparison to the reference sites the revegetation sites tended to have an undeveloped litter layer and a hard surface crust which reduces the infiltration capacity of moisture to enter the soil profile. Infiltration capacity was slightly lower or had remained unchanged and this year had infiltration indices that ranged from a low of 37.6 (GBReveg2) to a high of 47.0 (GBReveg5).

Figure 8-3. LFA infiltration indices recorded in the Grey Box woodland monitoring sites.

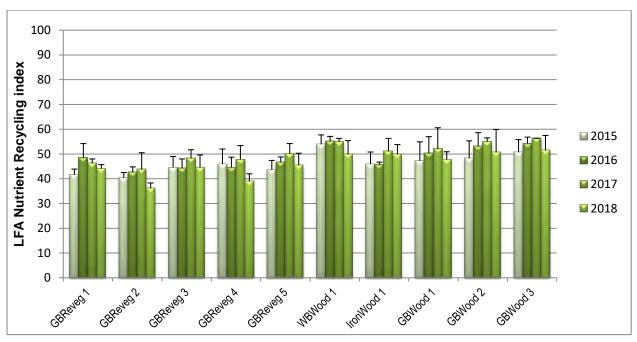
In the Grey Box revegetation sites, there were limited to no perennial trees or shrubs and the litter and humus layers were presently less developed but cryptogams were usually abundant. Heavy grazing has however caused a deterioration of grassy understorey and subsequently nutrient recycling indices also declined in all of the revegetation pasture areas. Nutrient recycling indices ranged from a low of 36.2 (GBReveg2) to a high of 45.5 (GBReveg5).

Figure 8-4. LFA nutrient recycling indices recorded in the Grey Box woodland monitoring sites

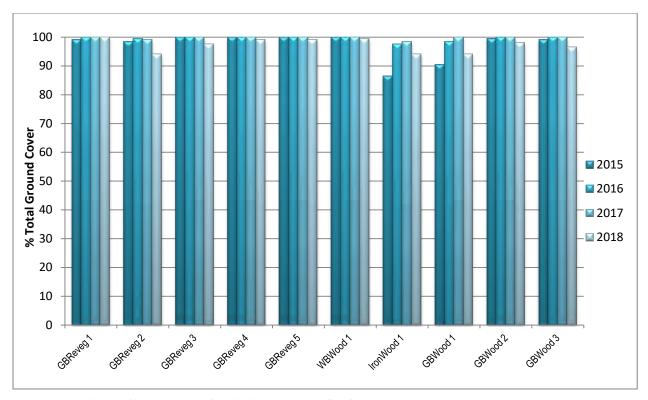
Total ground cover, which is a combination of leaf litter, annual plants, cryptogams, rocks, logs and live perennial plants (<0.5m in height) continued to be relatively high in the woodland reference sites though this year it had slightly decreased to provide a target range of 94.0 – 98.0% (Figure 8-8). Despite some minor reductions in ground cover in the some of the remaining sites, all sites had an adequate total ground cover this year and ranged from 94.0 % (GBReveg2, IronWood1) to 100% cover in GBReveg1.

Figure 8-8. Total ground cover recorded in the Grey Box woodland monitoring sites.

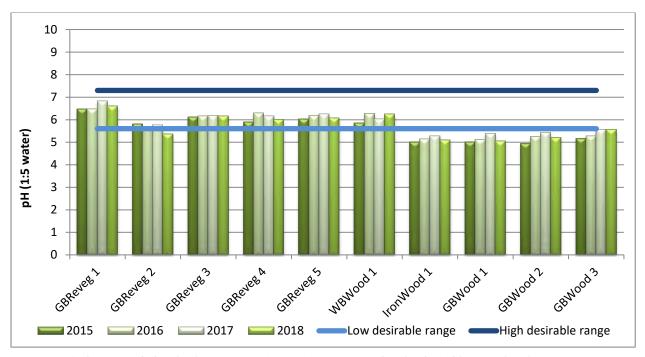
In GBReveg2 and the Ironbark woodland, the soil pH was similar to the reference sites with pHs of 5.3 and 5.1 respectively and were also strongly acidic. The White Box woodland and remaining derived grassland areas had a slightly higher pH which ranged from 6.0 (GBReveg4) to 6.6 (GBReveg1) with these soils being moderately acidic to neutral and within desirable agricultural ranges.

Figure 8-15. Soil pH recorded in the Grey Box monitoring sites compared to the desirable agricultural range.

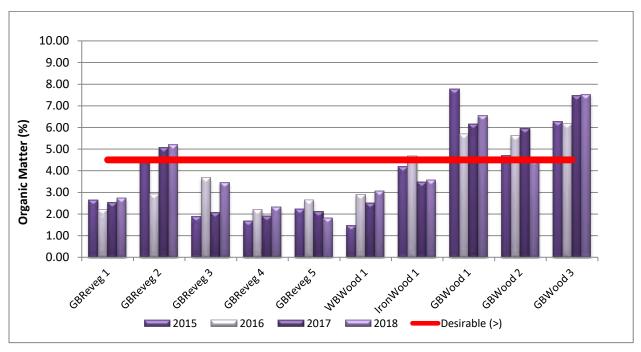
In the Grey Box woodland reference sites Organic Matter (OM) levels were at or higher than desirable agricultural threshold of 4.5%, with OM concentrations ranging from 4.5 - 7.5% (Figure 8-17). At GBReveg2, there was 5.2% OM recorded this year with these being similar to the local woodlands and desirable ranges. OM in the remaining sites were lower than the Grey Box woodlands and ranged from a low of 1.8% in GBReveg5 to a high of 3.6% in the Ironbark woodland.

Figure 8-17. Organic Matter concentrations recorded in the Grey Box monitoring sites compared to desirable agricultural levels.

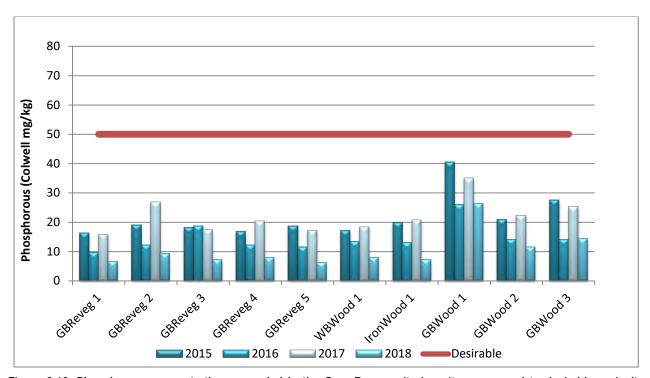
Phosphorous levels were lower than the agricultural standards across all Grey Box monitoring sites and this year there was a decrease in P recorded across all sites. They remained the highest within the woodland reference sites which had a P range of 11 – 26 mg/kg this year. P concentrations in the remaining revegetation sites, WBWood1 and IronWood1 were lower than this range and were lowest at GBReveg5 with 5 mg/kg to a high of 9 in GBReveg2 (Figure 8-18).

Figure 8-18. Phosphorous concentrations recorded in the Grey Box monitoring sites compared to desirable agricultural levels.

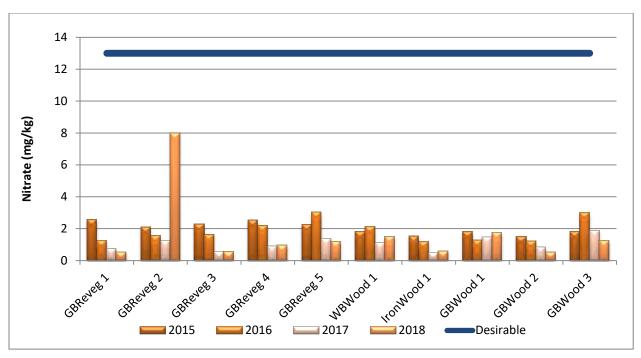
Nitrate levels were lower than the agricultural standards across all Grey Box monitoring sites and there continued to be little differences between the sites, with the exception of a small spike in GBReveg2 this year with 8.0 mg/kg. In the reference sites N ranged from 0.5 – 1.7 mg/kg and the remaining sites had N concentrations which fell within this range (Figure 8-19).

Figure 8-19. Nitrate concentrations recorded in the Grey Box monitoring sites compared to desirable agricultural levels.

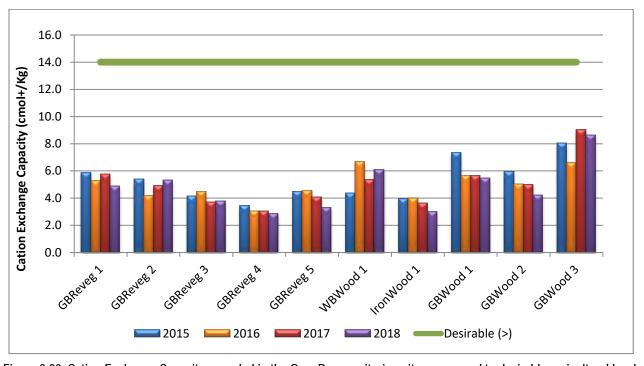
Cation Exchange Capacity (CEC) is the capacity of the soil to hold the major cations (calcium, magnesium, sodium and potassium) and is also a measure of the potential fertility of the soil. All of the Grey Box monitoring sites had a low CEC and in the reference sites CEC ranged from 4.2 – 8.6 cmol/kg (Figure 8-20). Sites GBReveg1, GBReveg2 and WBWood1 had a CEC which were similar to the reference sites. The remaining sites had a low CEC ranging from a low of 2.9 cmol/kg (GBReveg4) to a high of 3.8 cmol/kg (GBReveg2).

Figure 8-20. Cation Exchange Capacity recorded in the Grey Box monitoring sites compared to desirable agricultural levels.

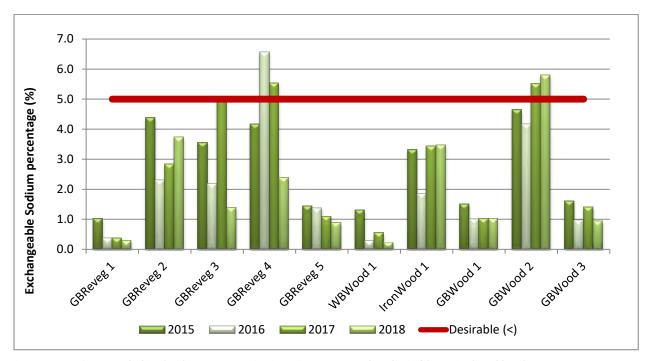
ESP recorded in the woodland reference sites was highly variable and ranged from 0.9 – 5.8% (Figure 8-21), with site GBWood2 slightly exceeding the minimum 5% threshold for sodicity. This year all remaining sites had an ESP that was well below the 5% threshold for sodicity and ranged from a low of 0.3% in GBReveg1 to a high of 3.7% in GBReveg2 indicating the soils are non sodic (Isbell 1996).

Figure 8-21. ESP recorded in the Grey Box monitoring sites compared to desirable agricultural levels.

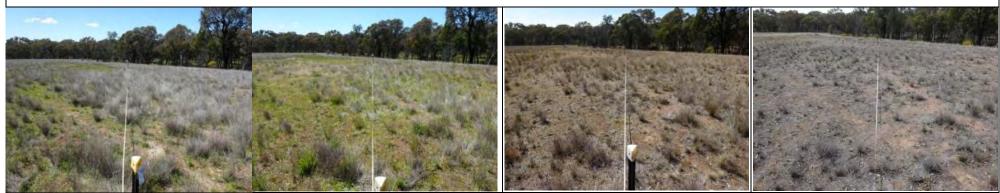
**DReveg2**: Degraded native pasture dominated by *Aristida racemosa* (three-awn Grass, but the exotic annuals *Hypochaeris glabra* (Smooth Catsear) and *Vulpia muralis* (Rats-tail Fescue) were also abundant. The site was relatively diverse and maintained relatively good ground cover. Mosses and cryptogam were scattered throughout. Presently there was no tree or shrub regeneration. In 2016 there was slightly more biomass but little other change was apparent. In 2017, the grass was grazed low except for scattered stressed tussocks of Aristida leaving limited ground cover apart from litter and cryptogams and some small bare patches have developed. There was evidence of rabbits (scratchings). In 2018, the remnant grass tussocks were very stressed and the ground cover in between was grazed very low. There was a decline in cryptogam cover and bare patches were developing. There continued to be a lot of moss cover (dead) and a lot of macropod/rabbit scat had accumulated.

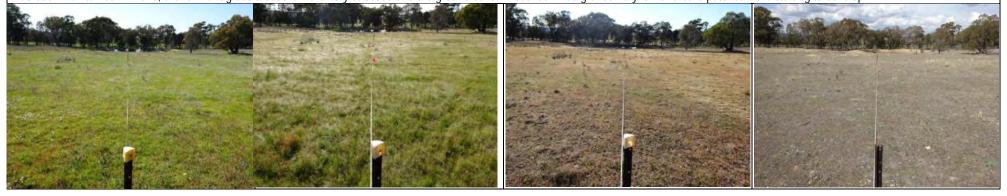
DReveg3: Degraded native pasture dominated by the exotic annuals *Hypochaeris glabra* (Smooth Catsear), *Vulpia muralis* (Rats-tail Fescue), *Aira cupaniana* (Silvery Hairgrass) and *Parentucellia latifolia* (Red Bartsia). The site was however relatively diverse and maintained relatively good ground cover. Mosses and cryptogam were scattered throughout. Presently there was no tree or shrub regeneration. In 2016 there was slightly more biomass but little other change was apparent. In 2017, the grass was grazed low except for scattered stressed tussocks of Aristida but good ground cover has been maintained. In 2018, the remnant grass tussocks were very stressed and the ground cover in between was grazed very low and bare patches were starting to develop.

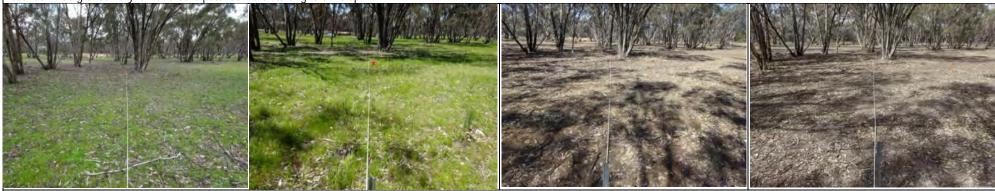
**DWoodLQ:** Open regrowth *E. dwyeri* woodland with occasional *E. albens* on the cleared grazing ecotone. The understorey was diverse but contained an abundance of annual grasses and forbs. The site maintained good ground cover with leaf litter dominant under the mature trees canopies. In 2016 there was a significant increase in live ground cover and the trees appeared healthier. In 2017, there was a good cover of eucalypt leaf litter and scattered native grasses. The majority of trees were in medium health. In 2018, the remnant grass tussocks were very stressed and the ground cover in between was grazed very low and bare patches were starting to develop.

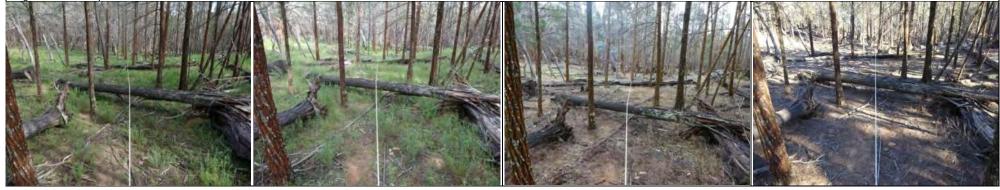
**DWood1:** Regrowth *E. dwyeri – Callitris* endlicheri woodland with scattered *E. dwyeri* and *E. dealbata* trees and a moderate density of *Callitris* endlicheri saplings. Many saplings have recently died probably over the prolonged summer which has opened up the canopy. *Gonocarpus tetragynus* (Hill Raspwort), *Cheilanthes sieberi* (Rock fern) and *Hypochaeris glabra* (Smooth Catsear) are dominant in the understorey and there is a god cover of leaf litter. There are many fallen branches and Cypress trunks and there is an adjacent rocky granite outcrop. There were numerous *Callitris* seedlings. In 2016 there was little apparent change. In 2017, there was typically a good cover of leaf litter and scattered native grasses and perennial forbs with these being stressed. The trees appeared healthy. More mature Callitris have died with more also having fallen over. In 2018 the site had opened up with remaining trees appearing to be healthy. There was little live ground cover and some Callitris regeneration has persisted.

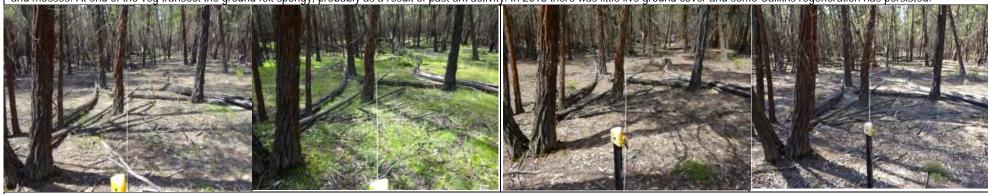
**DWood2**: Relatively open regrowth woodland of *Callitris endlicheri* and occasional *E. sideroxylon* (Mugga Ironbark). There were many Callitris stags with some having fallen down. There were scattered pockets of *Brachyloma daphnoides* (Daphne Heath) and a range of sparsely scattered native herbs however *Vulpia muralis* (Rat's Tail Fescue) was also common in pockets. There was extensive Callitris regeneration ~ 5cm in height. Coral Lichen was common throughout the larger woodland area and were present at the end of the vegetation transect. There was an extensive network of ant tunnels. In 2016 there was a significant increase in live ground cover. In 2017, there was typically a good cover of leaf litter, scattered sub-shrubs but live ground cover was limited. Occasional patches of lichens and mosses. At end of the veg transect the ground felt spongy, probably as a result of past ant activity. In 2018 there was little live ground cover and some Callitris regeneration has persisted.

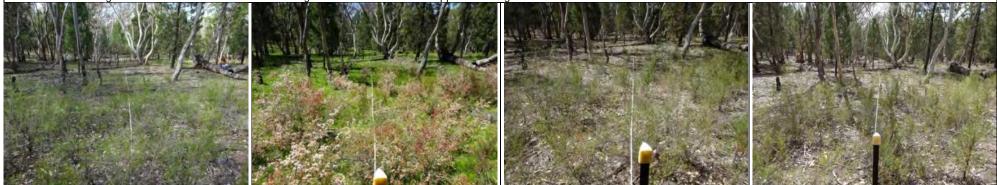
**DWood3:** A grassy clearing with low density *E. dwyeri – Callitris endlicheri* in the bottom of the slope within a major drainage depression. There were scattered patches of *Calytrix tetragona* and a significant number of small *Callitris* and *Calytrix* seedlings. The understorey contained a wide diversity of native herbs. There was extensive sedimentation within the site as a result of extensive overland erosion from the adjacent slopes which had low ground cover. In 2016 there was a significant increase in live ground cover and the understorey shrubs were flowering. In 2017, site had been heavily grazed. Typically good ground cover had been retained but there was limited live ground cover and the Calytrix were very stressed. The mature trees also appeared to be drought stressed, there continued to be a significant number of small *Callitris* seedlings. In 2018 there was little apparent change.

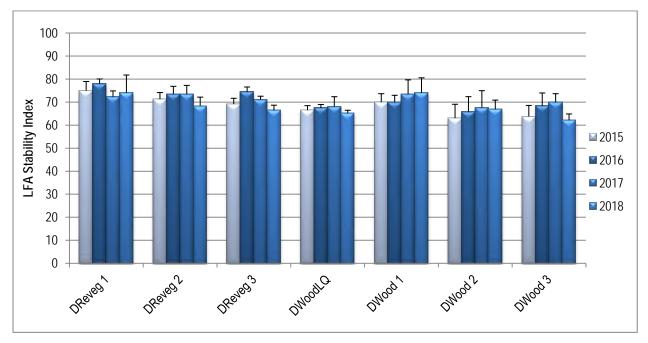
In the Dwyer's Red Gum derived native grasslands stability also tended to decline in all sites except DReveg1 and stability indices ranged from a low of 65.5 (DReveg3) to a high of 74.1 (DReveg1) and all sites continued to have a stability which was similar to or more stable than the reference sites. Despite the lack of a mature tree canopy, the high stability indices can be attributed to the high abundance of perennial ground covers, very hard soil crusts which usually contained a significant abundance of cryptogam cover. The sandy clay soils were subjected to some slaking but there tended to be less recent evidence of erosion or deposition within these sites in comparison to the reference sites.

Figure 9-2. LFA stability indices recorded in the Dwyer's Red Gum woodland monitoring sites.

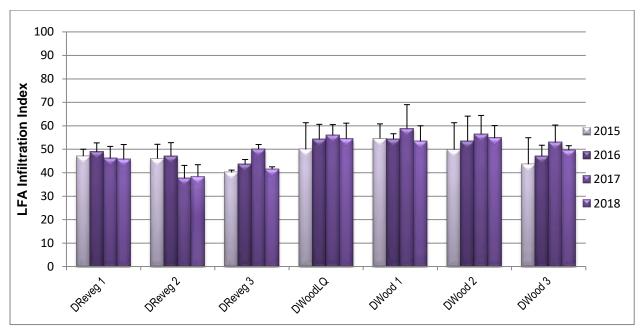
In the derived grassland revegetation sites, the litter layer was undeveloped and there typically was a hard surface crust which reduces the infiltration capacity of moisture to enter the soil profile, but cryptogams were often abundant. Over the past two years however, there has tended to be an increase in leaf litter and cryptogams and the soils had become more coherent and stable. In the grassland revegetation sites the dry conditions, combined with heavy grazing has resulted in a reduction in integrity of the herbaceous ground covers and litter and cryptogam layers. Thus the infiltration capacity in these sites has declined to provide indices ranging from 38.4 – 45.7. All Dwyer's Red Gum revegetation sites therefore had a low infiltration capacity compared to the reference sites again this year.

Figure 9-3. LFA infiltration indices recorded in the Dwyer's Red Gum woodland monitoring sites.

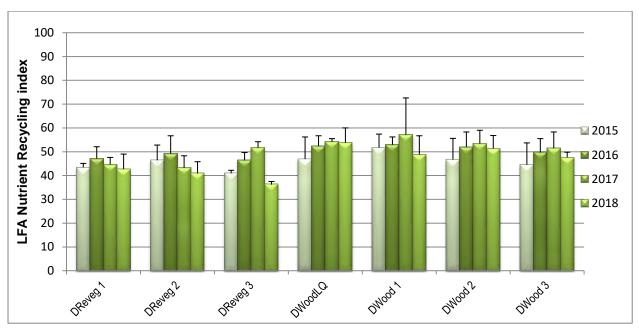
In the Dwyer's Red Gum revegetation sites there was also a reduction in nutrient recycling capacity this year with a low of 36.2 in DReveg3 and a high of 42.7 in DReveg1.

Figure 9-4. LFA nutrient recycling indices recorded in the Dwyer's Red Gum woodland monitoring sites.

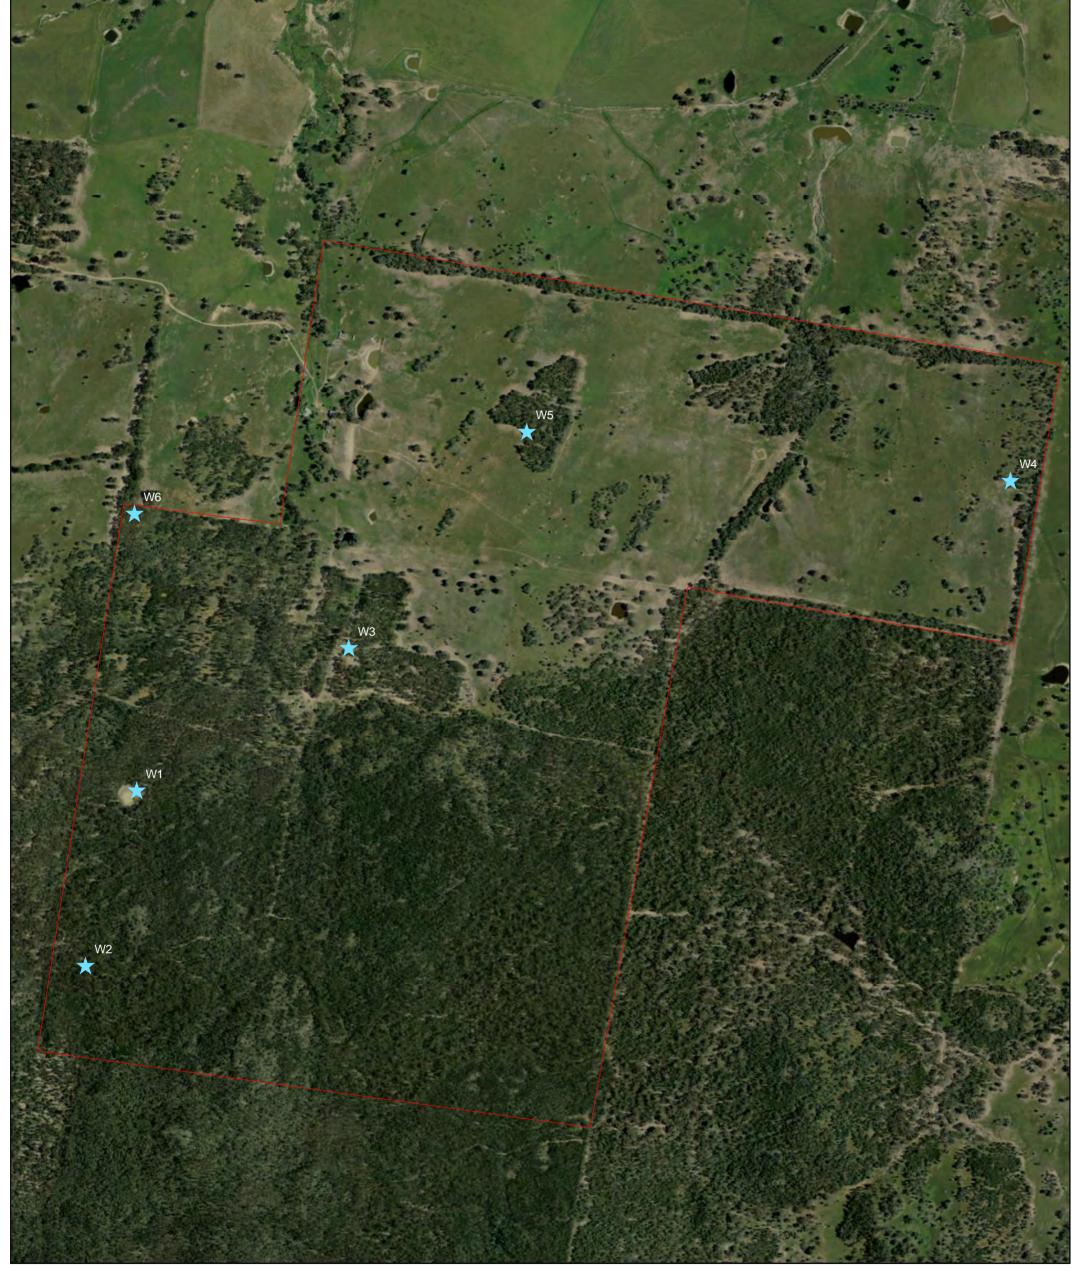
Consistent with surveys in winter 2014 to 2017, as the regeneration areas do not meet the height requirements for monitoring at this stage, surveys were only undertaken at woodland locations within Kokoda. The six surveys sites were positioned in areas of suitable habitat for both targeted species.

In the previous 2017 winter survey period the ecologist had noted that there was also abundant flowering eucalypts (e.g. *Eucalyptus sideroxylon* – Mugga Ironbark) at three of the remnant spring bird survey sites. These three sites were surveyed additionally on two separate mornings in winter to target the Regent Honeyeater and Swift Parrot. In 2018, after a lower than average rainfall, these eucalypts were not flowering as abundantly and as such were not considered as additional survey sites for the winter survey period.

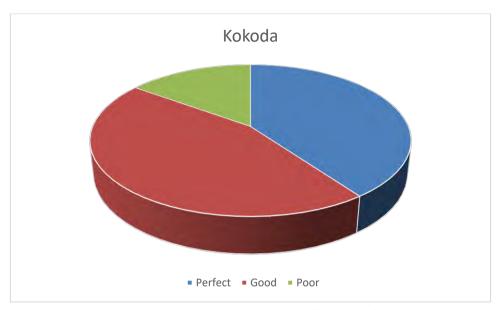
Figure 1. Percentage of nest box condition per location.
