Name of Mine	Northparkes Mines
Name of Leaseholder and Mine Operator	CMOC Mining Pty Ltd
Mining Leases	ML1247, ML1367, ML1641 and ML1743
Environment Protection Licence	EPL 4784
Development Consent	DC11_0060, (as modified)

## SCOPE OF REPORT

This report provides a summary of monitoring results for the period from 1 January to 31 March 2021. This monitoring is undertaken in accordance with the Environmental Monitoring Program (available at www.northparkes.com.au). Details of air quality, noise and water monitoring locations are available in the Environmental Monitoring Program.

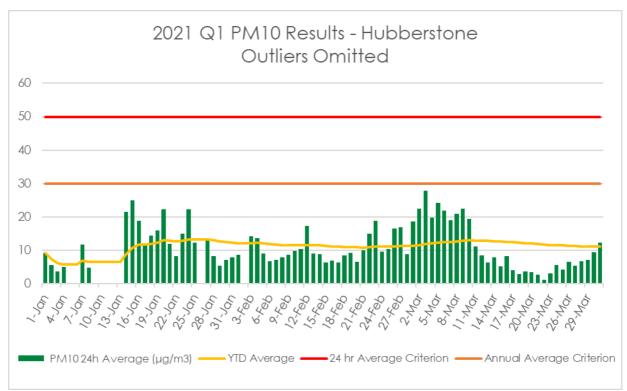
Figure 1: Hubberstone

- 26 Jan 2021 (102.6 μg/m3) following analysis of results, the elevated reading was caused by an instrument error, recording of 25,270 μg/m³ during a 10-minute averaged period. The 10-minute averaged periods prior to and post the extreme reading recorded 22 μg/m³ and 18 μg/m³ respectively. Excluding this extreme reading from the result, the PM<sub>10</sub> 24 hour average would be 19.0 μg/m³. This result was deemed non-mine related and removed as an outlier.

- <u>2 Feb 2021 (118.5 μg/m3)</u> following analysis of results, the elevated reading was caused by an instrument error, recording of 25,250 μg/ m³ during a 10-minute averaged period. The 10-minute averaged periods prior to and post the extreme reading recorded 0 μg/ m³ and 4 μg/ m³ respectively. Excluding this extreme reading from the result, the PM<sub>10</sub> 24 hour average would be 9.5 μg/ m³. This result was deemed non-mine related and removed as an outlier.

- 11.2 μg/m³ at Hubberstone
- 12.0 µg/m³ at Milpose, and
- 8.5 µg/m³ at Hillview.

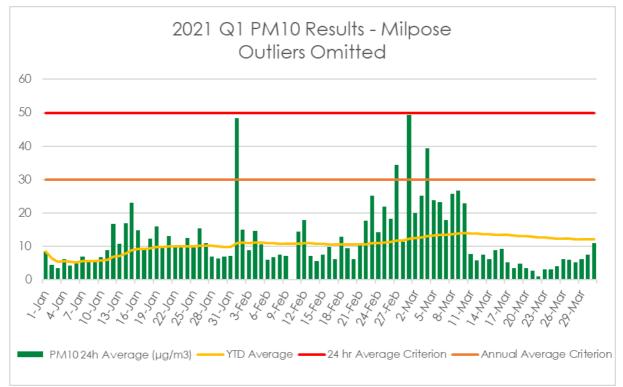
Figure 2: Milpose

• 10 Feb 2021 (59.0 µg/m³) – prevailing winds (NE) were experienced from the project area prior to PM<sub>10</sub> readings becoming elevated. During the period of elevated results, wind speeds are weaker and from an ESE direction. If the project was generating airborne particulates, it would of more than likely been recorded during the stronger winds that were prevailing from the NE direction. It has also been noted that the resident has livestock in the surrounding paddock with their primary source of water to the ESE of the monitoring location. It has therefore been concluded that the elevated reading were not likely mine generated and therefore not reportable. The elevated reading has been omitted from the results.

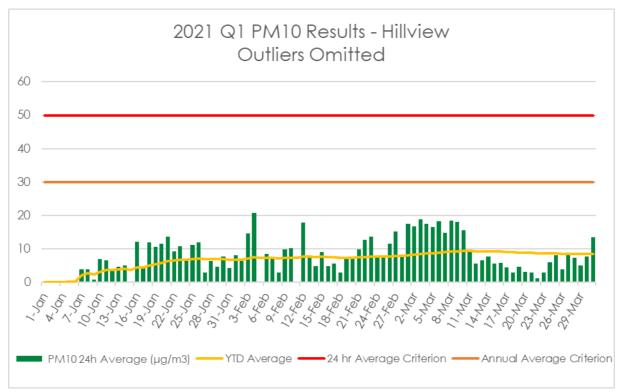
Figure 3: Hillview

- 6 Jan 2021 (102.6 μg/m³) following analysis of results, the elevated reading was caused by an instrument error, recording of 14,240 μg/m³ during a 10-minute averaged period. Five 10-minute averaged periods recorded 0 μg/m³ prior to and post the extreme result. Excluding this extreme reading from the result, the PM₁0 24 hour average would be 3.7 μg/m³. This result was deemed non-mine related and removed as an outlier.
- 11 Feb 2021 (118.5 µg/m³) Analysis of PM10 data shows that periods recording high levels of particulate matter occur when the prevailing winds come from a Northerly and Northeasterly direction. As this is the opposing direction to the mine, it is highly unlikely that the elevated reading was caused by mining operations and has since been omitted from results.

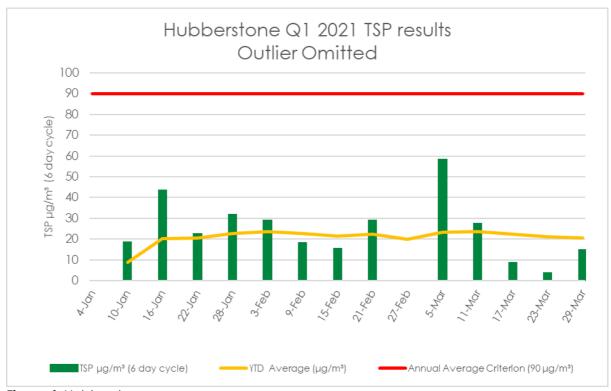
Figure 4: Hubberstone

Both Hubberstone and Hillview recorded dust levels at the TSP monitoring locations under the required average annual criteria set by the Consent (90  $\mu$ g/m³) for the quarter for the reporting period.

- 22.1 µg/m³ at Hubberstone
- 26.3 µg/m³ at Milpose, and
- 20.4 µg/m³ at Hillview.

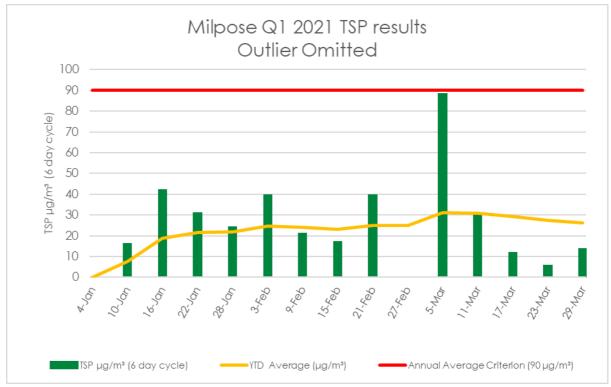
Figure 5: Milpose

Milpose recorded one elevated result of 163  $\mu$ g/m³ on 27 February. Low wind speeds ( $\leq$ 5 m/s) were experienced during 95% of the period, with the moderate to strong winds (>5 m/s) experienced from 1900 to 2000 hours. The stronger winds prevailed from the North, averaging 9 degrees during the hour period, suggesting the mine was an unlikely contributor to the elevated result. The result was removed as an outlier.

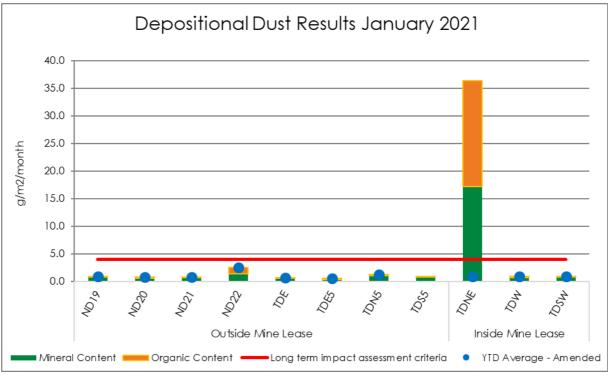
Figure 7: January depositional dust results for all locations

- January: 36.3 g/m²/month Analysis of this result showed that 19.1 g/m²/month was attributed to combustible matter and 17.2 g/m²/month was attributed to ash content. Observations during the sampling activities noted that the bottle had a considerable amount of bird droppings in the funnel and large amounts of debris in the sample bottle. Northparkes will continue to monitor for trending results.
- <u>February: 39.2 g/m²/month</u> Analysis of this result showed that 25.7 g/m²/month was attributed to combustible matter and 13.5 g/m²/month was attributed to ash content. Observations during the sampling activities noted that the bottle had a considerable amount of bird droppings in the funnel and large amounts of debris in the sample bottle. Northparkes will continue to monitor for trending results.

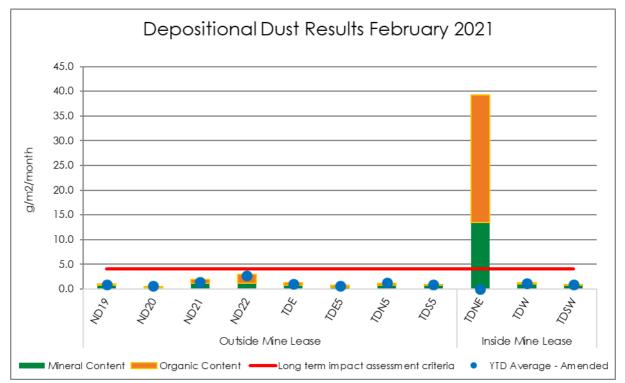
Figure 8: February depositional dust results for all locations

During the quarter, TDNE, TDE and ND22 recorded results above the internal trigger level of 4.0 g/m²/month, with ND20 and ND22 and triggering the maximum increase of 2 g/m²/month at a residence on privately owned land. An internal investigation was undertaken for all results and are detailed below.

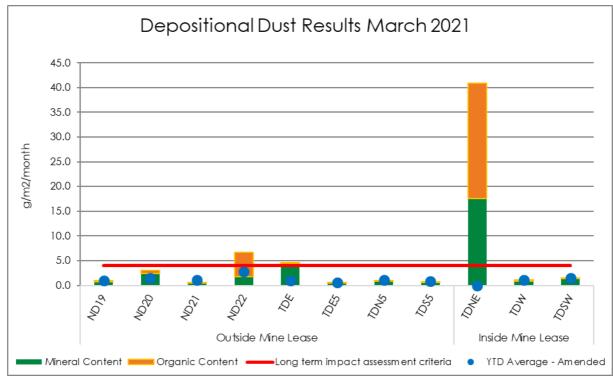
Figure 9: March depositional dust results for all locations

March: 3.5 g/m²/month – an increase of 2.5 g/m²/month was recorded from the previous February monitoring period. Analysis of weather data from Northparkes onsite meteorological station showed that 27% of potential dust generating wind (>7 m/s) was from the project area. As the project contains a large amount of agricultural buffer area, further investigation found that only 5% of potential dust generating winds came from areas that had been disturbed by mining activities. 60% of strong prevailing winds occurred between a North and Easternly direction. During the monitoring period, several activities occurring within close proximity to the monitoring location and are most likely the source of increased particulates. These include a number of agricultural activities, animal husbandry and prescribed burning.

• March: 6.7 g/m²/month – an increase of 3.8 g/m²/month was recorded from the previous February monitoring period. Investigation of the laboratory analysis showed that 4.9 g/m²/month was attributed to combustible matter, suggesting that tree litter was the main contributing factor to the increased result. ND22 gauge location is within close proximity to visual mtigation tree screen and has previously reported high levels of combustible matter. Northparkes will look to relocate the gauge to a more appropriate location to ensure representative particulate data is captured.

March: 4.6 g/m²/month – the elevated TDE result was noted to have potentially occurred
from several activities occurring within close proximity to the monitoring location. These
include a number of agricultural activities, animal husbandry, prescribed burning and
mining. The result will be observed during the next monitoring periods for upward trending
and possible causes.

March: 40.9 g/m²/month – Analysis of this result showed that 25.7 g/m²/month was attributed to combustible matter and 13.5 g/m²/month was attributed to ash content. Observations during the sampling activities noted that the bottle had a considerable amount of bird droppings in the funnel and large amounts of debris in the sample bottle. Northparkes have actioned an investigative program to be undertaken during future monitoring periods to understand the cause of the increase particulate matter.
