Northparkes Mines
A century of mining together

2021 Annual Review

Document Details	
Name of Operation	CMOC-Northparkes Mines
Name of Operator	CMOC Mining Pty Ltd operating as CMOC Mining Services Pty Ltd
Development Consent/Project Approval Number	DC11_0060, as modified
Name of holder of development consent/Project Approval	CMOC Mining Pty Ltd
Mining Leases	ML1247, ML1367, ML1641, ML1743
Name of holder of mining lease	CMOC Mining Pty Ltd
Water Licence #	Refer to Table 4 Summary of Licences
Name of holder of water licence	CMOC Mining Pty Ltd
MOP Commencement Date	1 st January 2020
MOP Completion Date	30 th June 2022
Annual Review Commencement Date	1 st January 2021
Annual Review Completion Date	31 st December 2021
I, Jianjun Tian, certify that this audit report is a true and accurate record of the compliance status of CMOC-Northparkes Mines for the period 1 st January 2021 to 31 st December 2021 and that I am authorised to make this statement on behalf of CMOC Mining Pty Ltd.

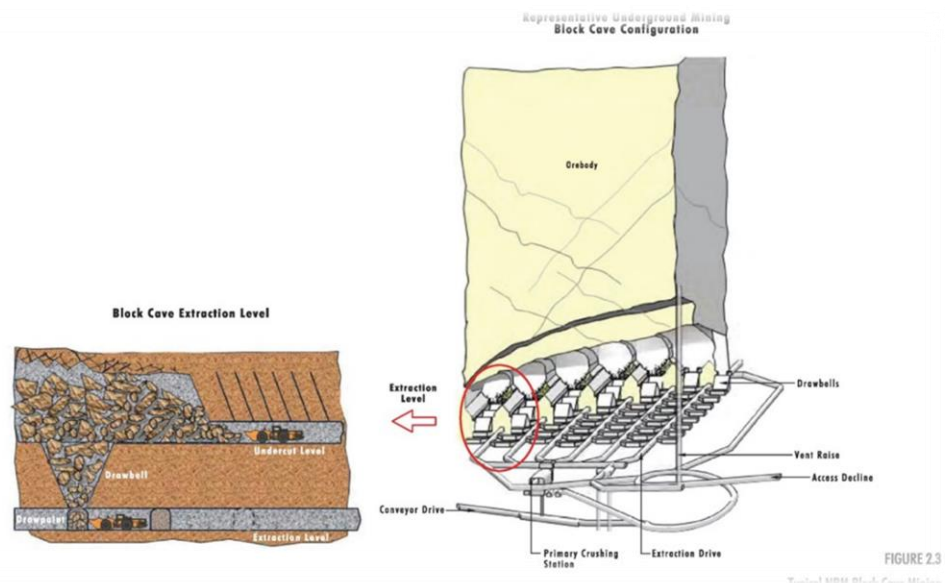
Figure 4 Block Cave Mining Method

In 2021 Northparkes continued with the development of the new Block Cave (E26 Lift 1 North). Construction started in January 2019 and by February of 2022 the production of the new block cave will commence. This new block cave is scheduled to start full production in 2023.

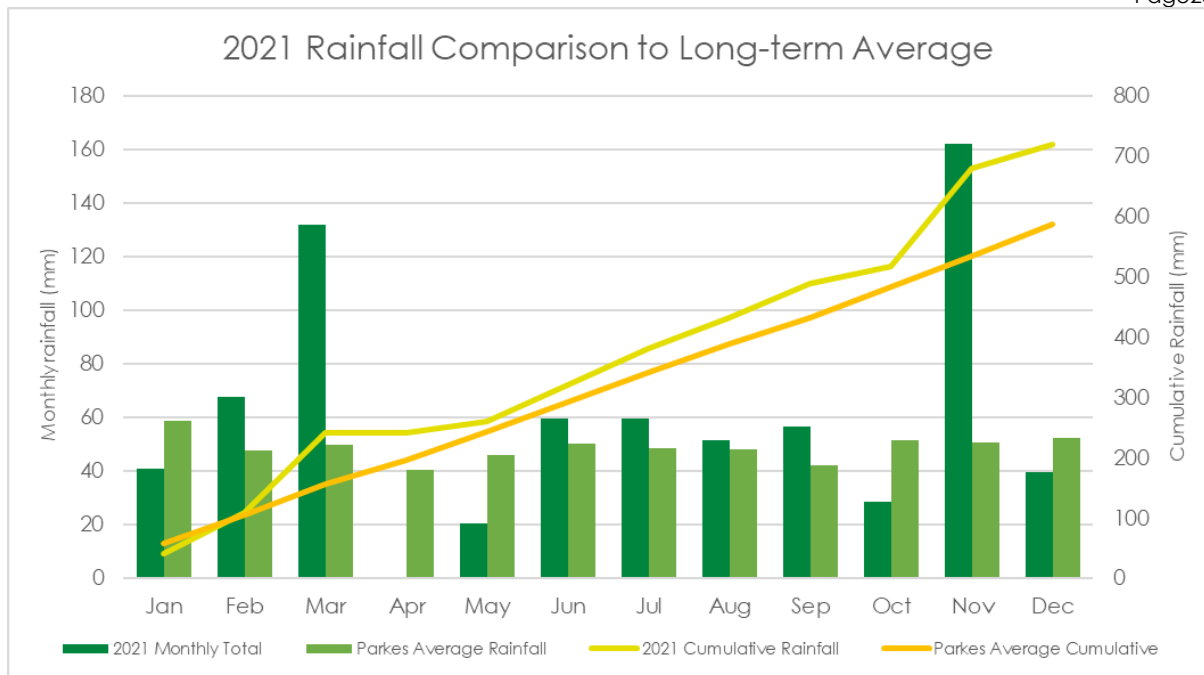
Figure 8 Comparison of 2021 rainfall to long term average for Parkes.

The total onsite rainfall recorded at the MET monitoring station for the period was 719.8mm and represents a 76.8mm (10%) decrease from the previous reporting period. The rainfall received during the reporting period was 132.6mm above the long-term average for the region (587.2mm). A comparison of 2021 rainfall to long-term averages for Parkes is shown in Figure 8 below.

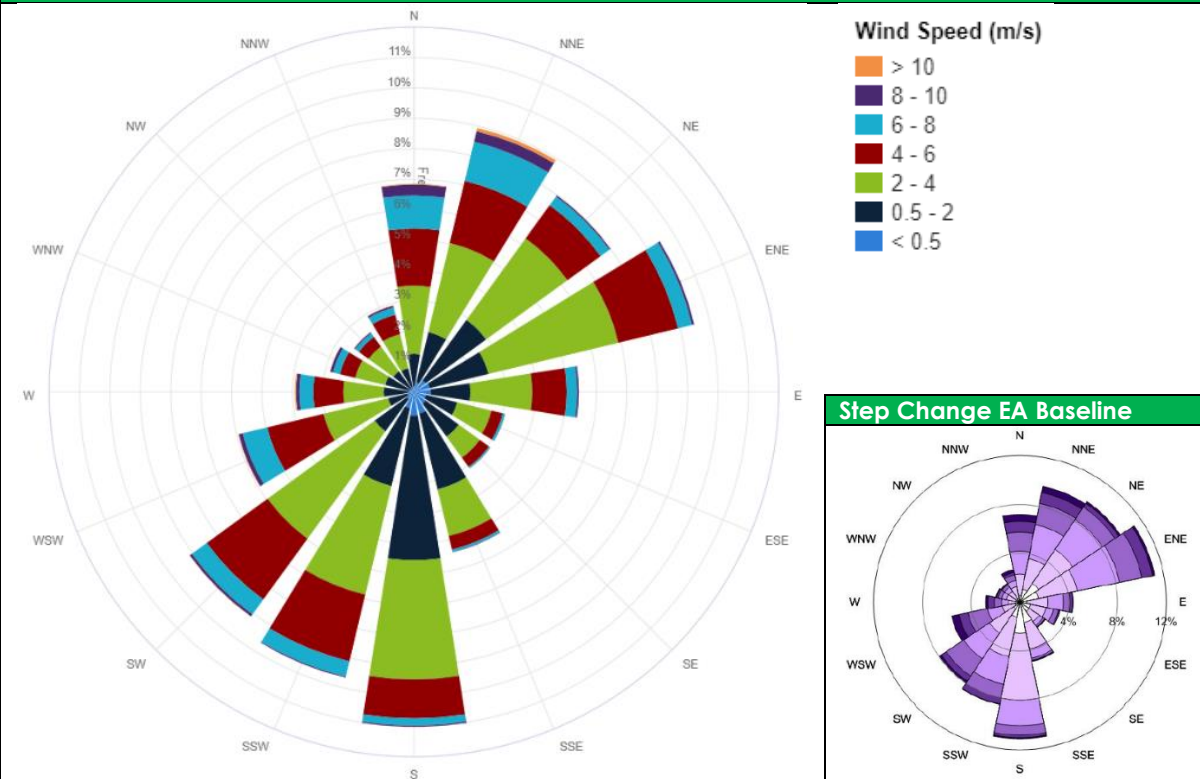
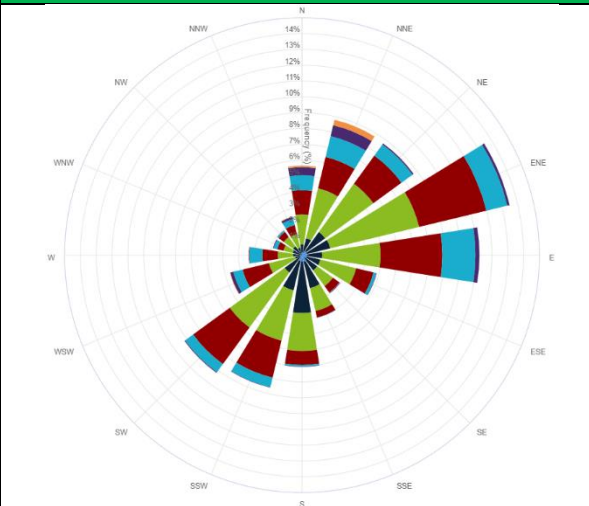
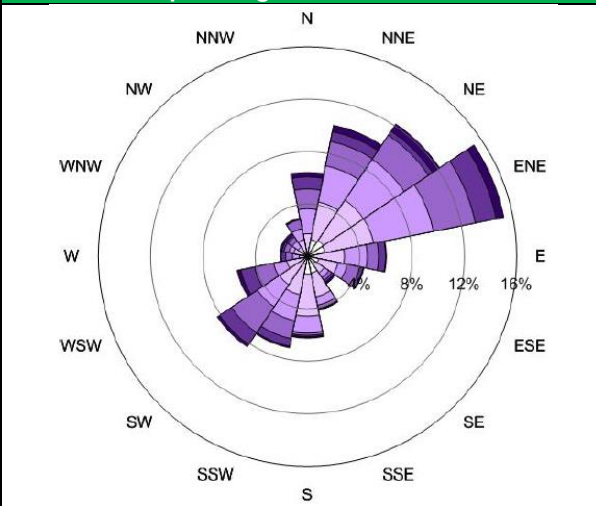
Figure 9 2021 seasonal wind rose comparison against Step Change EA baseline

Analysis of data reveals that prevailing winds during the 2021 reporting period were largely inline with that recorded for the Step Change Environmental Assessment (EA), Umwelt 2013. Prevailing winds for the period were typically received from the northeast or south south west. Average wind speeds were generally consistent through the year recording 3.02m/s in H1 and 3.12m/s in H2.

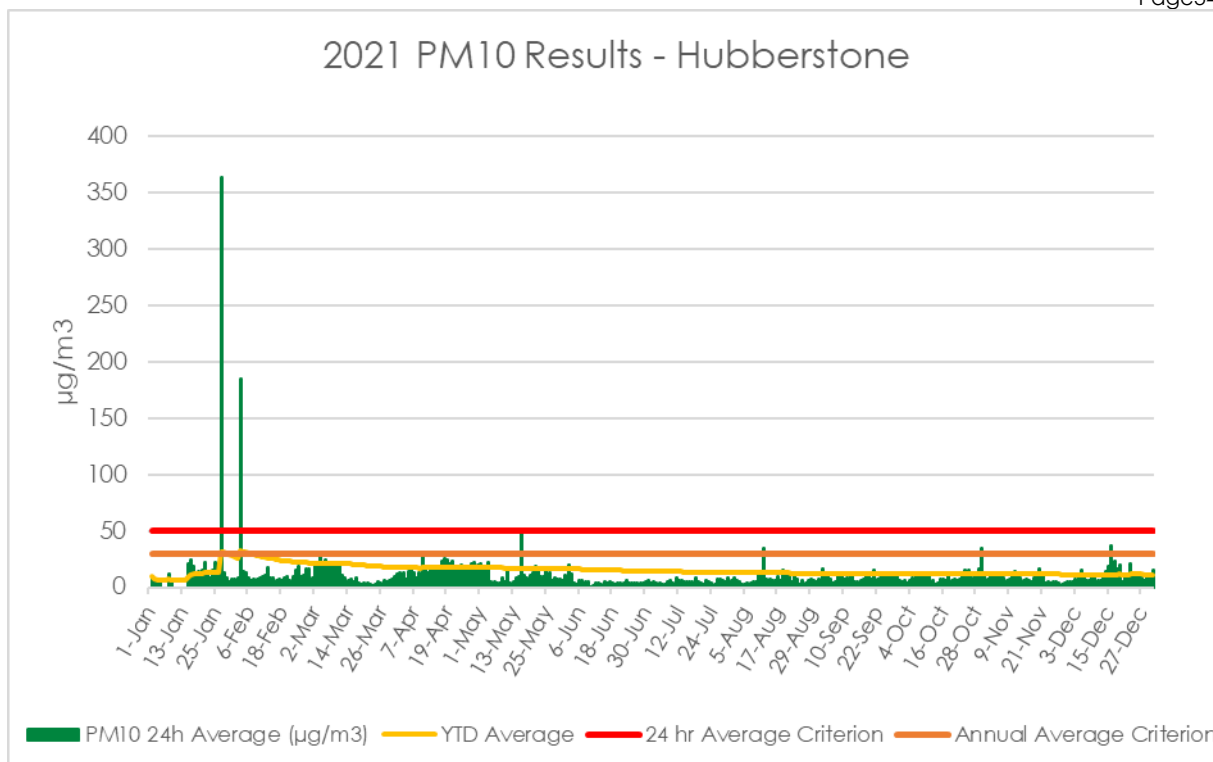
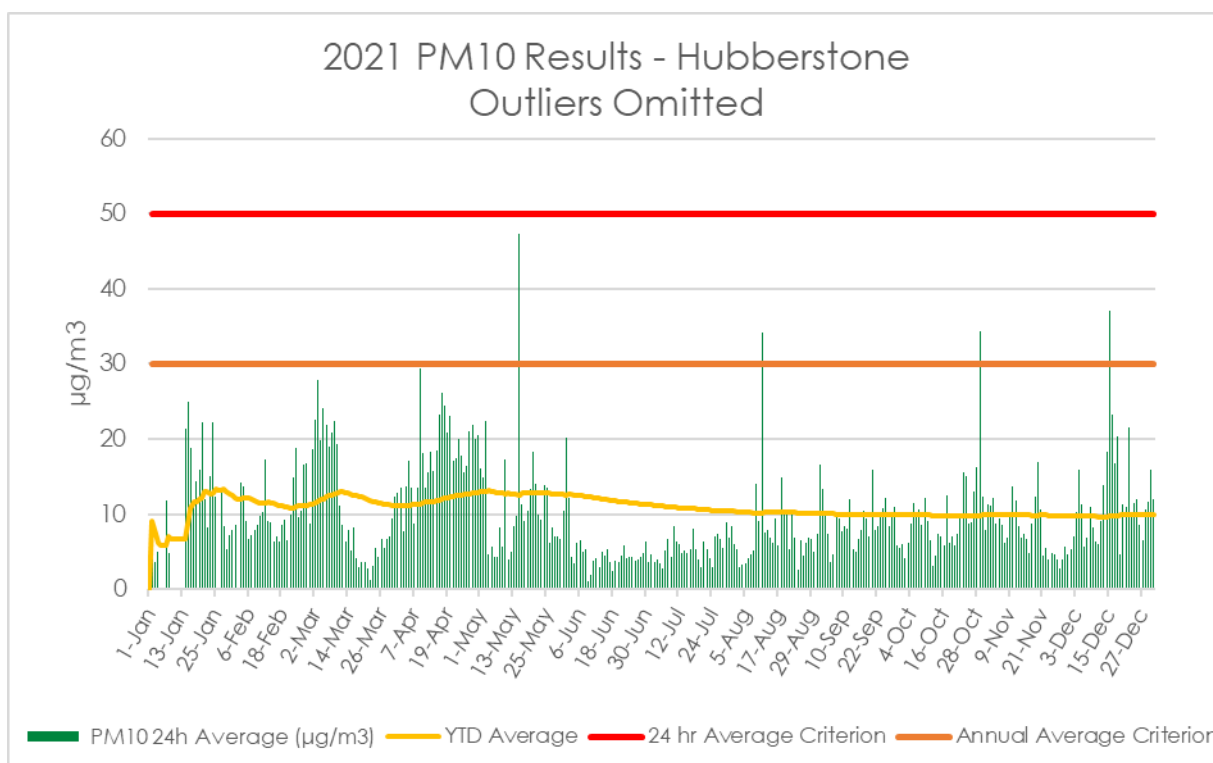
Figure 10 PM10 Monitoring results - Hubberstone

Figure 11 PM10 Monitoring results with outliers omitted - Hubberstone

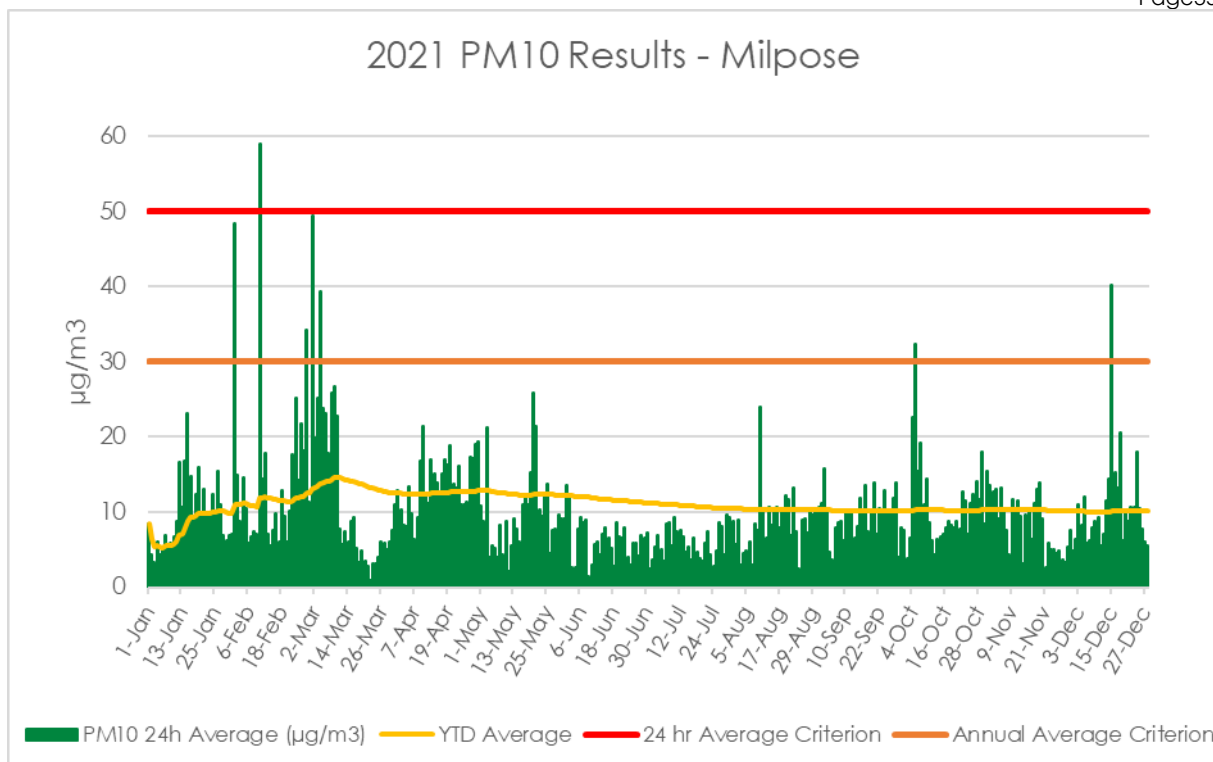
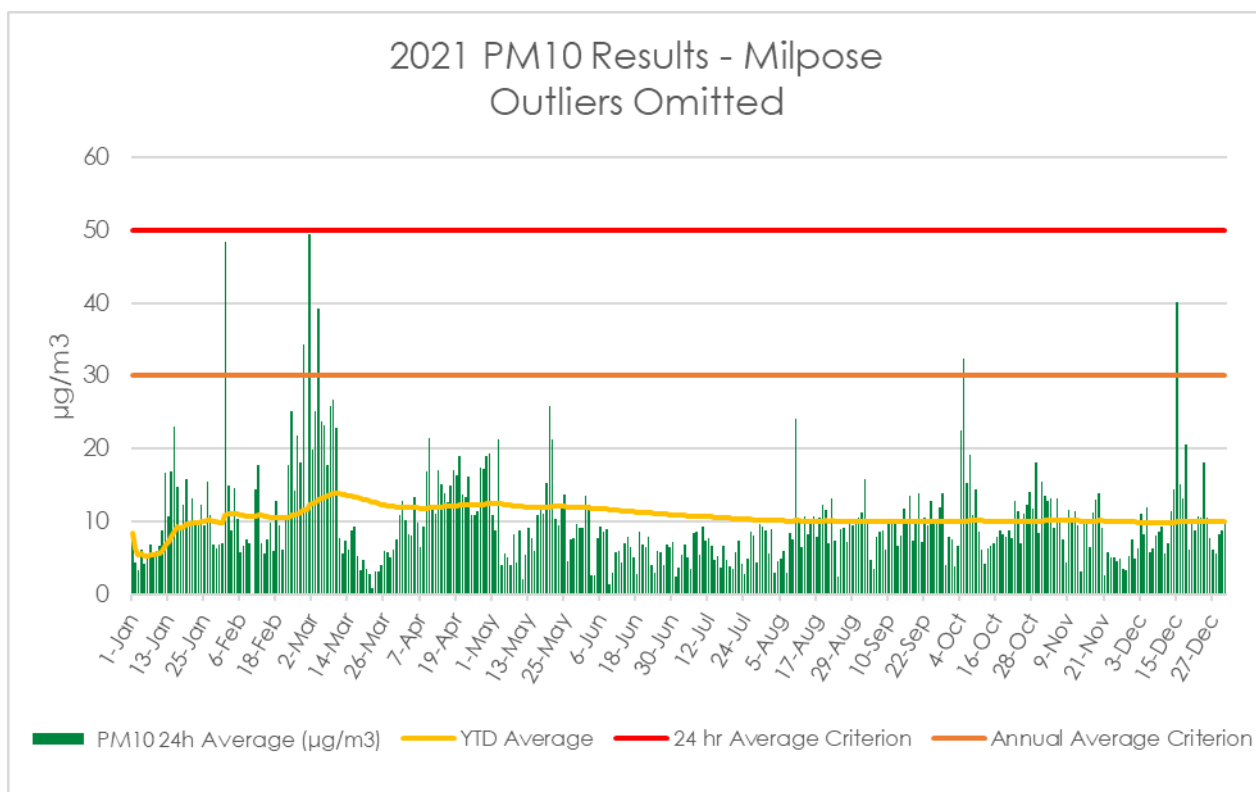
Figure 12 PM10 Monitoring Results – Milpose

Figure 13 PM10 Monitoring results with outliers omitted – Milpose

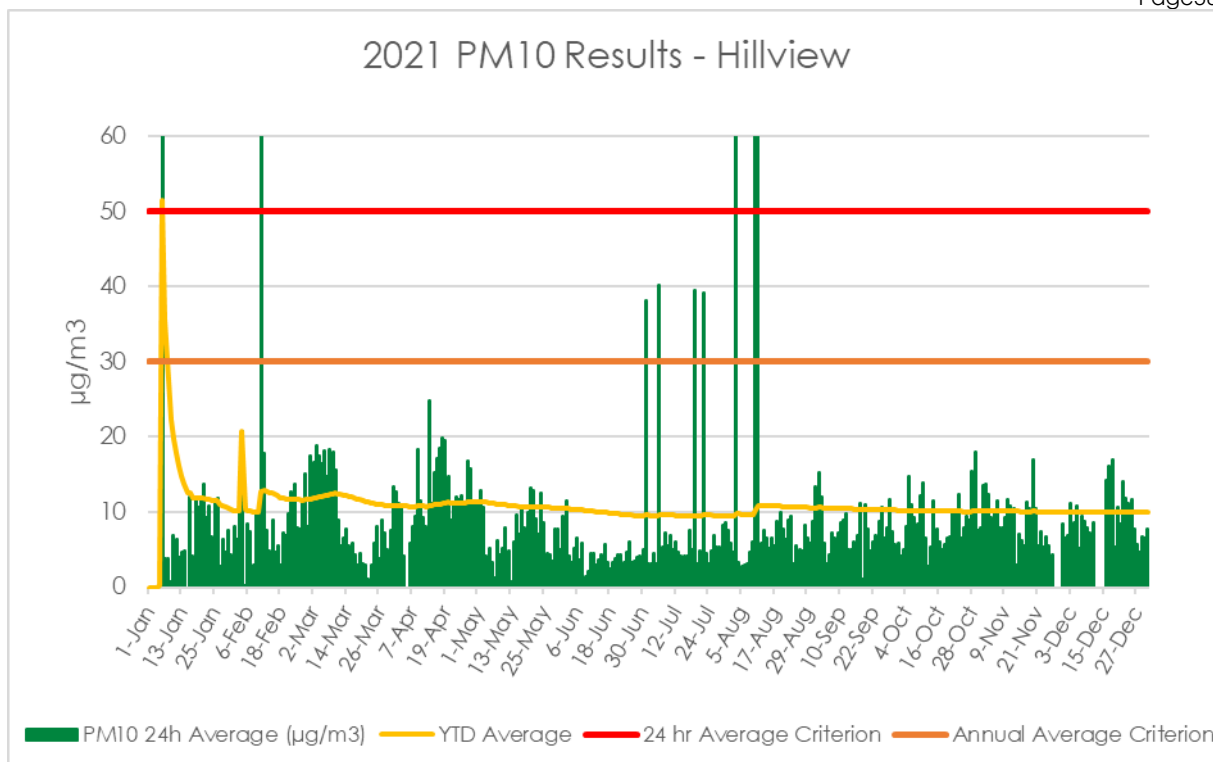
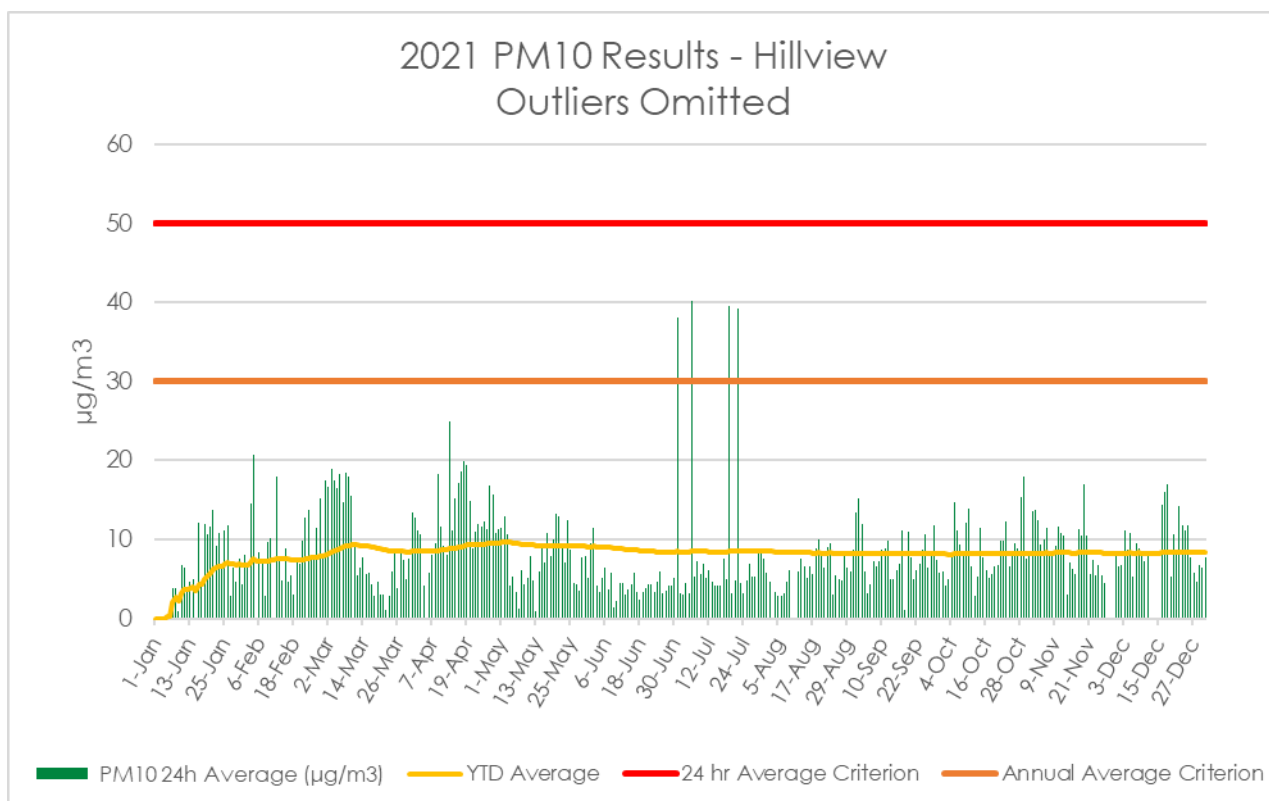
Figure 14 PM10 Monitoring Results – Hillview

Figure 15 PM10 Monitoring results with outliers omitted – Hillview

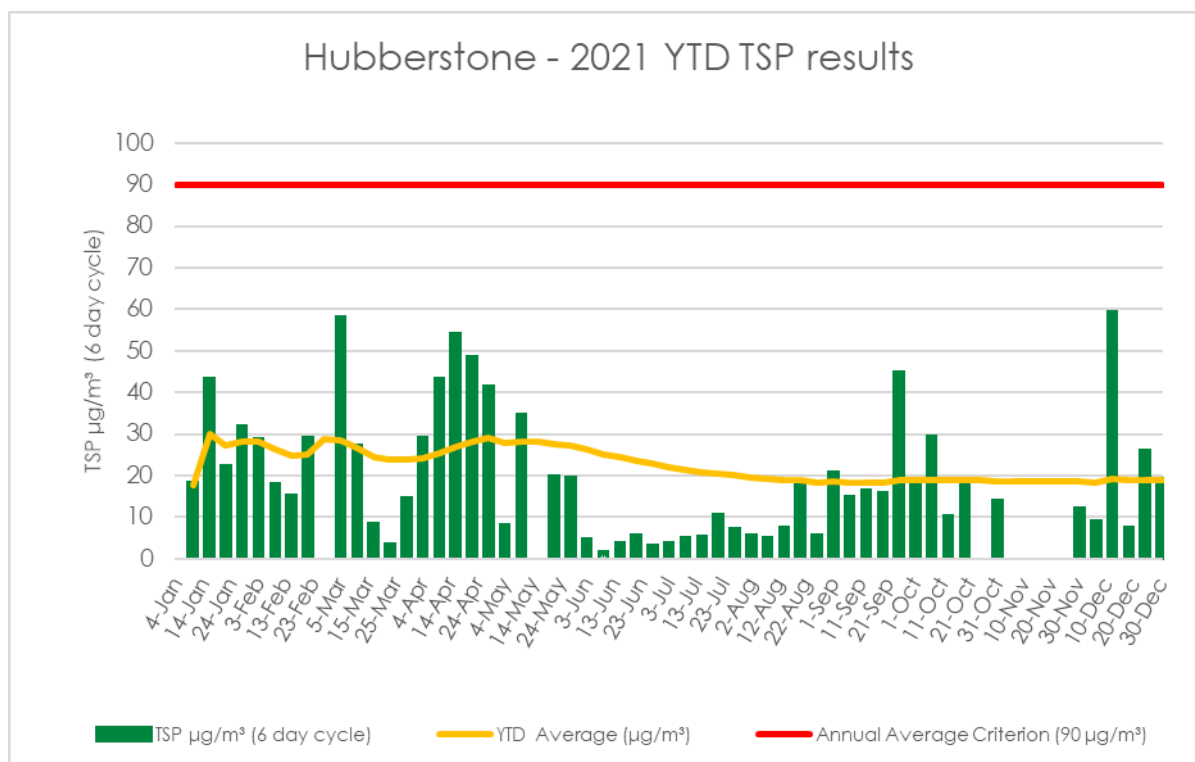
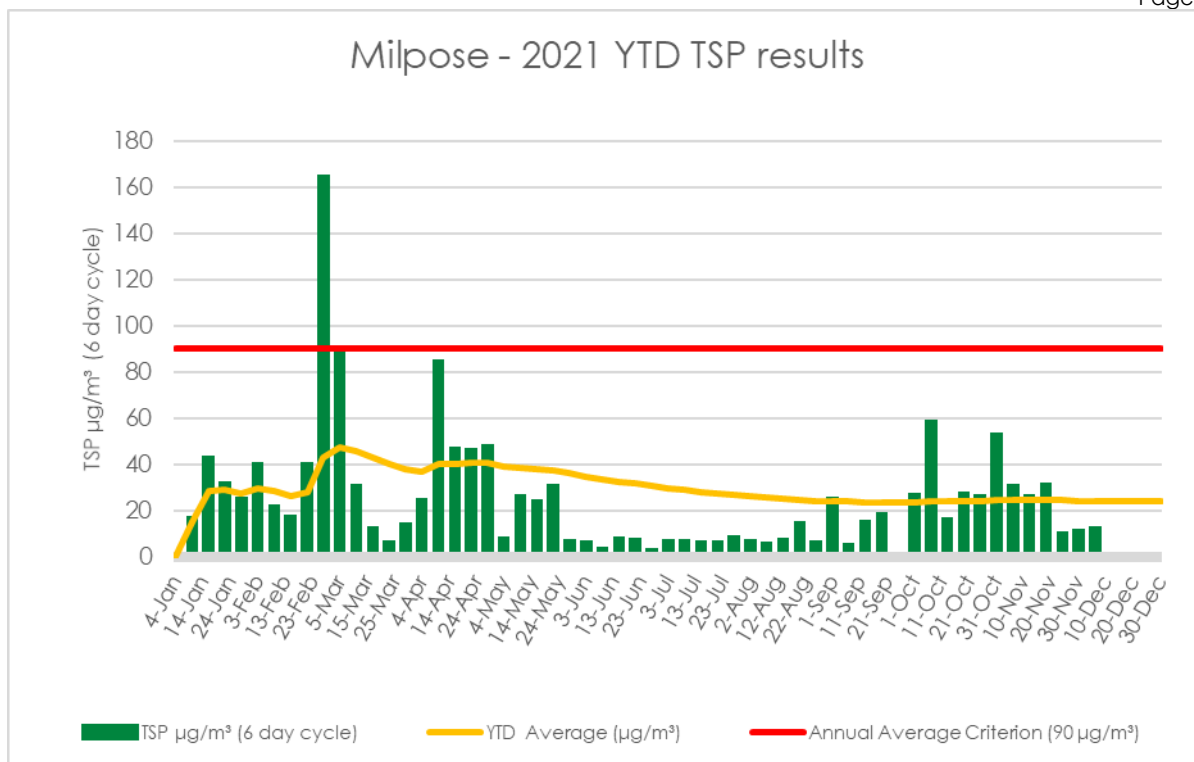
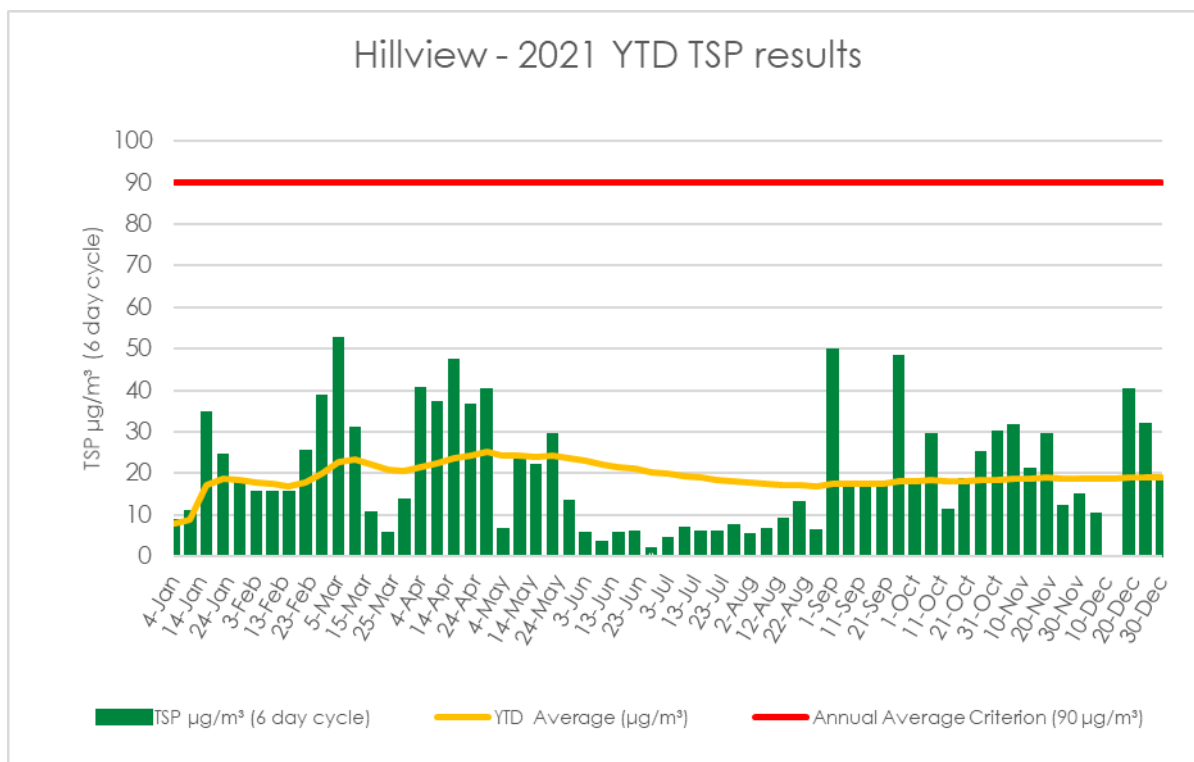
The missing data for Hubberstone, Milpose and Hillview in Figure 16, Figure 17 and Figure 18, respectively, were the result of power supply issues to the monitoring unit.

Figure 16 TSP Results for Hubberstone

Figure 17 TSP Results for Milpose

Figure 18 TSP Results for Hillview

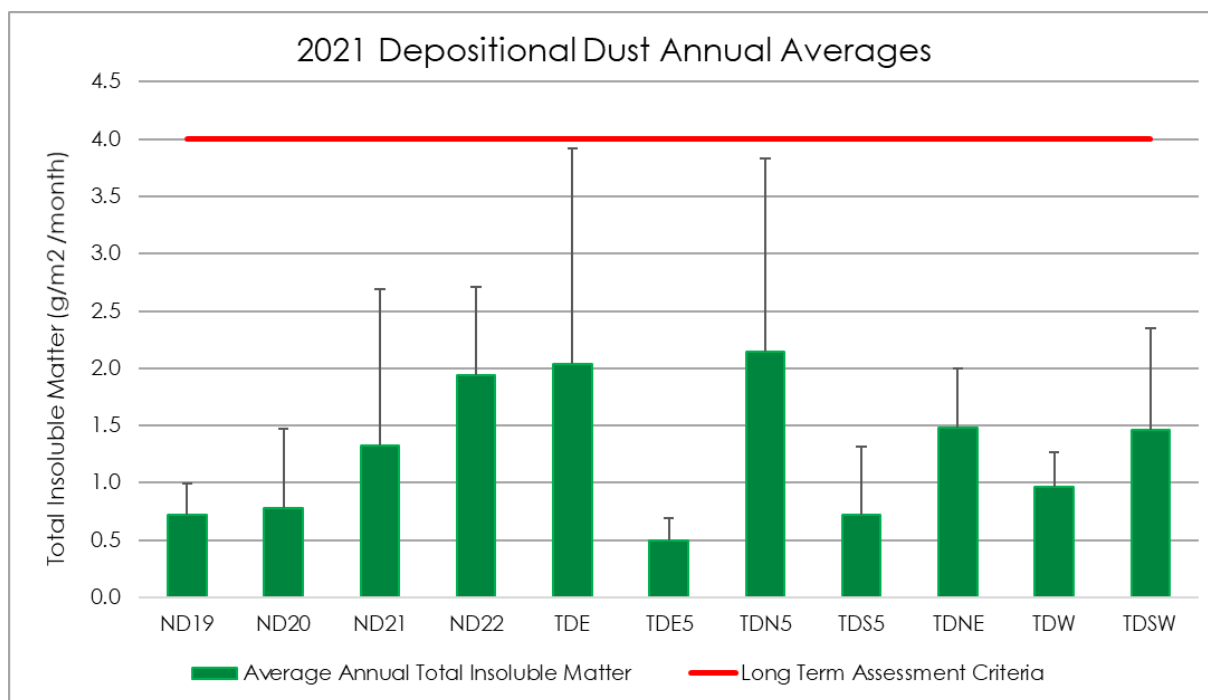
Figure 19 Depositional Dust Annual Averages

Depositional dust samples were analysed by a NATA accredited laboratory to determine sample contamination by naturally occurring impurities. Figure 19 presents the annual average results following laboratory analysis of all eleven dust gauges. The results indicate that all reportable depositional dust gauges remained below the annual average criterion of 4.0 g/m²/month for the 2021 period.

All dust gauge results, with outliers removed, remain well below the predicted concentrations in the Step Change EA and criteria of the Consent, shown in Table 16 above. Between 2013 and 2015, the rolling annual average of all gauges was on an upward trend. During 2015, the trend stabilised and then began trending downwards during 2016. Depositional dust levels during the 2018 and 2019 periods reported upward trends as a result of increasing drought conditions. During January and February of 2020, drought conditions were still heavily impacting recorded dust levels before widespread rainfall prompted results to return to that in line of long-term historical data. Results in 2021 continued to trend downward as above average rainfall maintained significant quantities of groundcover and soil moisture.

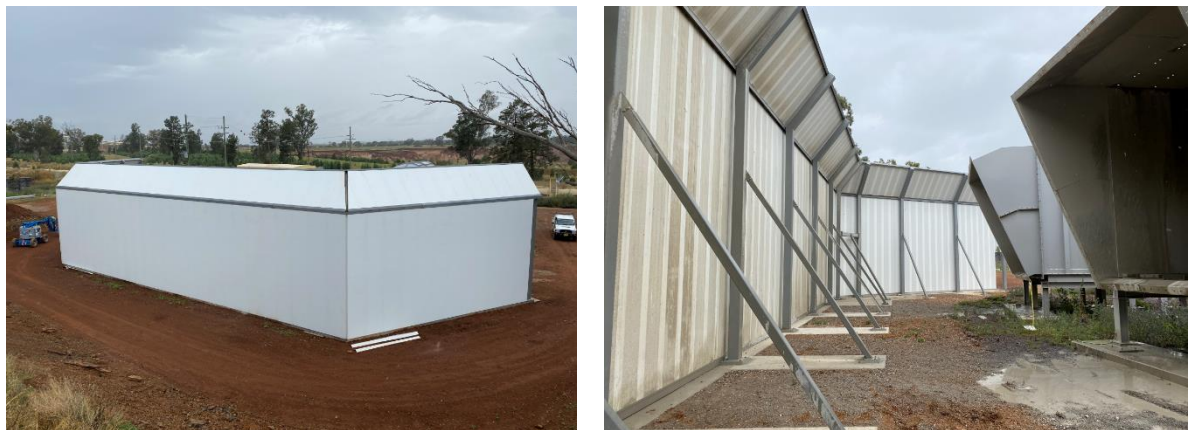
Figure 20 Photos of the constructed acoustic barrier at the E48 vent fan.

During the previous reporting period, Northparkes identified increased noise impacts from the commissioned E48 vent fan. Several mitigative options were investigated, concluding that the installation of an acoustic barrier was to be most effective and feasible. The installation of the barrier was completed in January 2022 and has provided effective noise mitigation to the residences west of site. Figure 20 below shows the configuration of the constructed noise barrier in relation to the E48 vent fan.

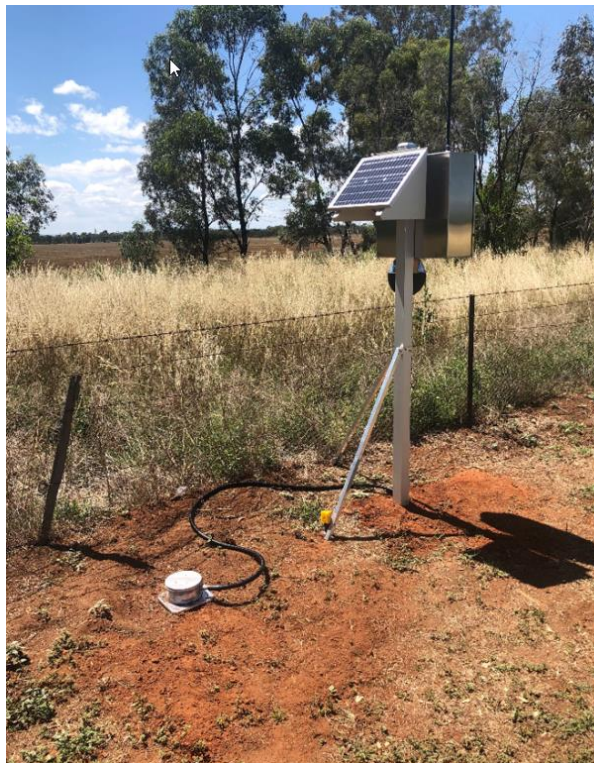
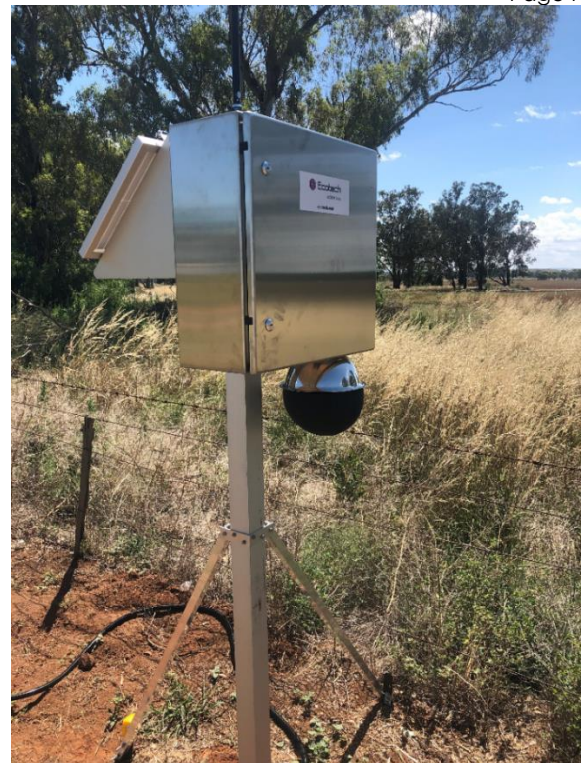
Figure 21 Installed blast monitor at a nearby residence.

The Blast Management Plan (BMP) will be reviewed and submitted for approval prior to undertaking surface blasting. Photos of the installed monitors are shown below in **Figure 21**.

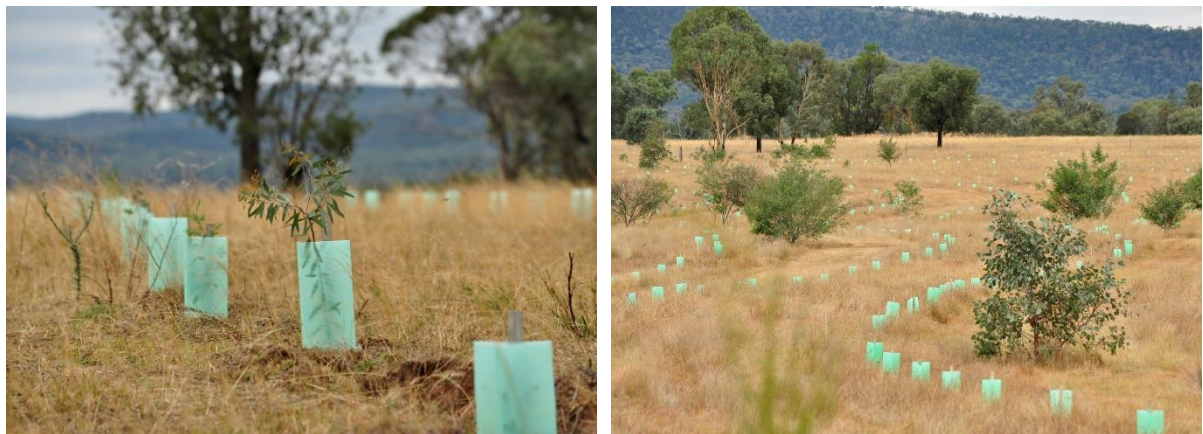
Figure 22 Plant installed in April trial planting and Spring planting lines

During the reporting period, Northparkes continued to implement the active regeneration planting which was initiated in the 2020. The total planting program consists of 18,000 tubestock, installed across 37 hectares to restore farmland to a Grey Box Grassy Woodland (GBGW) ecosystem. In May of 2021, 8,655 remaining tubestock were planted with a combination of mycorrhiza, water crystals, tree tonic and native fertiliser. To prevent grazing and vegetation competition, 400mm core flute guards and weed matting was placed around the installed plants. The 8,500 individuals were a combination of tree and shrub species, the majority, approximately 75%, were targeted at providing diversity within the midstorey of the community.

Widespread rain was experienced throughout the region promoting quick establishment and further aided through the abundance of native vegetation, reducing the grazing pressure by macropods. Maintenance of the tubestock will be undertaken as required to ensure success of the planting program.

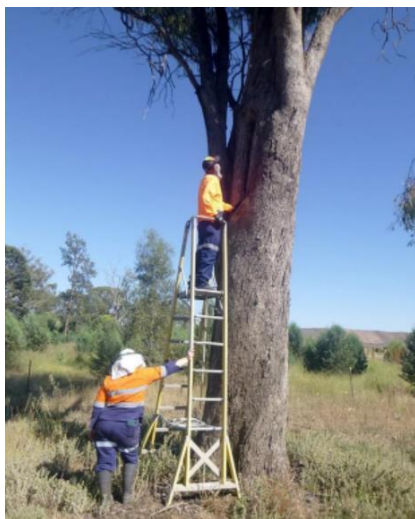
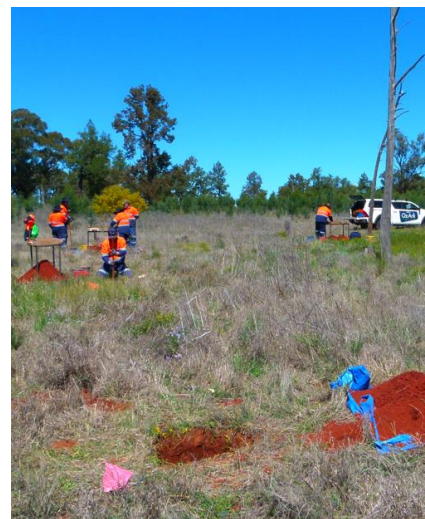
Figure 25 Limestone State Forest Tree and E44 Sieving Pits

Whilst carrying out the assessment of the E22 portal area, further investigation into a previously determined potential scar tree was undertaken by Wiradjuri elders and an Archaeologist. As a result of the closer analysis, the tree was deemed not to be Aboriginal modified. This recorded site will be removed from the Northparkes and AHIMS database within the next reporting period.

Within the reporting period a significant amount of cultural heritage assessment was carried out for the E44 Rocklands SSD project. The potential project area and haul road for the E44 satellite pit was surveyed and then a number of sieve transects were completed. A number of Aboriginal objects were identified during the survey, however none were identified as part of the sieving program. Those found will be added to the AHIMS database, however the most significant scatter was determined to have been placed there in the past 20 years. This fieldwork was carried out on exploration licences and is not part of the current mining leases.

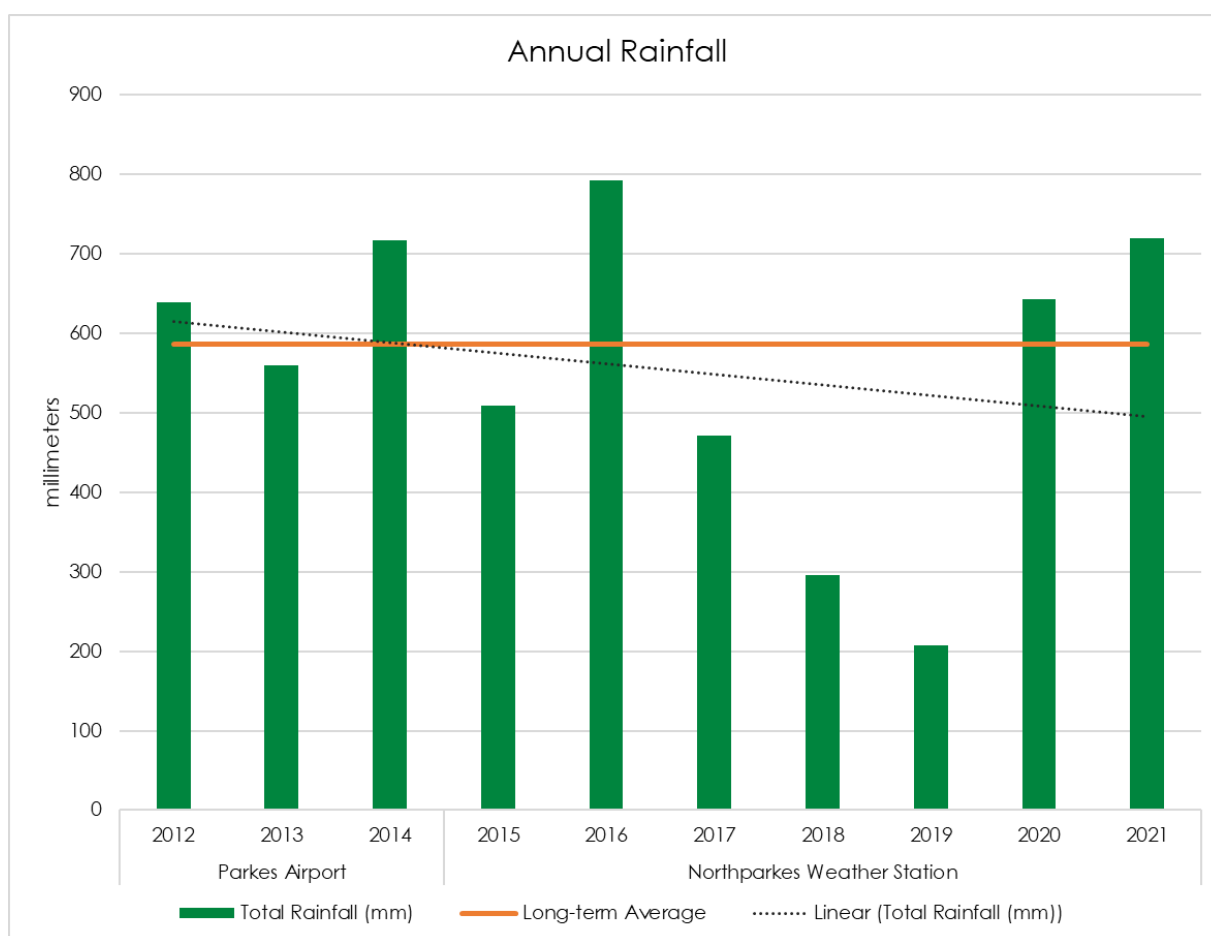
Figure 26 Annual rainfall at Northparkes mines (Note: Parkes airport rainfall data 2012 - 2014)

Onsite water storages are heavily dictated by surface water inflows. Annual rainfall over the past decade has been following a decreasing trend (Figure 26) which puts further emphasis on the need to conserve, protect and recycle water resources. Northparkes continually look to optimise water use and investigate opportunities to operate more efficiently to manage water impact responsibly.

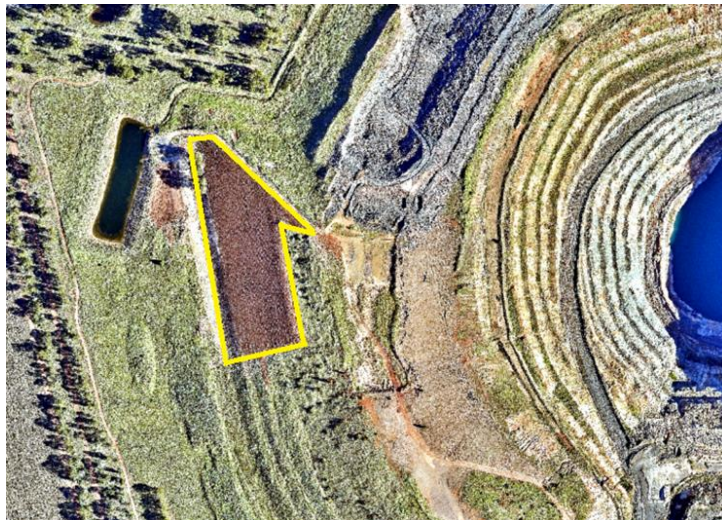
Figure 27 E22 waste rock batter rehabilitation repairs

Heavy rainfall immediately after the growth medium was applied, but before seed had germinated, has resulted in minor erosion rills forming. This area will be monitored in the next reporting period to determine if further works are required.

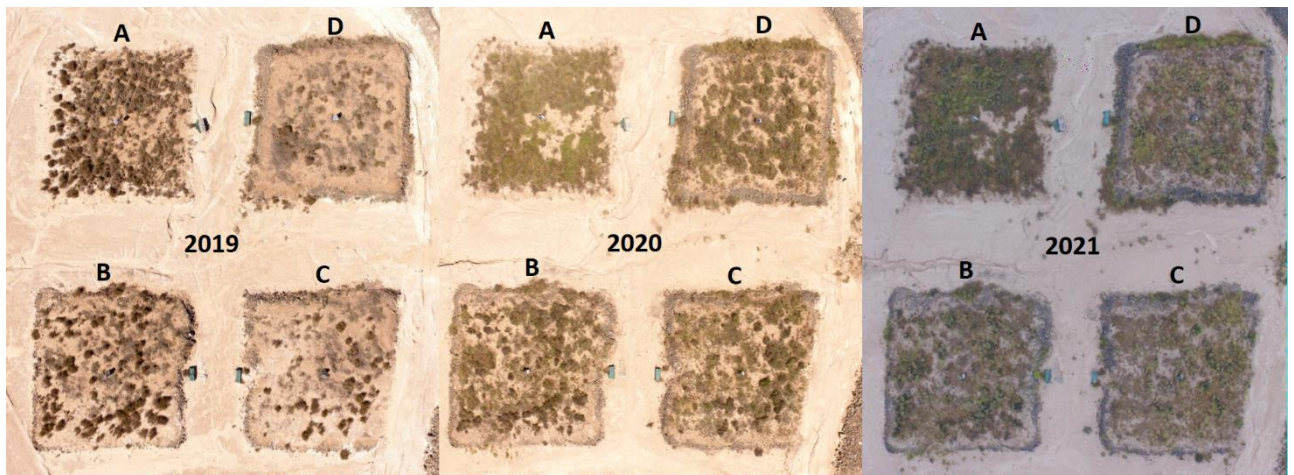
Figure 28 TSF1 trial plot groundcover comparison from 2019 to 2021

With increased rainfall over 2020 and 2021, which is significantly more than the preceding drought years, the increased groundcover across the plots is expected. The assessments will continue into the next reporting period.

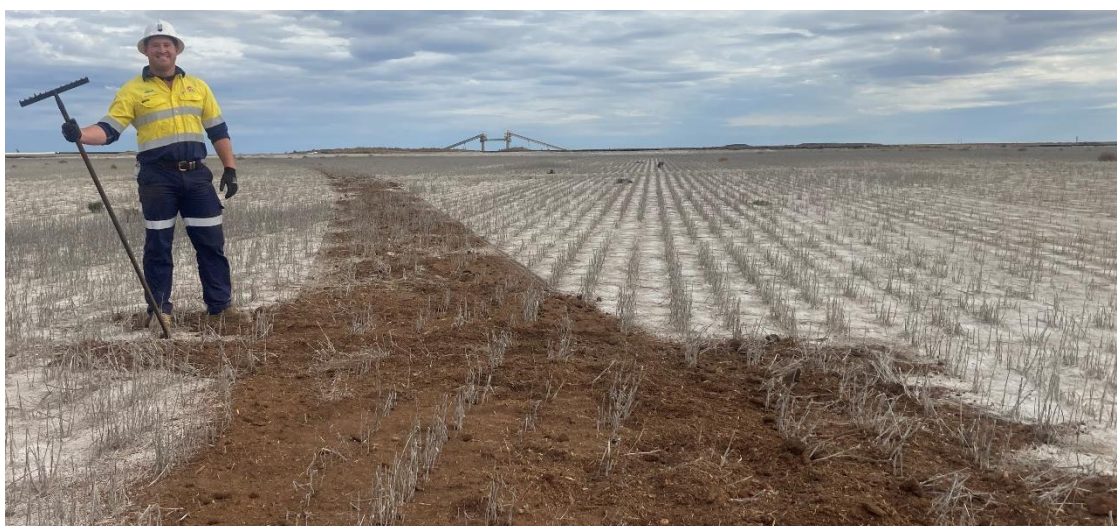
Figure 29 Chicken manure spread across TSF2 in 2021

To build on the study carried out in December 2020 by Landloch, a strip of chicken manure fertiliser was added across the TSF2 beach in 2021. As can be seen in Figure 29, the manure was added to a section of the TSF with minimal native species established. When access to the TSF2 beach is accepted, an assessment of the vegetative response will be assessed.

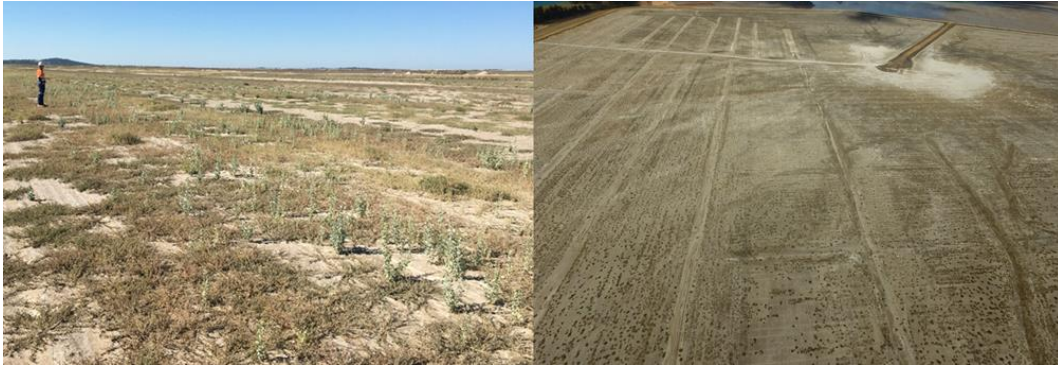
Figure 30 Bluebush and saltbush established directly within the TSF2 tailings (2021)

During 2020, a mix of native salt bush and blue bush species were sown in strips across TSF2, which has accelerated the native vegetation cover across the tailings. Figure 30 shows the established native species in the northeast corner of TSF2 from the tailings beach (Feb 2021) and via a drone (May 2021). Further assessment of species diversity and contribution to groundcover percentage will be carried out in 2022, once access to TSF2 is allowed.

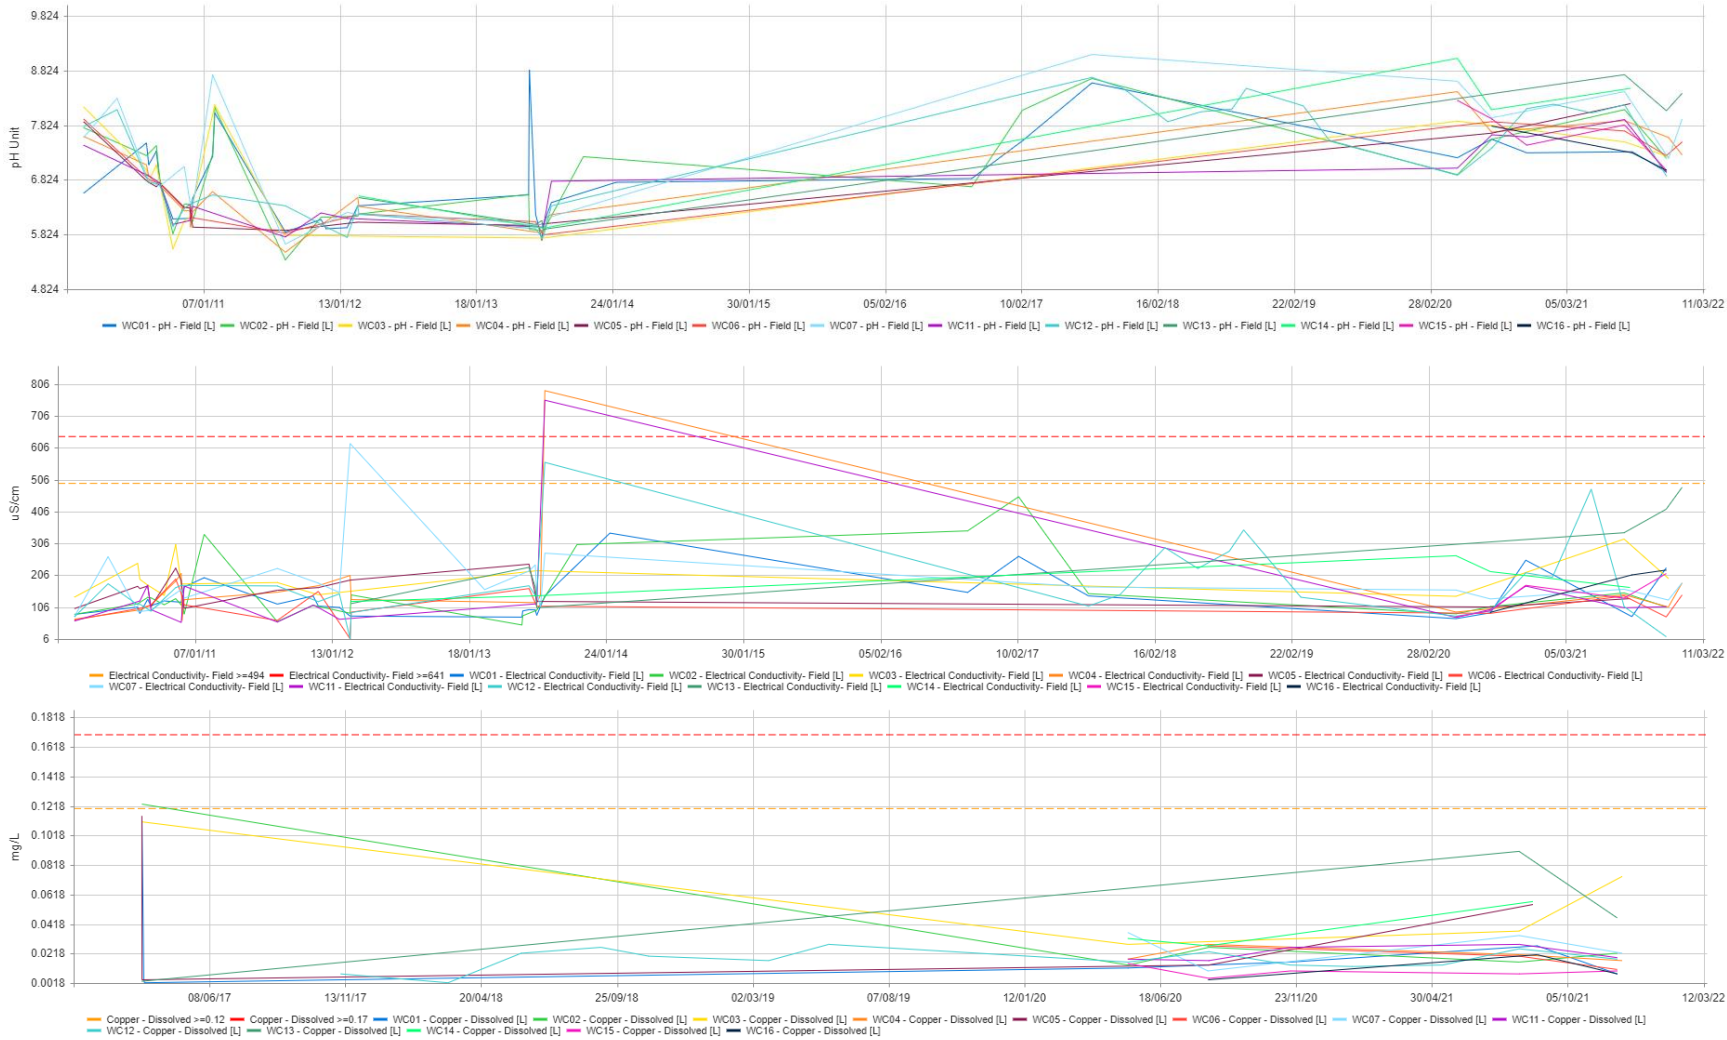
Surface water monitoring results – Water Course pH, electrical conductivity and copper
