Northparkes Mines
A century of mining together

2021 Annual Review

Document Details	
Name of Operation	CMOC-Northparkes Mines
Name of Operator	CMOC Mining Pty Ltd operating as CMOC Mining Services Pty Ltd
Development Consent/Project Approval Number	DC11_0060, as modified
Name of holder of development consent/Project Approval	CMOC Mining Pty Ltd
Mining Leases	ML1247, ML1367, ML1641, ML1743
Name of holder of mining lease	CMOC Mining Pty Ltd
Water Licence #	Refer to Table 4 Summary of Licences
Name of holder of water licence	CMOC Mining Pty Ltd
MOP Commencement Date	1 st January 2020
MOP Completion Date	30 th June 2022
Annual Review Commencement Date	1 st January 2021
Annual Review Completion Date	31 st December 2021
I, Jianjun Tian, certify that this audit report is a true and accurate record of the compliance status of CMOC-Northparkes Mines for the period 1 st January 2021 to 31 st December 2021 and that I am authorised to make this statement on behalf of CMOC Mining Pty Ltd.

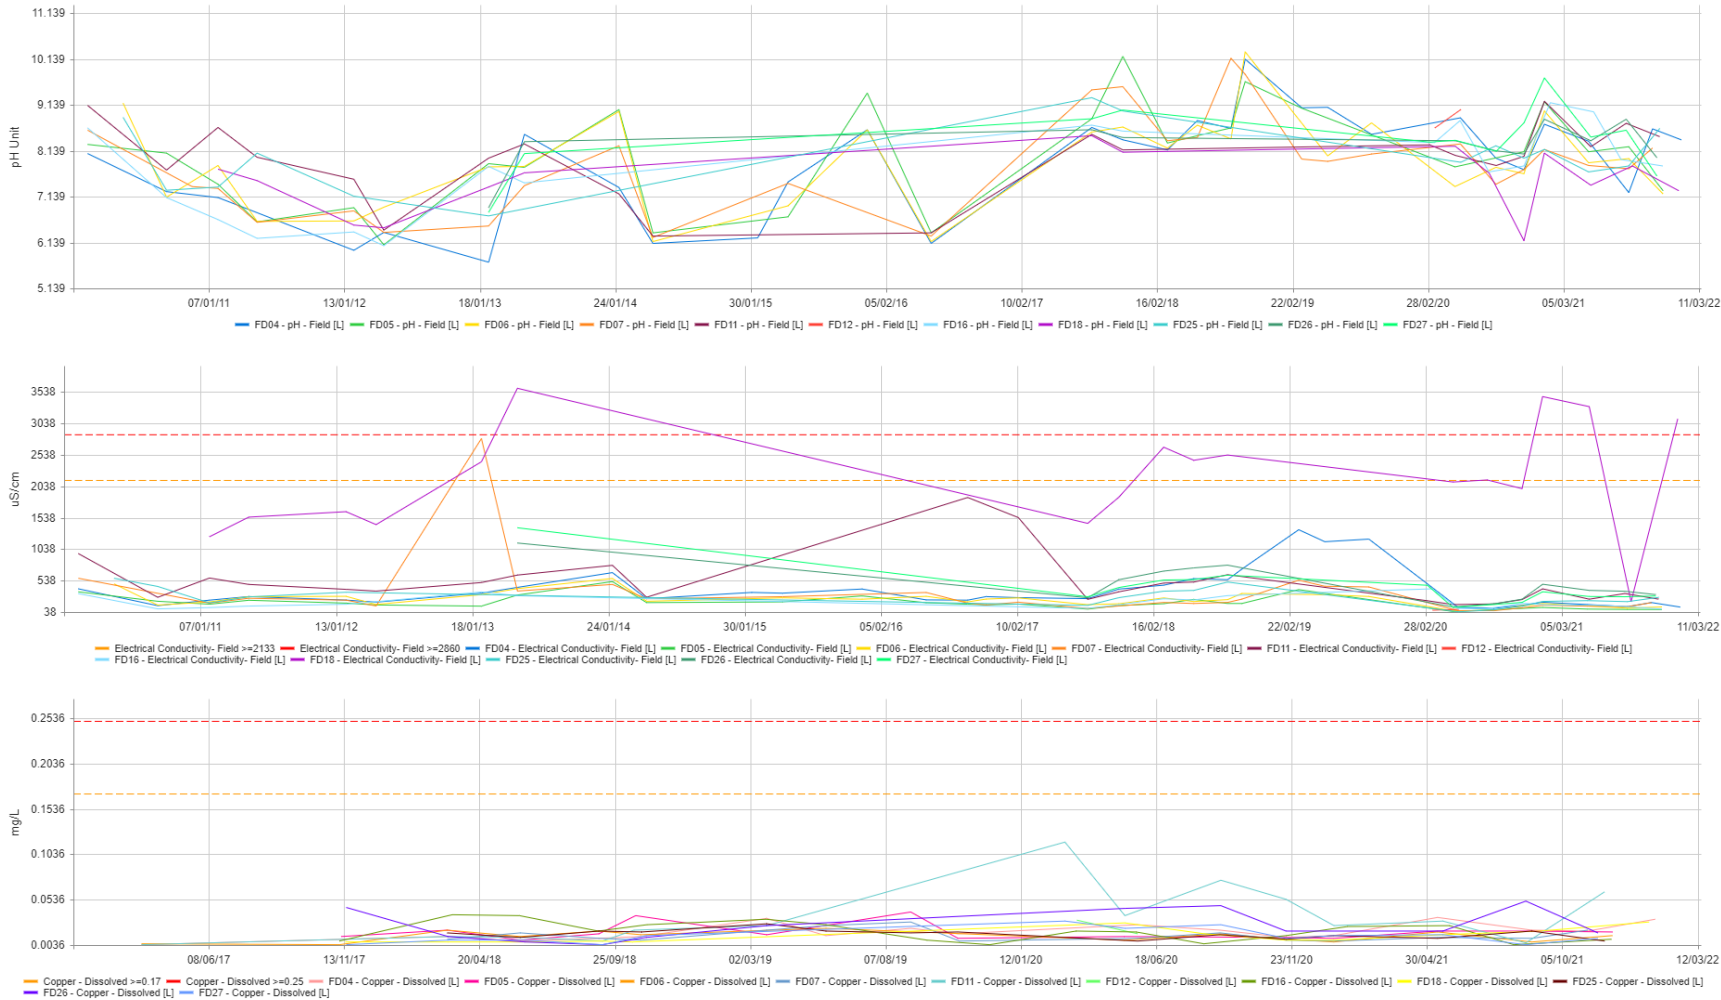
Surface water monitoring results – Farm dams pH, electrical conductivity and copper

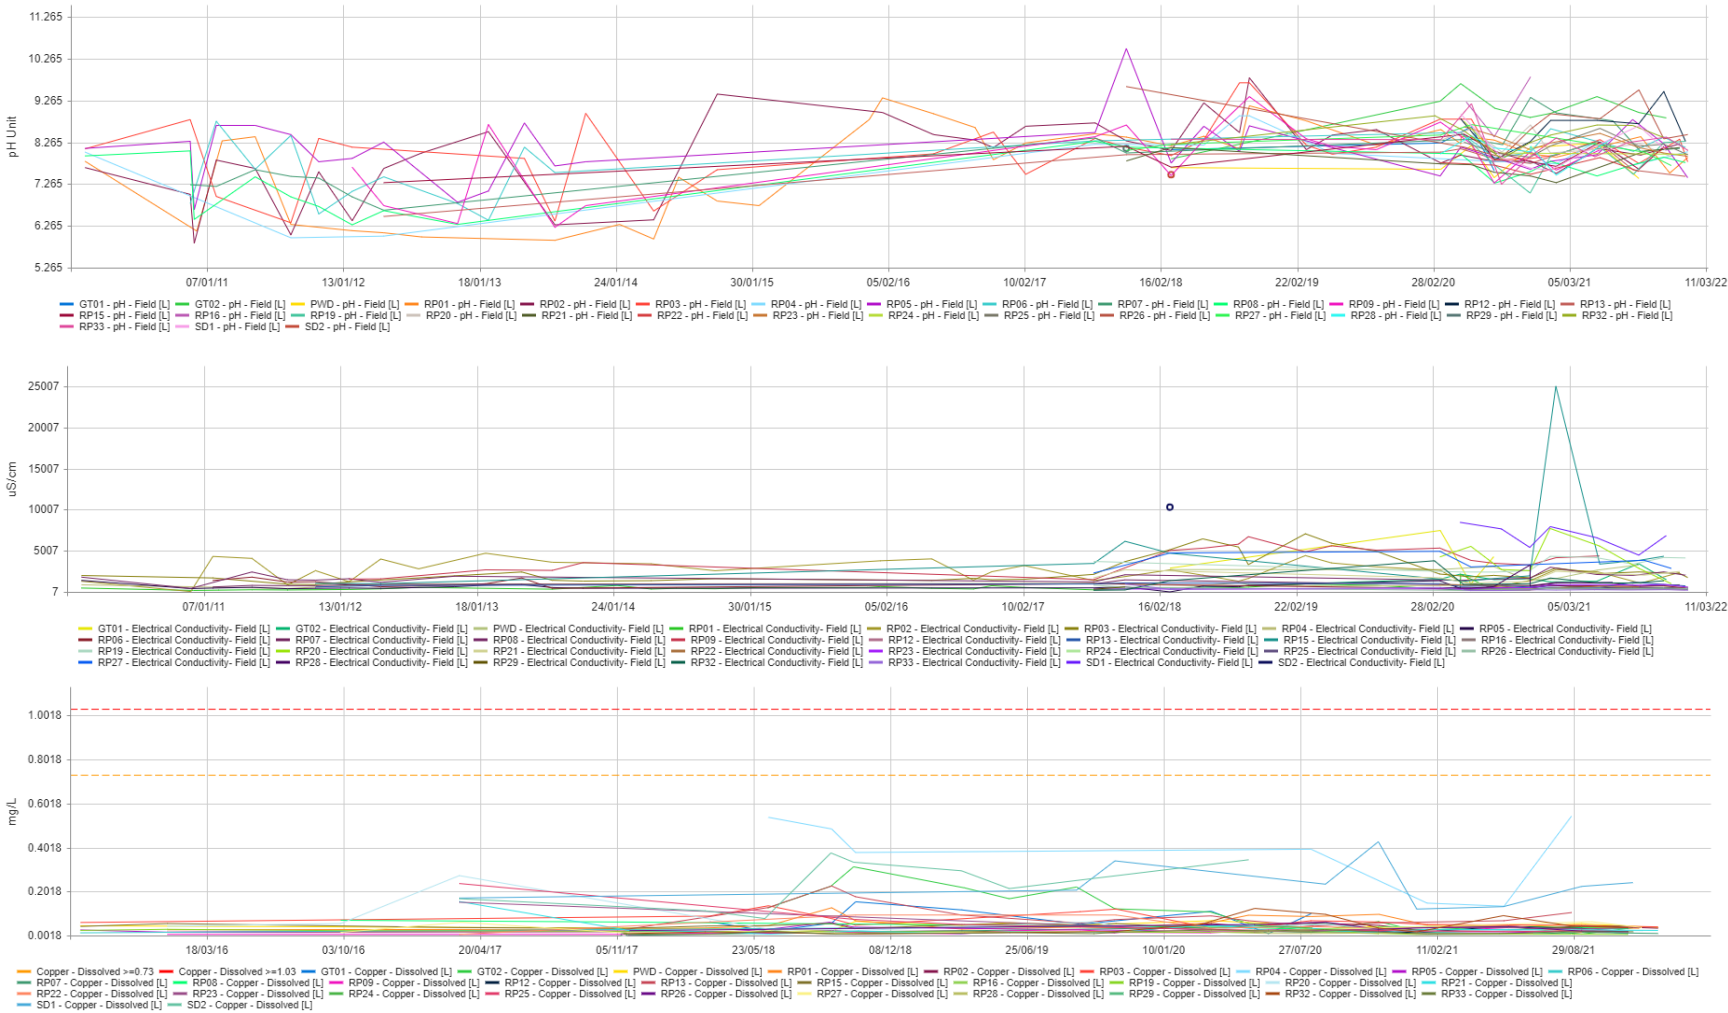
Surface water monitoring results – Retention ponds pH, electrical conductivity and copper

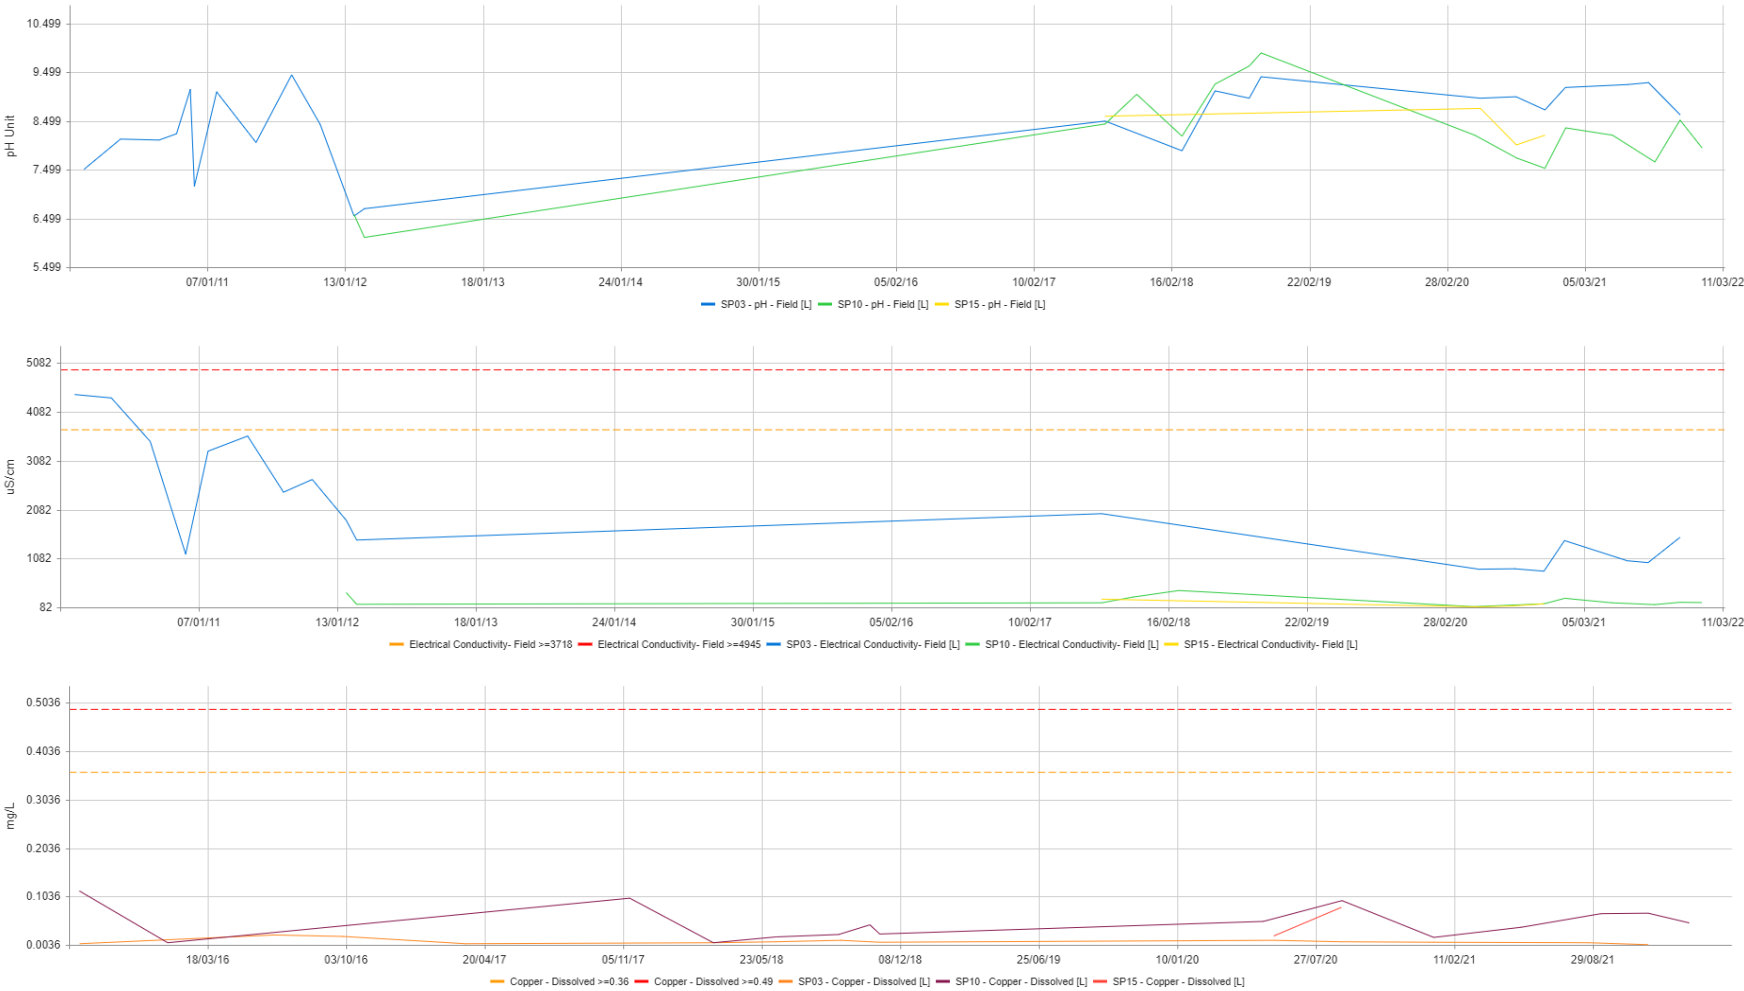
Surface water monitoring results – Sediment ponds pH, electrical conductivity and copper

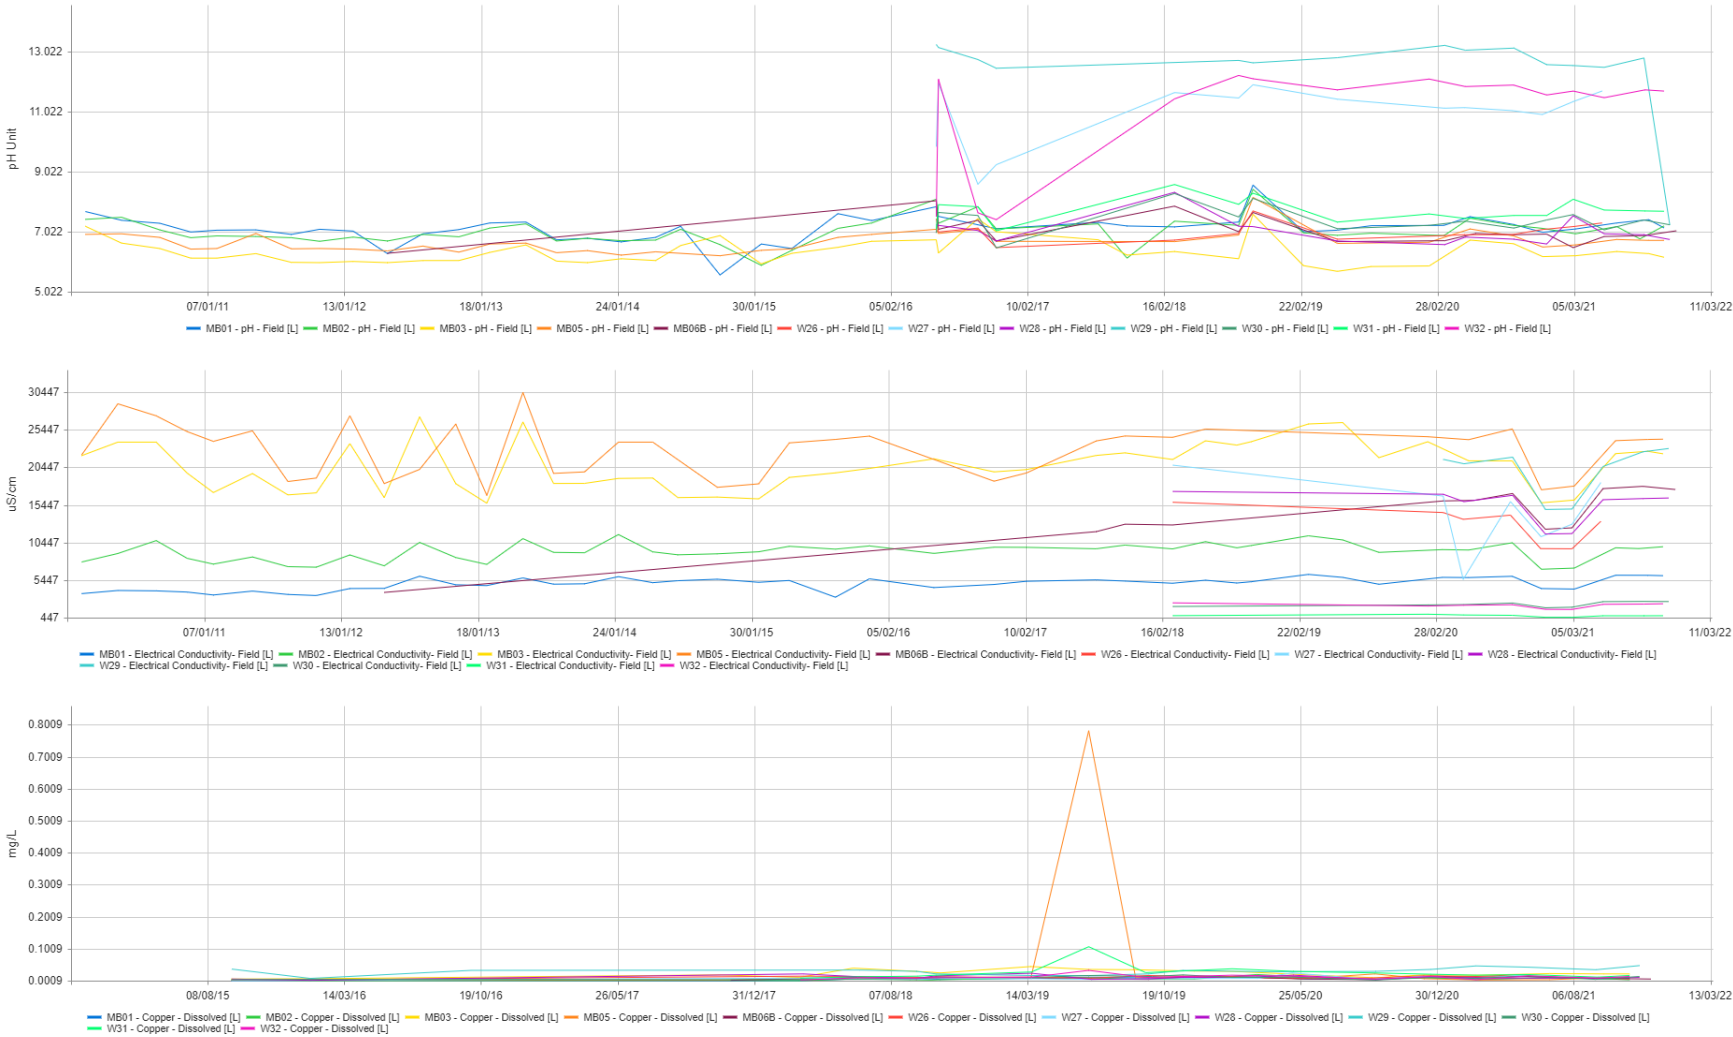
Ground water monitoring results – TSF bores pH, electrical conductivity and copper

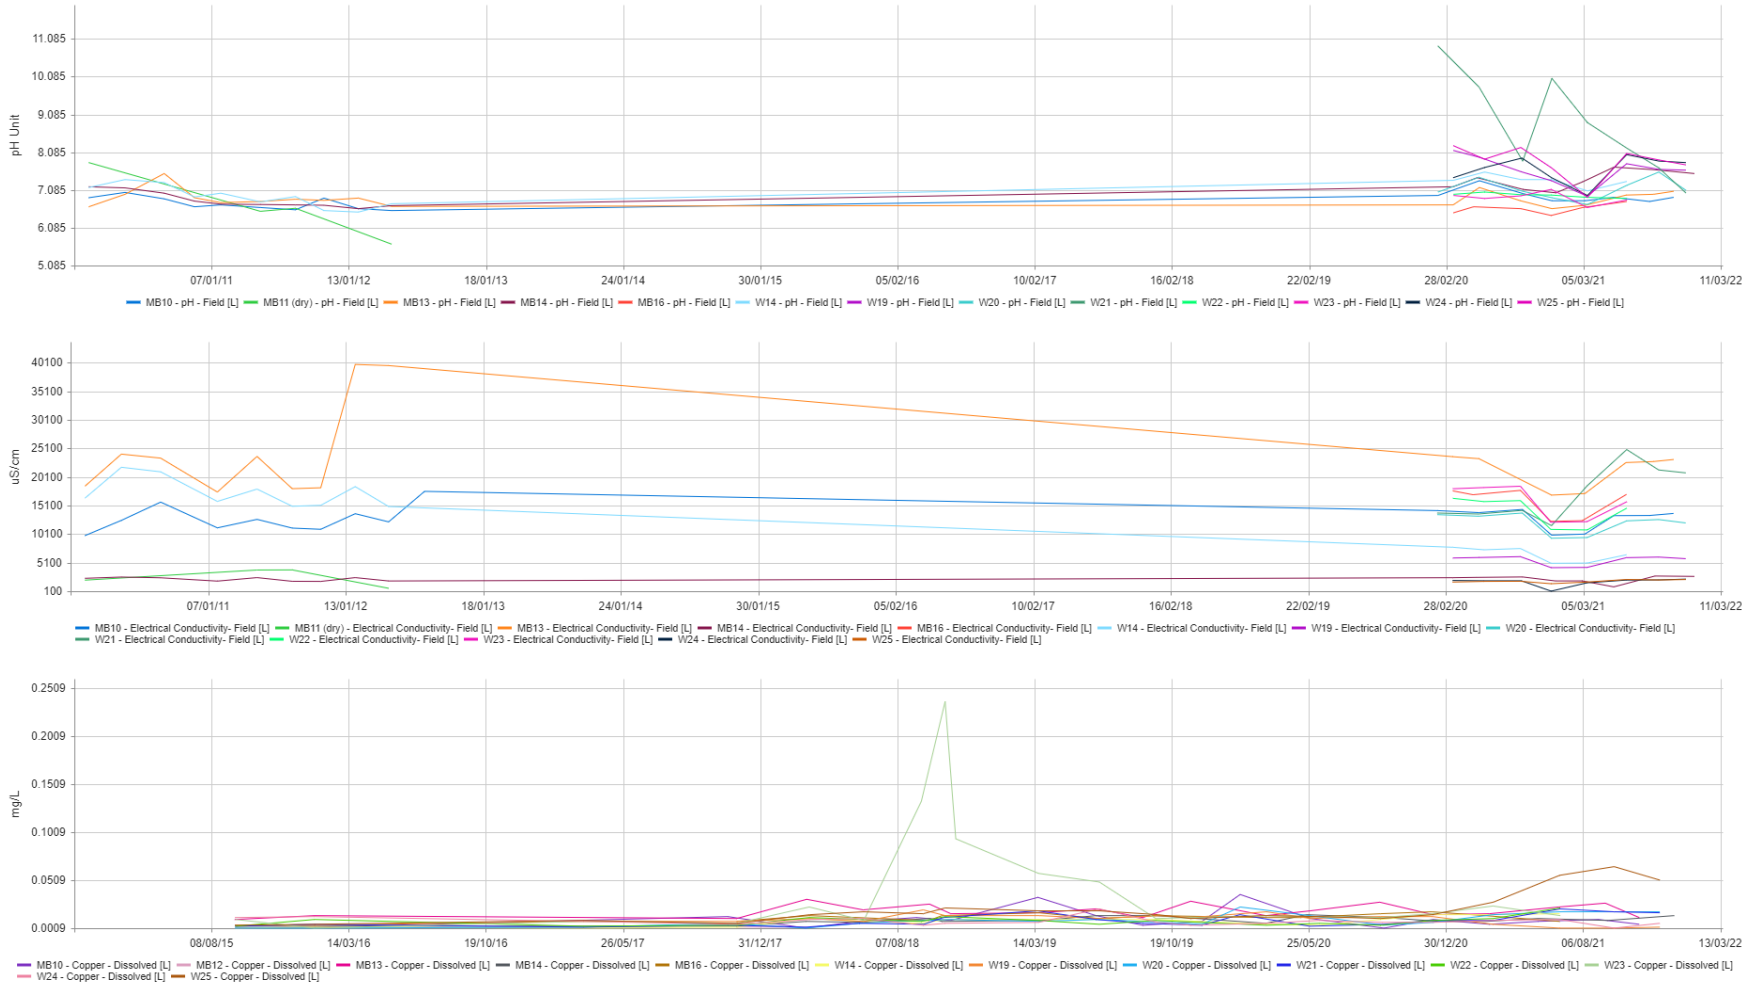
Ground water monitoring results – Opencut bores pH, electrical conductivity and copper

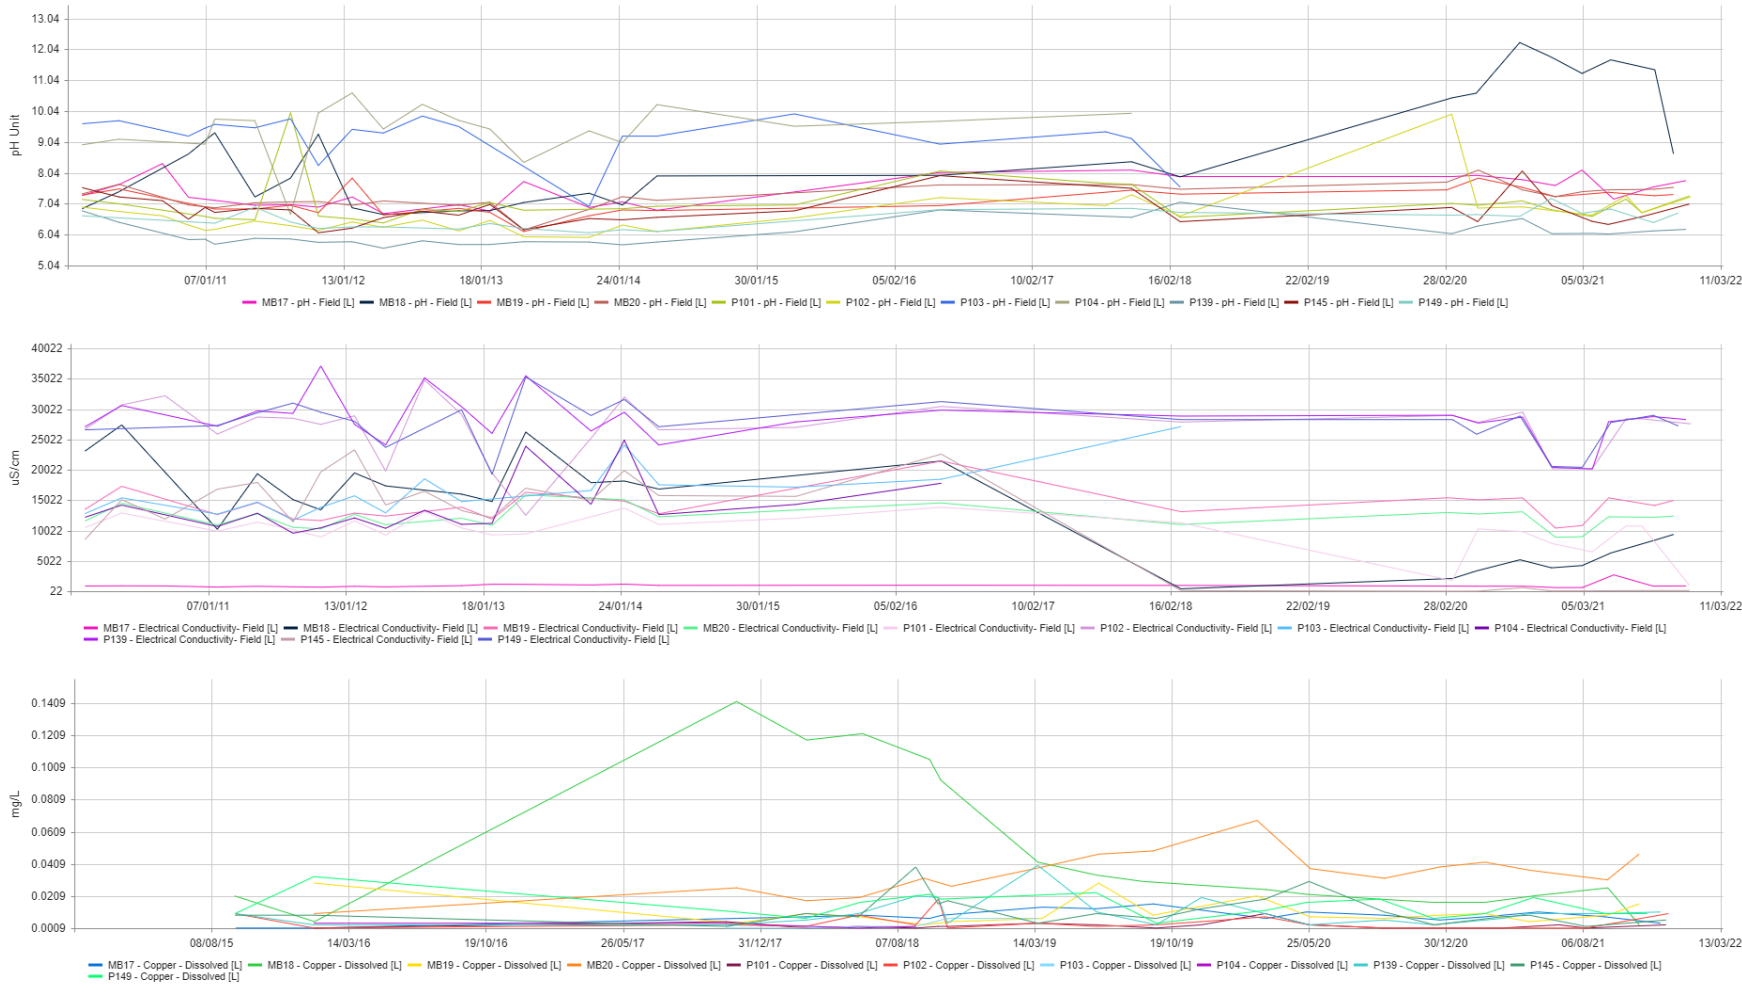
Ground water monitoring results – Underground bores pH, electrical conductivity and copper

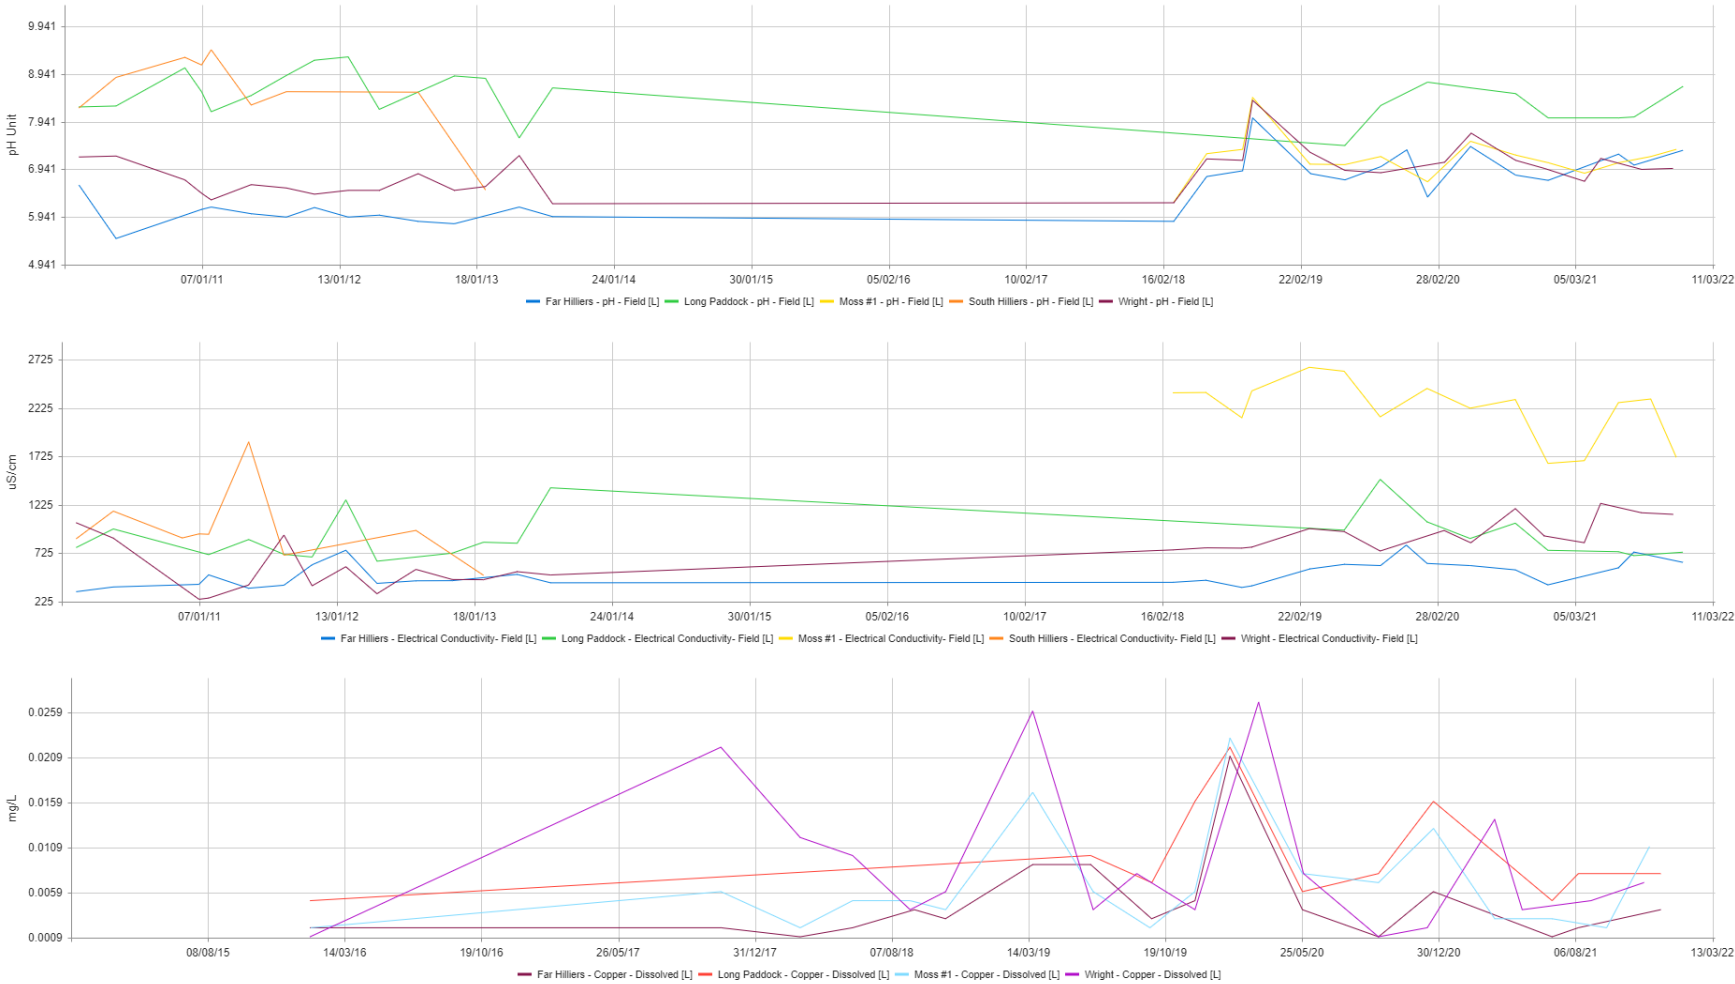
Ground water monitoring results – Regional bores pH, electrical conductivity and copper
