# 2023 Annual Review Northparkes Operations

Document Details	
Name of Operation	Evolution Mining Northparkes Operations
Name of Operator	Evolution Mining (Northparkes) Pty Ltd operating as Northparkes Mining Services Pty Ltd
Development Consent/Project Approval Number	11_0060, as modified
Name of holder of development consent/Project Approval	Evolution Mining (Northparkes) Pty Ltd
Mining Leases	ML1247, ML1367, ML1641, ML1743
Name of holder of mining lease	Evolution Mining (Northparkes) Pty Ltd
Water Licence #	Refer to Table 4 Summary of Licences
Name of holder of water licence	Evolution Mining (Northparkes) Pty Ltd
MOP/RMP Commencement Date	1 <sup>st</sup> January
MOP/RMP Completion Date	31 <sup>st</sup> December
Annual Review Commencement Date	1 <sup>st</sup> January 2023
Annual Review Completion Date	31 <sup>st</sup> December 2023
I, Rob Cunningham, certify that this audit report is a true Evolution Mining Northparkes Operations for the period am authorised to make this statement on behalf of Evolu	1 <sup>st</sup> January 2023 to 31 <sup>st</sup> December 2023 and that I

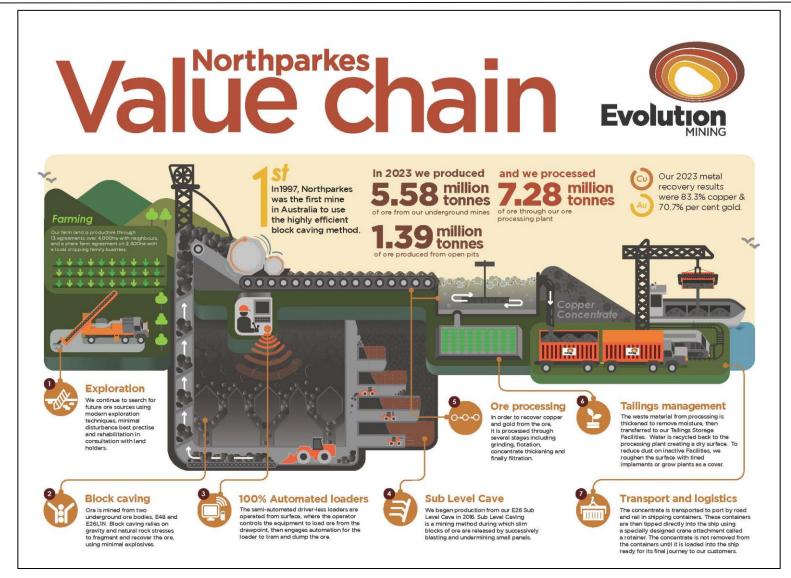
Figure 2 Northparkes Value Chain

A copy of the 2023 Northparkes Value Chain is provided as Figure 2. The value chain is a high-level model used to describe the process by which Northparkes receive raw materials, add value to the raw materials through various processes to create a finished product, and then sell that end product to customers. Northparkes conducts annual value-chain analysis by looking at every production step required to create a product and identifying ways to increase the efficiency of the chain. The overall goal is to deliver maximum value for the least possible total cost and impact, while creating a competitive advantage. Surface infrastructure and operation layout is shown in Figure 3.

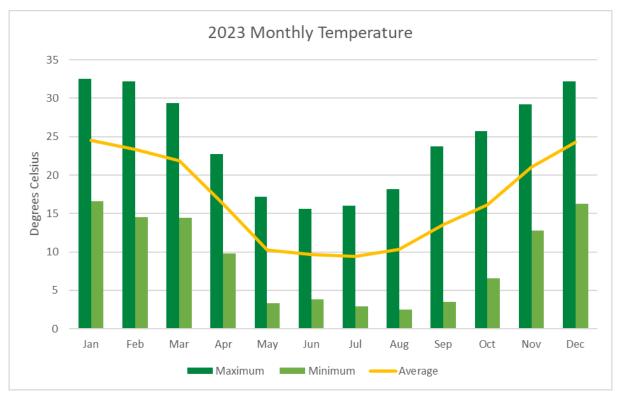
Figure 7 Average monthly temperature records (10m MET recordings)

Maximum, minimum and average temperatures are calculated daily, averaged in 15 minute interval recordings.

Compared to the long-term historical data, average maximum temperatures were largely higher during the period, averaging 1.2°C across all months. The average maximum for September was significantly higher than the long-term average, recording +4.2°C. Average minimum temperatures were largely lower during the period, averaging -1.6°C across all months, noting a significant difference of -3.8°C in May.

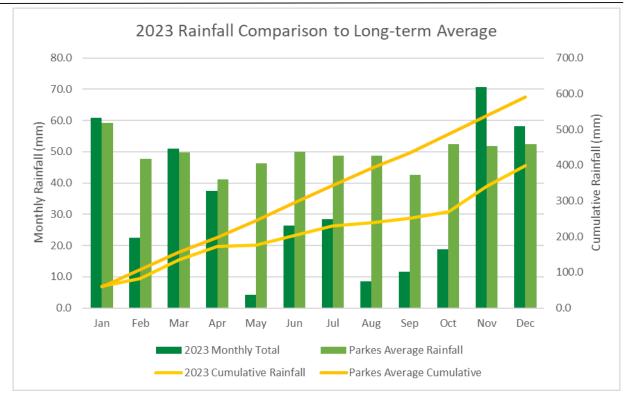
The total onsite rainfall recorded at the MET monitoring station for the period was 398.4mm. The rainfall received during the reporting period was 192.1mm below the long-term average for the region (590.2mm). Dry conditions aided the generation of airborne particulates during high wind events, requiring diligent management of onsite point sources that have the potential to generate significant dust. A comparison of the 2023 recorded rainfall to long-term average for Parkes is shown in Figure 8 below.

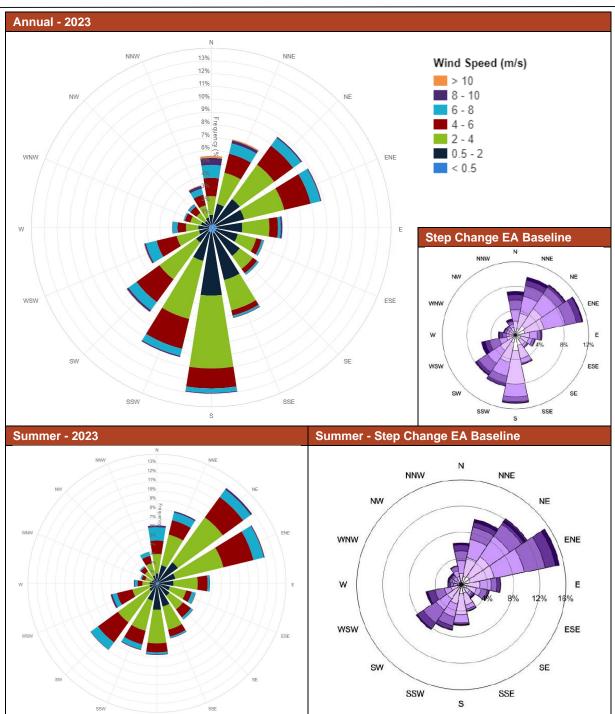
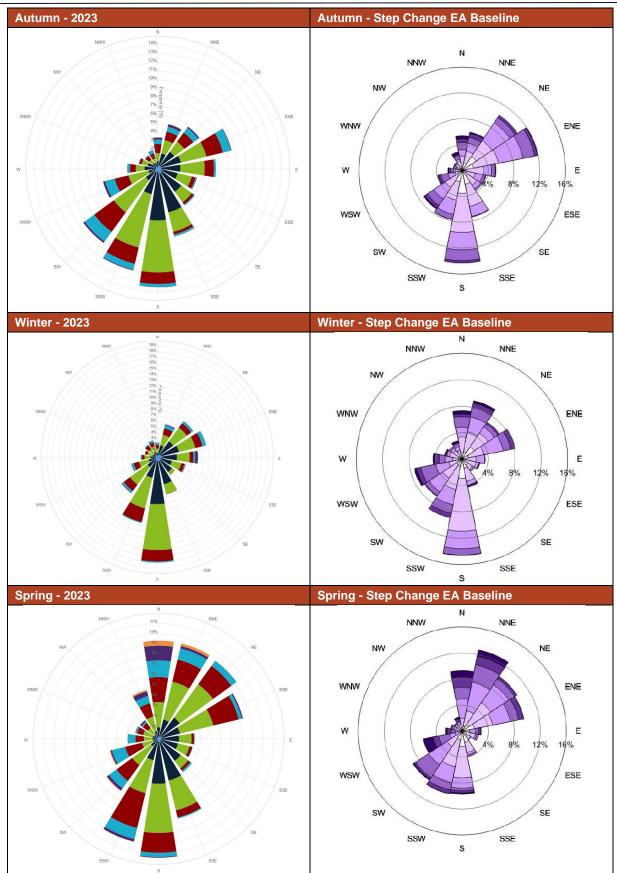
Figure 9 Seasonal wind rose comparison against Step Change EA baseline

Analysis of data reveals that prevailing winds during the 2023 reporting period were largely in line with that recorded for the Step Change Environmental Assessment (EA), Umwelt 2013. Prevailing winds for the period were typically received from the south, south south-west or north-east. Average wind speeds were generally consistent the Q1, Q2 and Q3, recording 3.29m/s, 2.76m/s, and 2.68m/s, respectively. Wind speeds in Q4 we notably higher than the other periods, averaging 3.75m/s. Wind data for the 2023 reporting period is presented by the wind roses in Figure 9. Wind speed values are all displayed as metres per second.

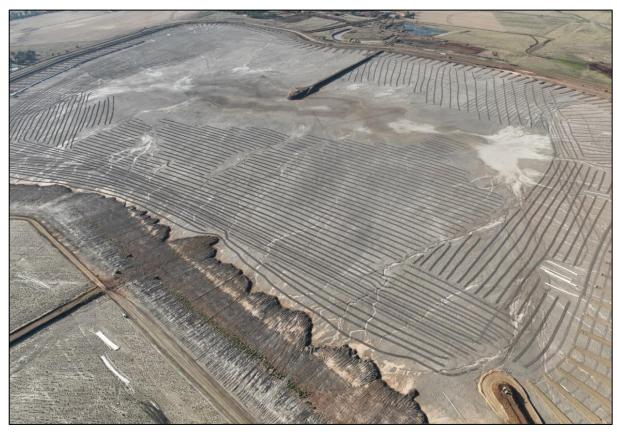
Figure 10 Ripping undertaken on Rosedale TSF for dust control

Below average rainfall conditions for the majority of the reporting period resulted in poor regional air quality during high wind events. Several high wind events in Q4 resulted in dust being emitted from the inactive facilities of Rosedale and TSF1, none resulting in contributions above the approved impact criteria. Targeted deposition and ripping of the tailings surface was instigated and provided immediate mitigation that managed dust generation. Ripping is scheduled on a regular basis to ensure that facilities have minimal surface area that is likely to incur dust lift off. Figure 10 below shows ripping undertaken on the Rosedale TSF.

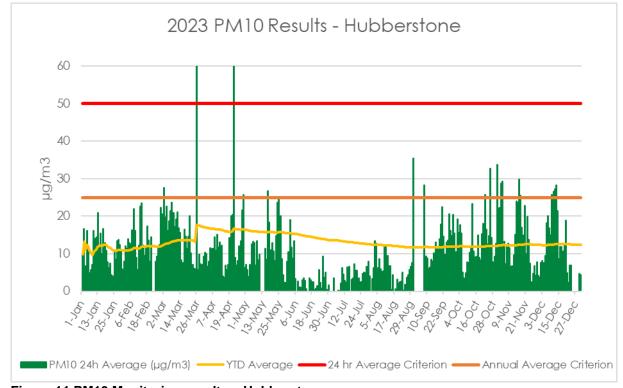
Figure 11 PM10 Monitoring results – Hubberstone

Monitoring results for the three locations were under the air quality criteria stated in the Consent, with all outliers removed. During the reporting period, there were five elevated readings recorded, comprising of two at Hubberstone and three at Milpose monitoring locations. These readings were internally investigated and found to be non-mine related. Due to the rural setting off the project area, monitoring results are regularly impacted by agricultural activities, requiring detailed investigations to determine the source of the particulates.

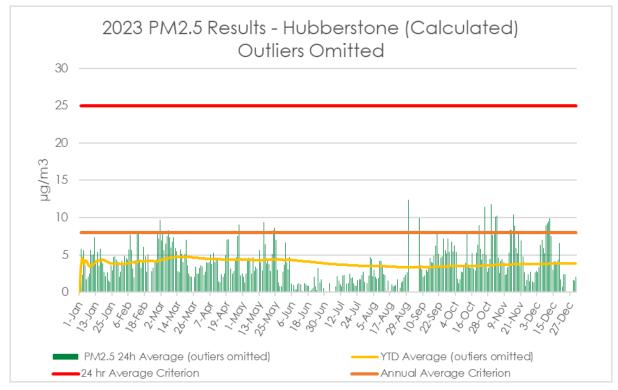
Figure 17 PM2.5 Monitoring results with outliers omitted – Hubberstone

Calculation based PM2.5 results for the 'Hubberstone' (Figure 17), 'Milpose' (Figure 18) and 'Hillview' (Figure 19) monitoring locations are detailed below. The PM2.5 criteria for exceedances (as nominated in the Consent) is >8  $\mu$ g/m<sup>3</sup> for the annual average and >25  $\mu$ g/m<sup>3</sup> for a 24-hour monitoring period. All results have had non-mine related outliers removed.

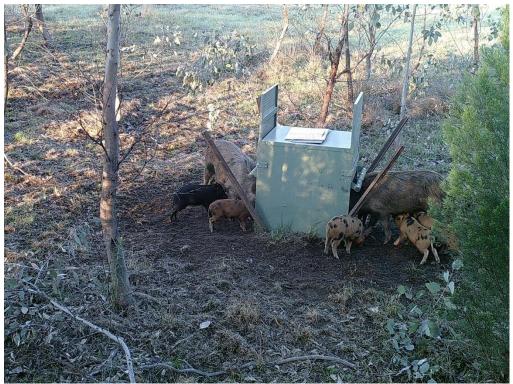
Figure 23 Pigs accessing hog hopper bait station

For the presence of pest animals noted in the table above, suitable pest management programs were developed in conjunction with the Local Land Service (LLS) and Northparkes. As part of a wider increase in feral pig populations, a rise in pig habitation was observed during the period at the Kokoda offset. Poison grain bait was administered out of a 'Hog Hopper', to specifically target the species and eliminate the potential for off-target deaths. There was positive uptake of the grain, with an immediate reduction in resident pigs evident. Concurrently, rabbit baiting was undertaken for an isolated site which resulted in a significant population decline. All uneaten grain was disposed of in accordance with the LLS recommendations.

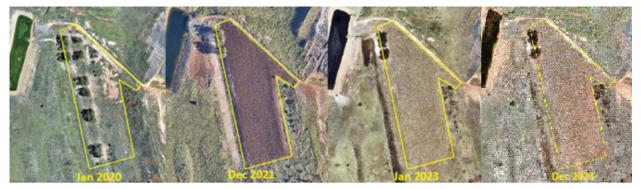
Figure 27 E22 waste rock batter rehabilitation repairs from 2020 to 2023

A small area on the western batter of the rehabilitated E22 waste rock emplacement had erosion repairs carried out in 2021. The area was reshaped, with erosion gutters and benches removed to create a consistent gradient Figure 27. Growth medium was sourced immediately below the area from a rehabilitation stockpile that was against the Sediment Pond 3 embankment.

During 2022 a range of vegetation species established creating the early succession of ecosystem development. As expected, the percentage of common introduced vegetation species were higher than the adjacent undisturbed areas. The species composition will continue to be monitored by Northparkes staff.

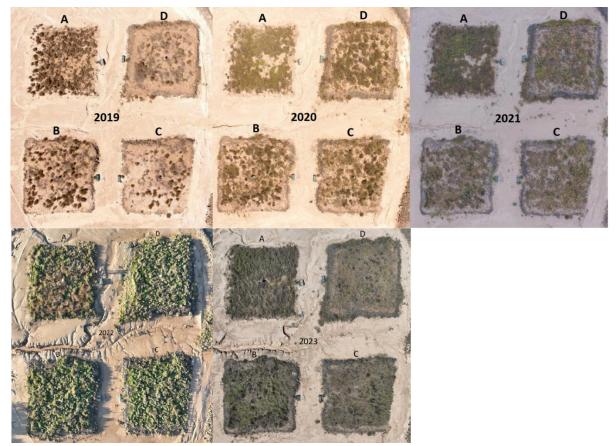
Figure 28 TSF1 trial plot groundcover comparison from 2019 to 2023

Drone photos have been taken of the trial plots from 2019 onwards to assist in monitoring the differences between groundcover percentage and indicate species diversity between each plot across the reporting years (Figure 28). Plot A continued to maintain the highest percentage of groundcover and higher contribution to cover from perennial grasses.

An external ecologist assessed the vegetation cover across the four TSF1 trial plots in October 2023 and compared the results to their August 2019 assessment. Figure 28 shows the changes in ground cover provided by living plants across each of the plots. The percentage of living groundcover was maintained with Plot A (0.1m topsoil) over the four years, however the percentage of living groundcover is less as the plot thickness increases.

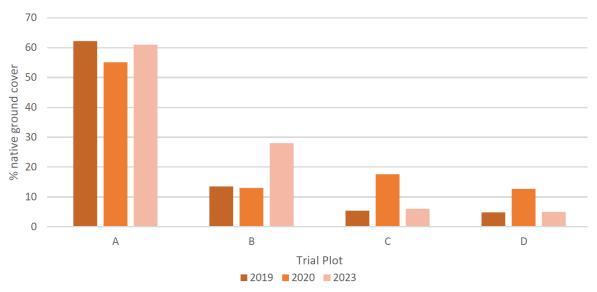
Figure 30 Percentage groundcover provided by Native Plants for TSF1 trial plots

The percentage of groundcover provided by native plants was compared across three different assessment years (Figure 30). Plot A (0.1m topsoil) has maintained the highest percentage of native groundcover across the assessment period. It is understood that all plots had the same seeding treatment, indicating that the variability in native groundcover is likely to be influenced by the depth of the cover.

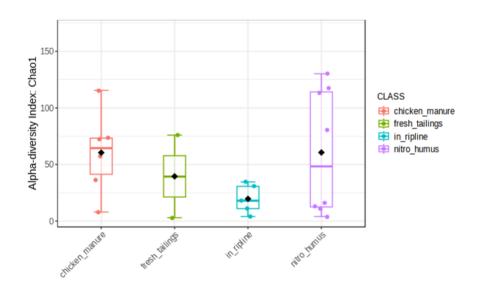
## Figure 31 Range of microbe diversity across different TSF2 tailings treatments

During 2023 the microbial results from the 2022 sampling program were assessed. The results from vegetated and bare areas at varying depths or fertilizer applications were compared. Figure 31 shows the range of microbes across four different tailings treatments on TSF2. As expected, the tailings with the application of chicken manure or nitro humus have increased microbial activity.

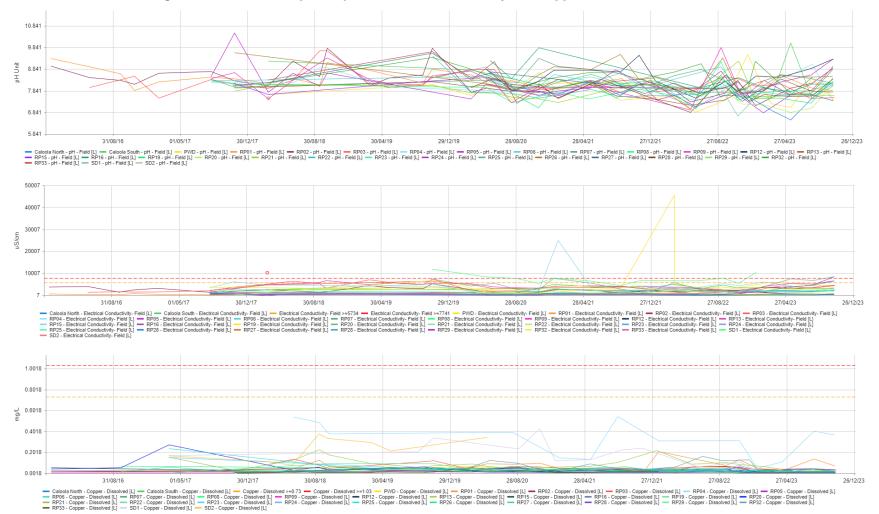
#### Surface water monitoring results – Sediment ponds pH, electrical conductivity and copper

#### Surface water monitoring results – Retention ponds pH, electrical conductivity and copper

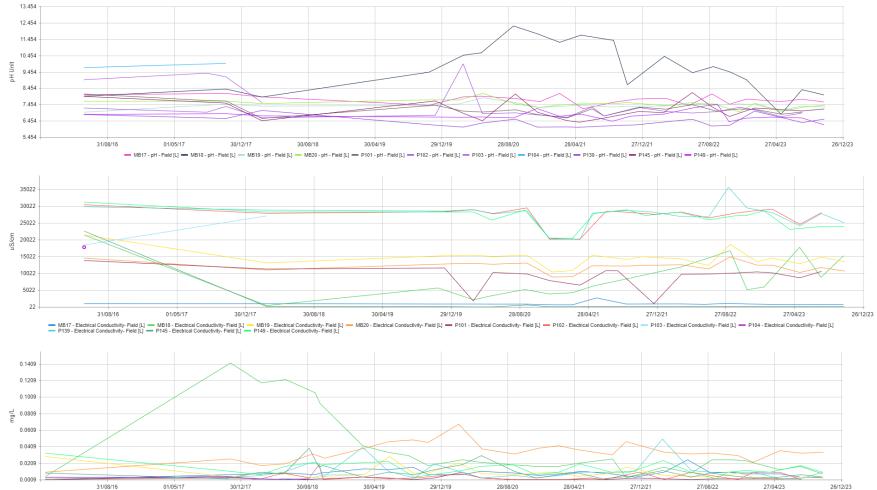
#### Ground water monitoring results - Underground bores pH, electrical conductivity and copper

MB17 - Copper - Dissolved [L] — MB18 - Copper - Dissolved [L] — MB19 - Copper - Dissolved [L] — MB19 - Copper - Dissolved [L] — P101 - Copper - Dissolved [L] — P102 - Copper - Dissolved [L] — P103 - Copper - Dissolved
