Northparkes Mines

Annual Environmental Management Report

January 2015 – December 2015

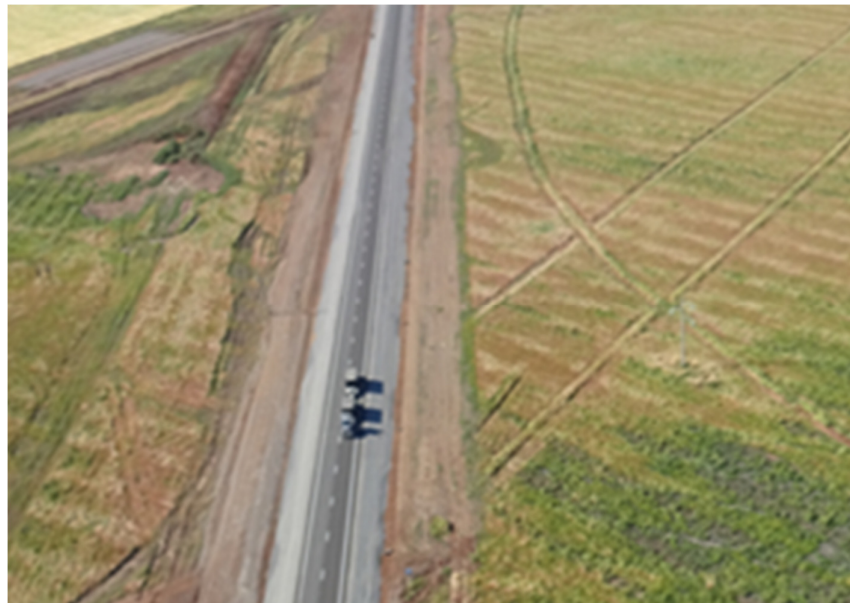
The new site access road was opened on 29 September 2015, in line with the original project schedule. A total of 200,000t of road base and 30,000 personnel hours went into the construction of the new access road, with zero injuries.

Figure 11 New site access road

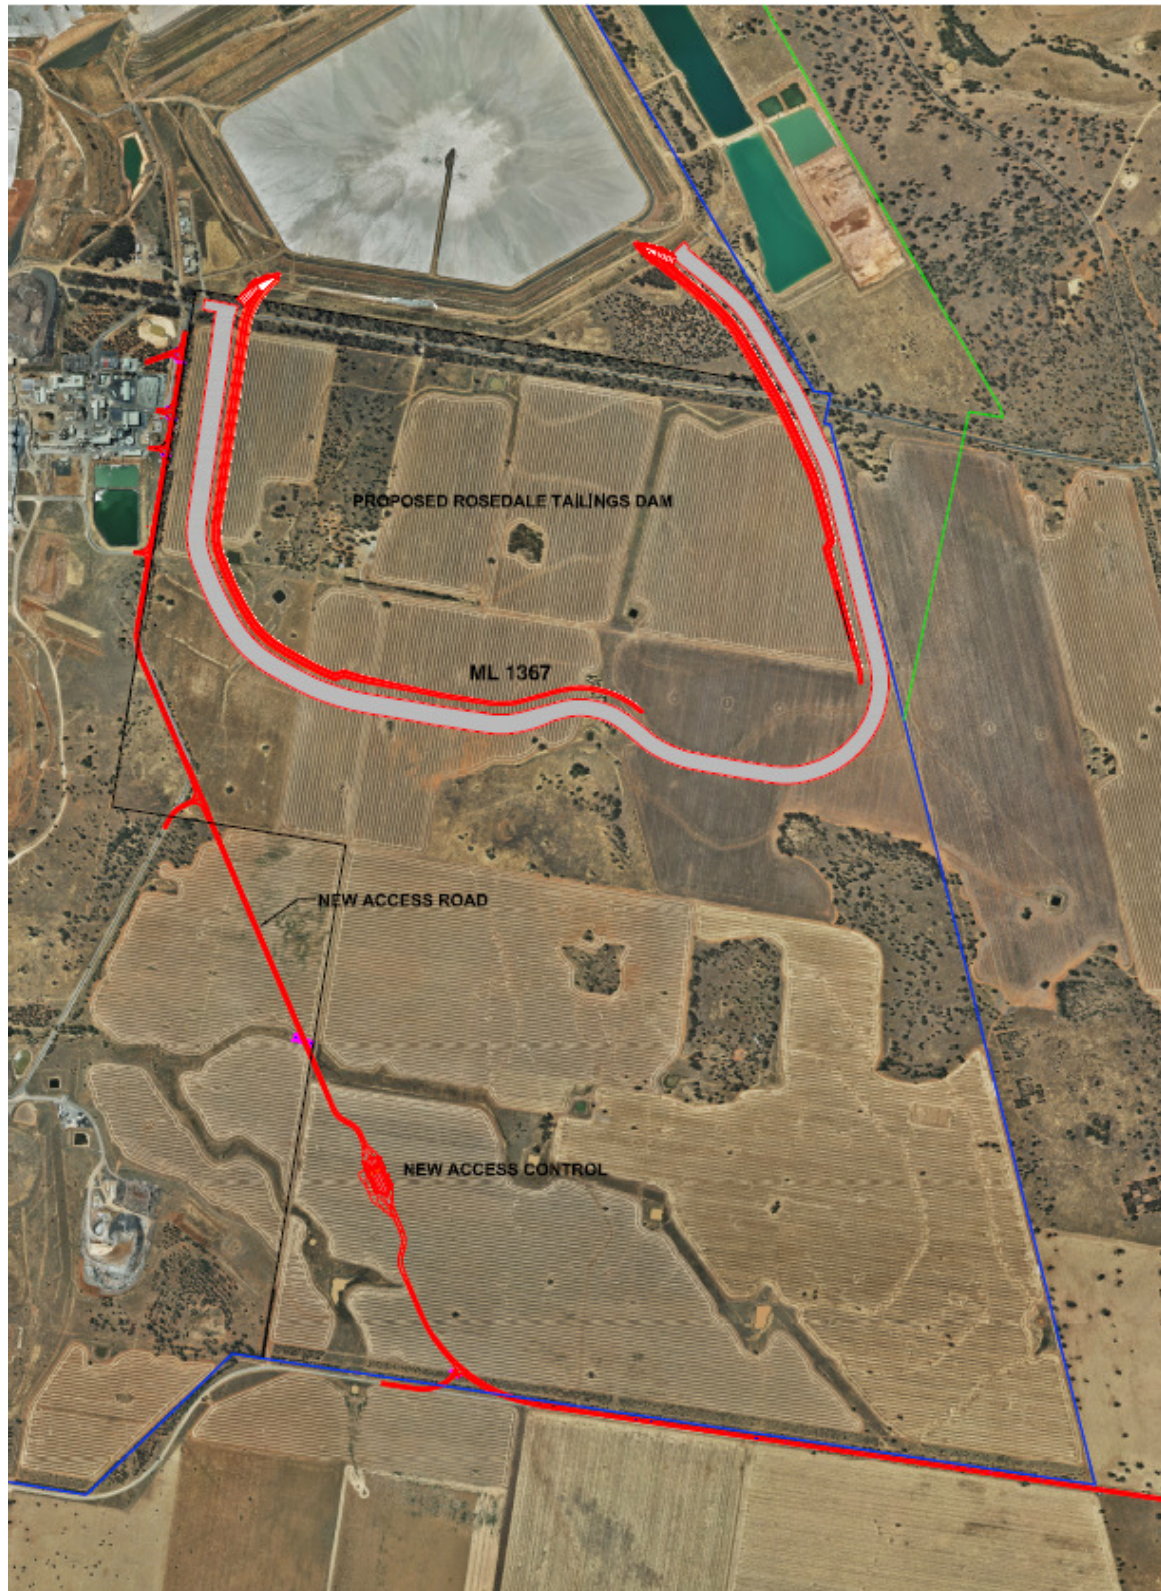
Figure 12 Proposed Rosedale TSF and New Site Access road

The development of the new Rosedale TSF resulted in the closure of the Northparkes Lane, formerly the principal mine site access. The site access road connects the McClintock's Lane to the existing internal access road between ore processing plant and underground operations offices. (Figure 12)

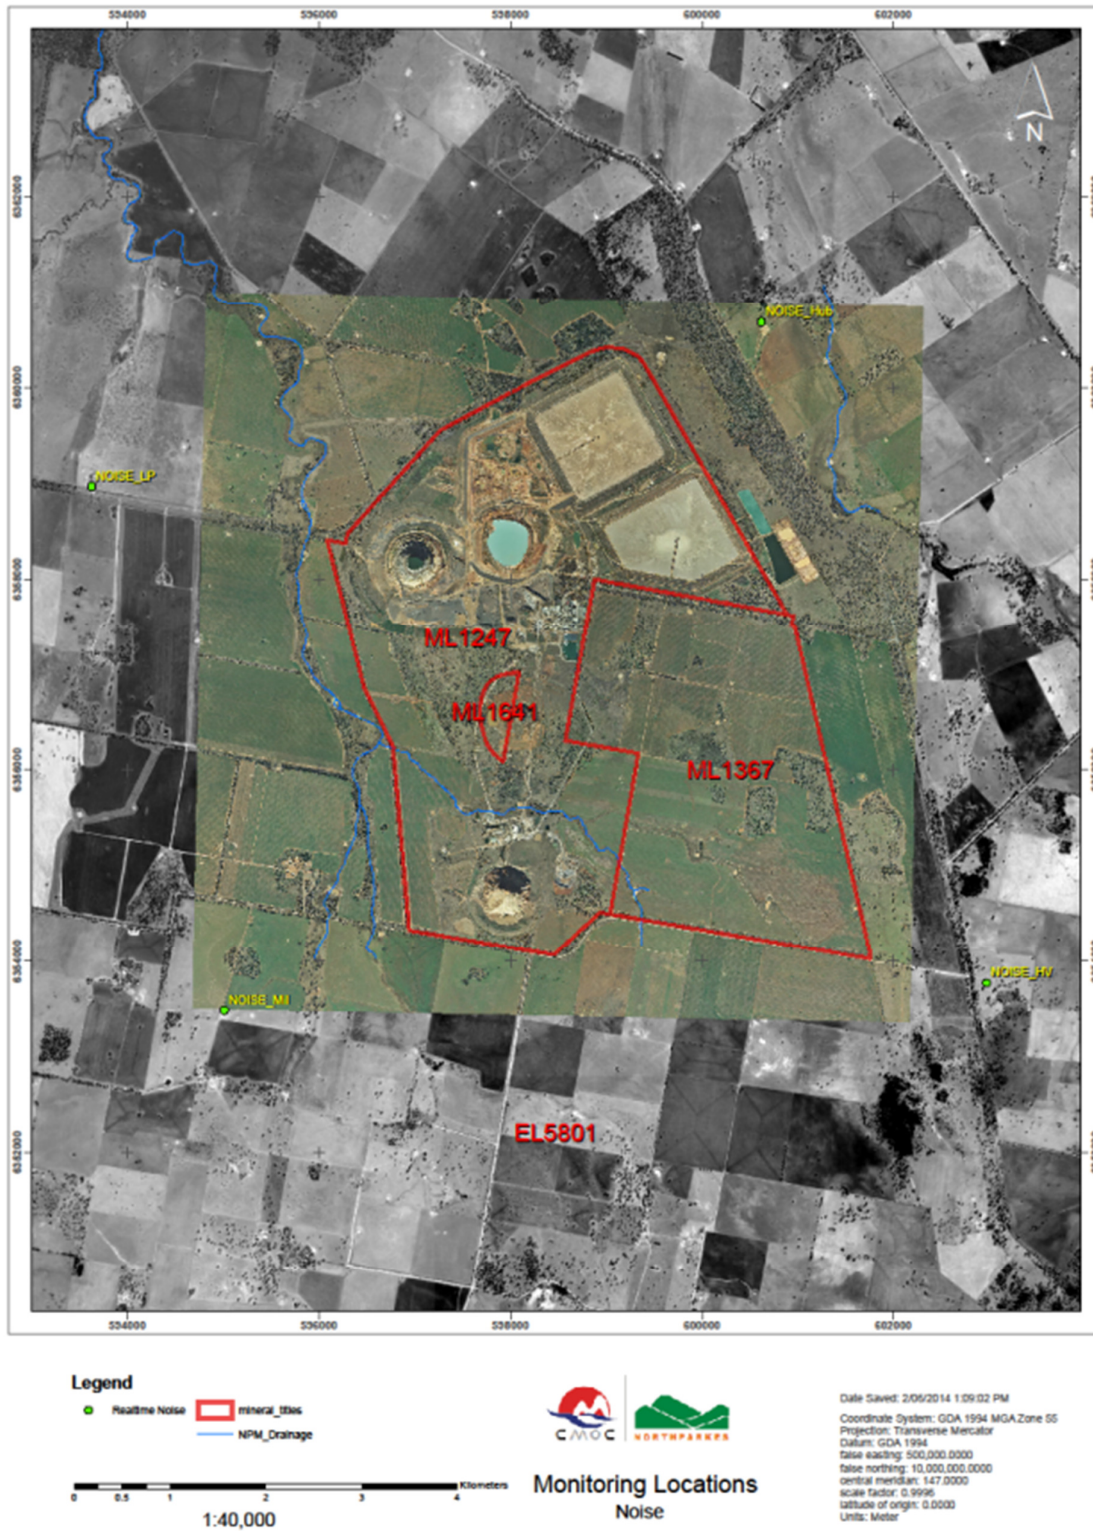
Figure 24 Northparkes Noise monitoring locations

Northparkes undertakes a noise monitoring program at three locations on privately owned properties outside the mining leases. The fourth location 'Hillview' has been added into the Northparkes Noise Monitoring Program as required by the Project Approval (11_0060). The program consists of both operator-attended and unattended surveys at the three nearest occupied residences 'Hubberstone', 'Milpose', 'Lone Pine' and 'Hillview' (Figure 24).

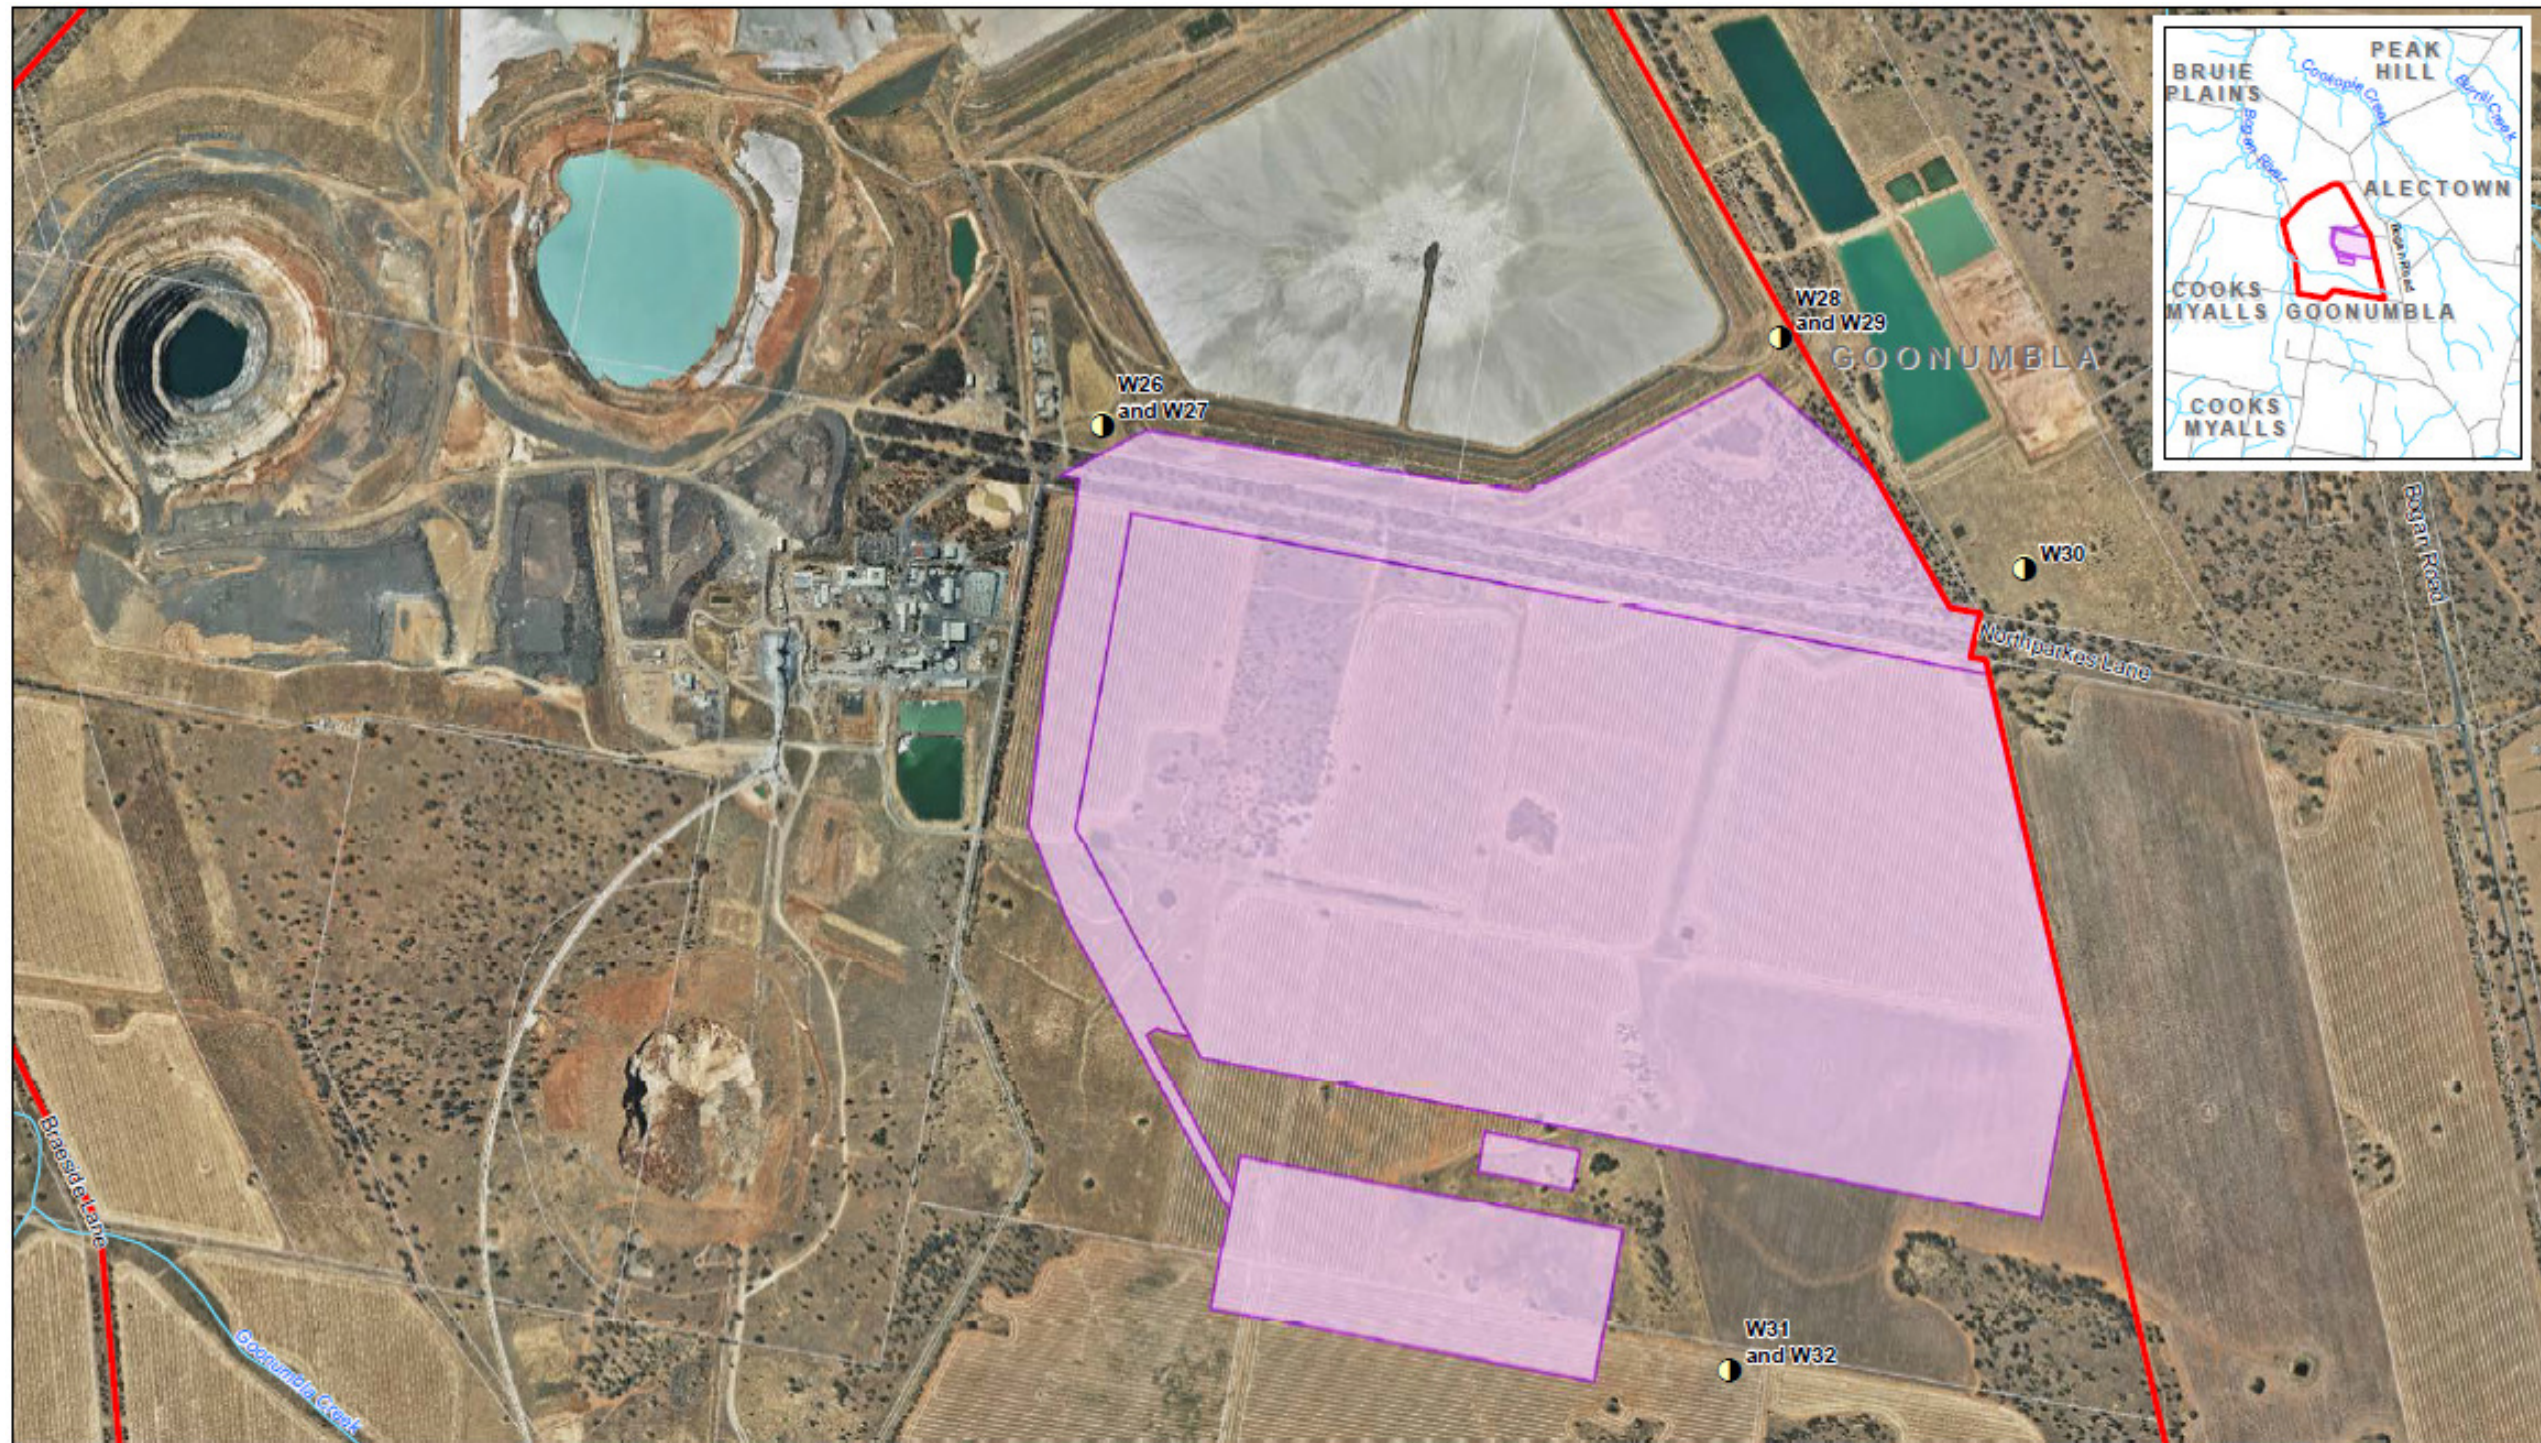
Figure 5-1

Figure 27 New groundwater monitoring bores at Rosedale tailings storage facility
