# 1 April to 30 June 2017 - Quarter 2 Environmental Monitoring Results Summary

<b>Name of Mine</b>	Northparkes Mines
<b>Name of Leaseholder and Mine Operator</b>	CMOC Mining Pty Ltd
<b>Mining Leases</b>	ML 1247, ML 1367, ML 1641 and 1743
<b>Environment Protection Licence</b>	EPL 4784
<b>Development Consent</b>	PA11-0060, (Mod 1-3)

# 1. SCOPE OF REPORT

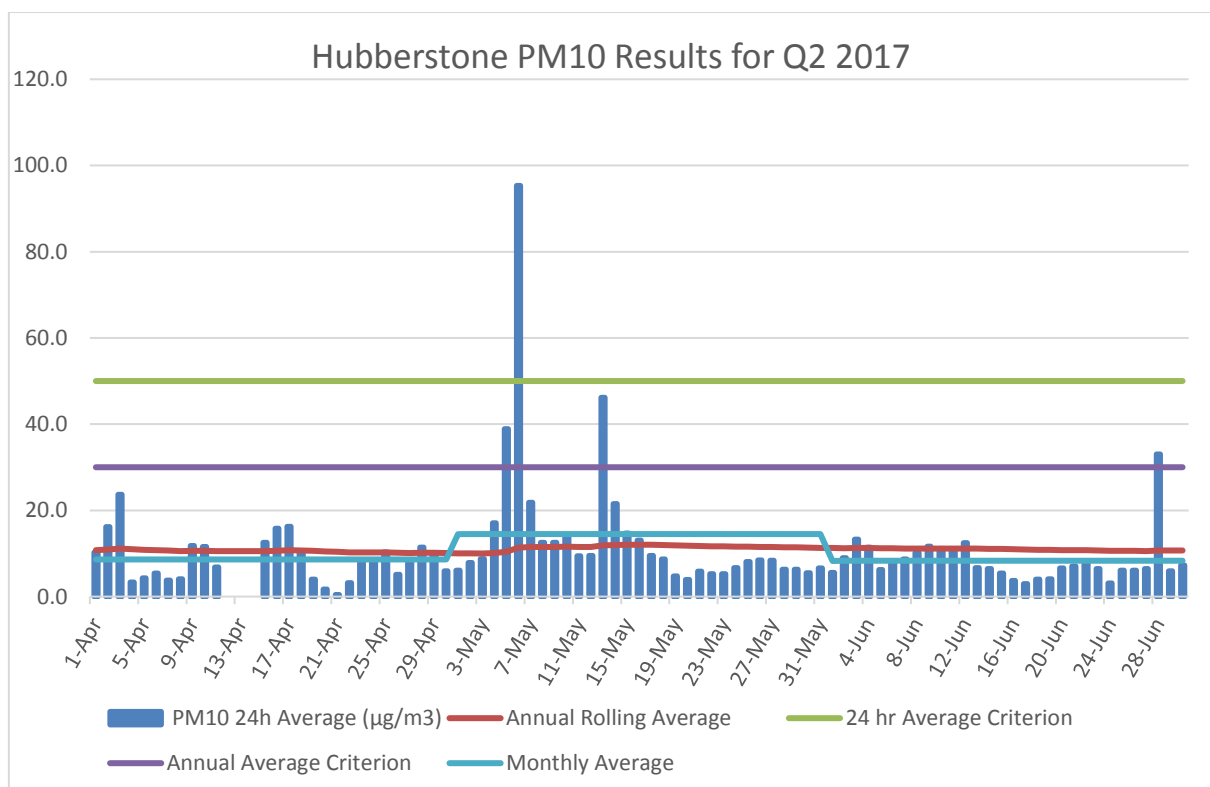
Figure 1: Hubberstone

PM<sub>10</sub> monitoring results for the 'Hubberstone', 'Milpose' and 'Hillview' monitoring locations, for the reporting period, are displayed in Figure 1, Figure 2 and Figure 3 respectively. The criteria for exceedances (as nominated in the Approval), is >30 µg/m<sup>3</sup> for the annual average and >50 µg/m<sup>3</sup> for a 24-hour monitoring period.

There was one 24hr criteria exceedance recorded at all locations on May 6<sup>th</sup>. Following an investigation, the result was found to be an isolated environmental anomaly and deemed non-mine related. The missing data for each of the locations was attributed to power surges, most likely the result of nearby lightning strikes, damaging equipment and/or equipment failure due to aging equipment.

The annual average PM<sub>10</sub> levels recorded at all PM<sub>10</sub> monitoring locations are below the predicted levels within the EA (20 µg/m<sup>3</sup>).

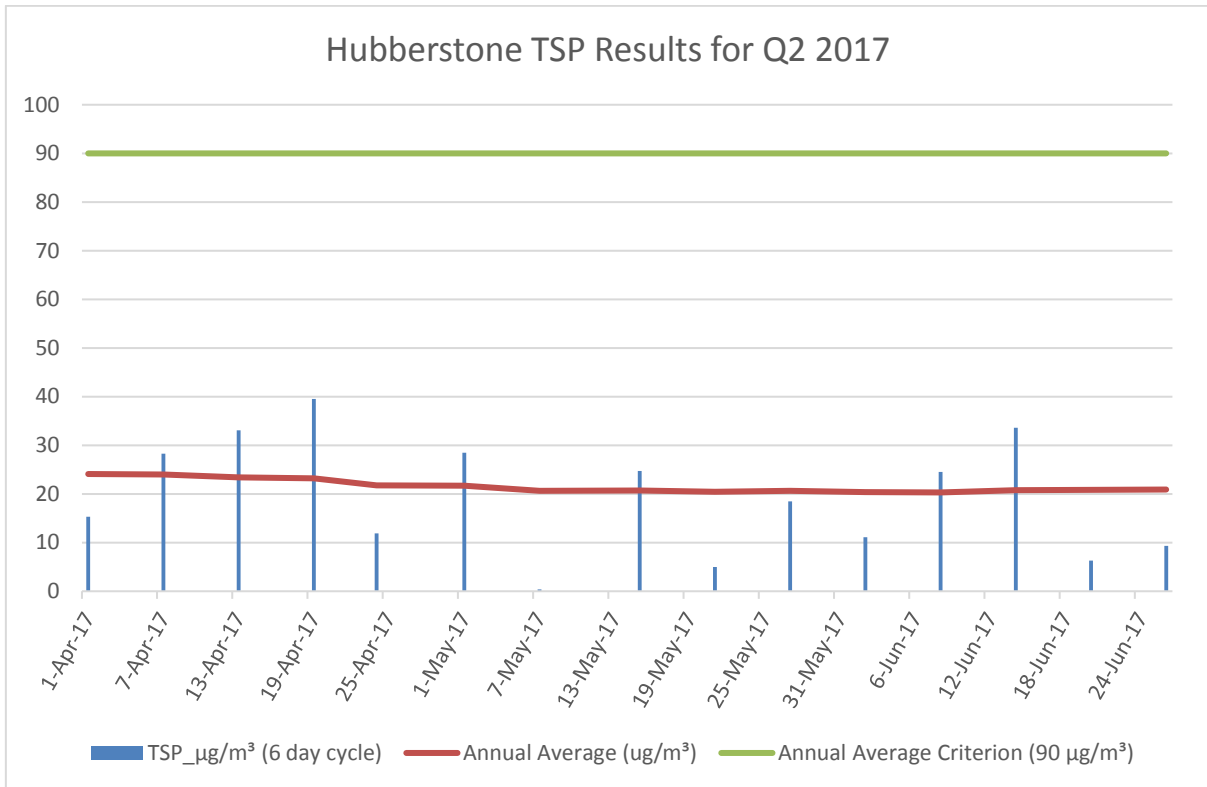
Figure 4: Hubberstone

All recorded dust levels at all TSP monitoring locations were under the required criteria set by the Approval (90 µg/m<sup>3</sup>) for the Q2 2017 monitoring period. Results are presented in Figure 4, Figure 5 and Figure 6 respectively. The annual average TSP dust levels recorded at all TSP monitoring locations are below the predicted levels within the EA (50 µg/m<sup>3</sup>).

The missing data for each of the locations was attributed to power surges, most likely the result of nearby lightning strikes, damaging equipment and/or equipment failure due to aging equipment.

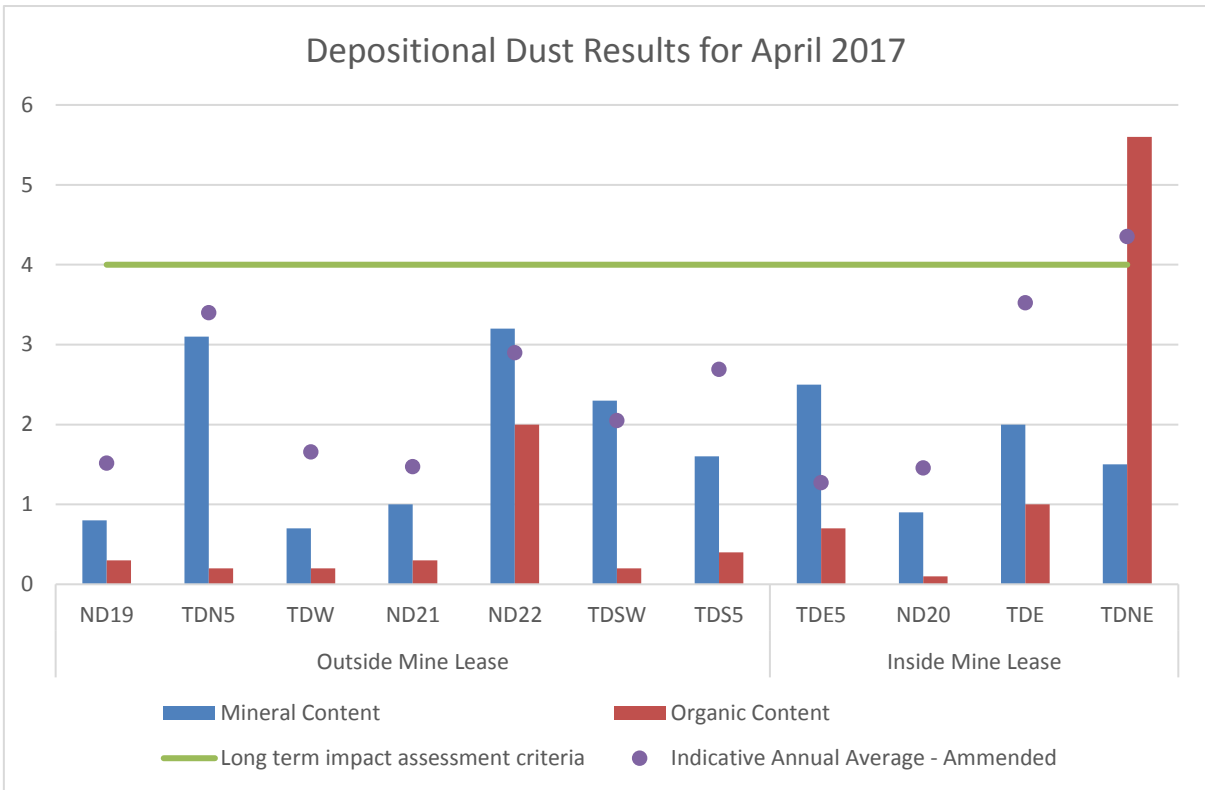
Eleven depositional dust gauges are located across the mining lease and neighbouring residential properties to monitor atmospheric dust. A summary of the monthly monitoring results at each monitoring location are presented in Figure 7, Figure 8 and Figure 9 respectively.

Although the indicative rolling average for the TDE and TDNE locations were slightly above the specified criteria for April, May and June, investigations determined that each location is consistently impacted by extraneous sources and does not represent Project generated dust, these months also coincide with an increase of localised agricultural activity. All other dust results remain below the criteria specified in the Approval.

**Figure 7:** April depositional dust results for all locations

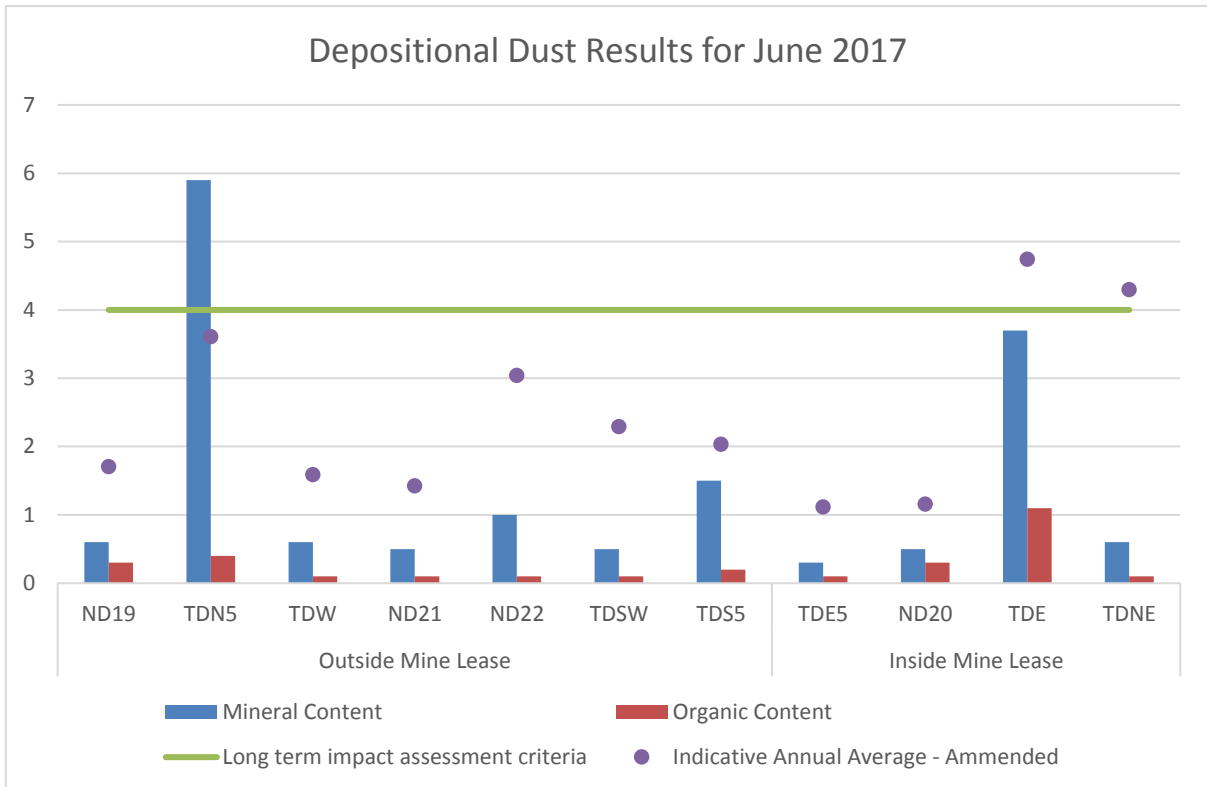
Figure 9: June depositional dust results for all locations
